# Harbor Lights Middle School

Coos\_sch12A

## FEMA 154 Rapid Visual Screening Score Card

Rapid Visual Screening - Senate Bill #2 - Seismic Needs Assessment  
Oregon Department of Geology and Mineral Industries

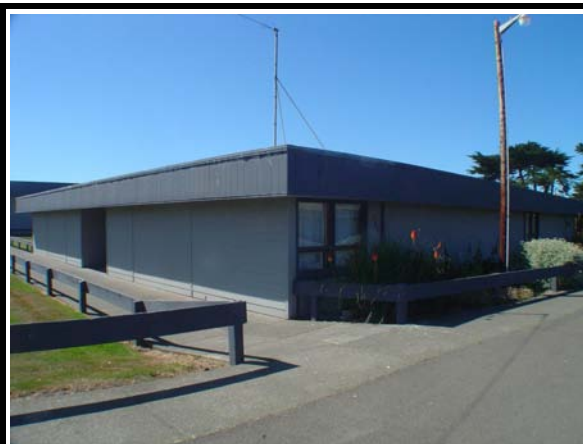
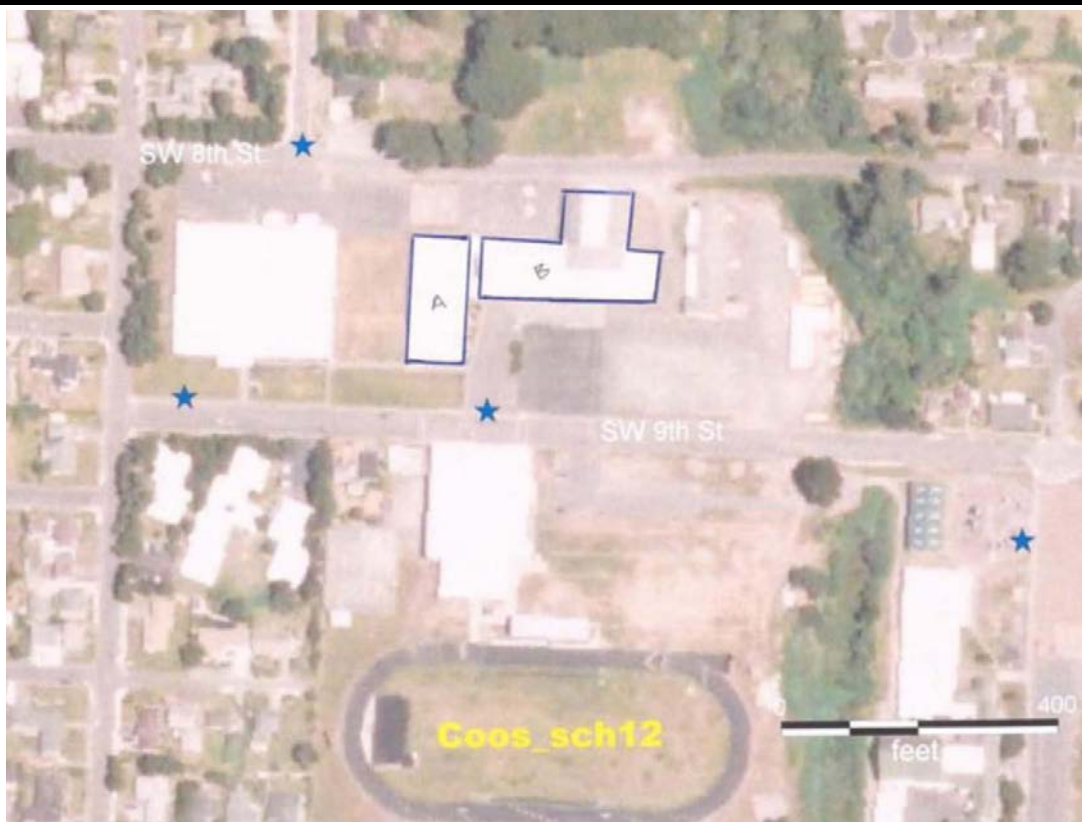
Type	Basic Score	Vert Irreg	Plan Irreg	Pre-Code	Post-Bench	Soil C	Soil D	Soil E	RVS Score
Primary	W2	3.8	0	0	0	0	0	-0.8	0	3
Secondary		0	0	0	0	0	0	0	0	0
Tertiary		0	0	0	0	0	0	0	0	0

W2

3

Low (<1%)

Plan Irregularities	Vertical Irregularities
None	None
None	None
None	None

Falling Hazards	Poor Conditions
None	None
None	None
None	None

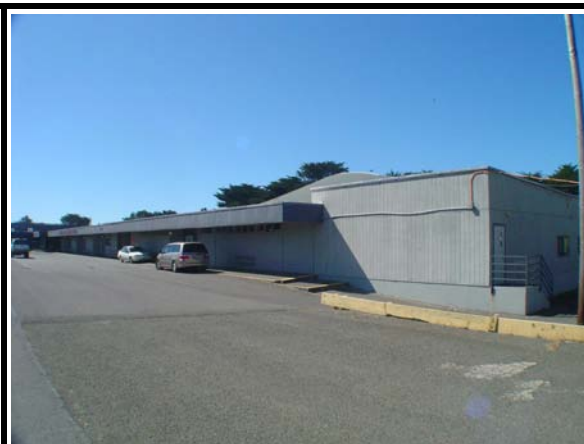
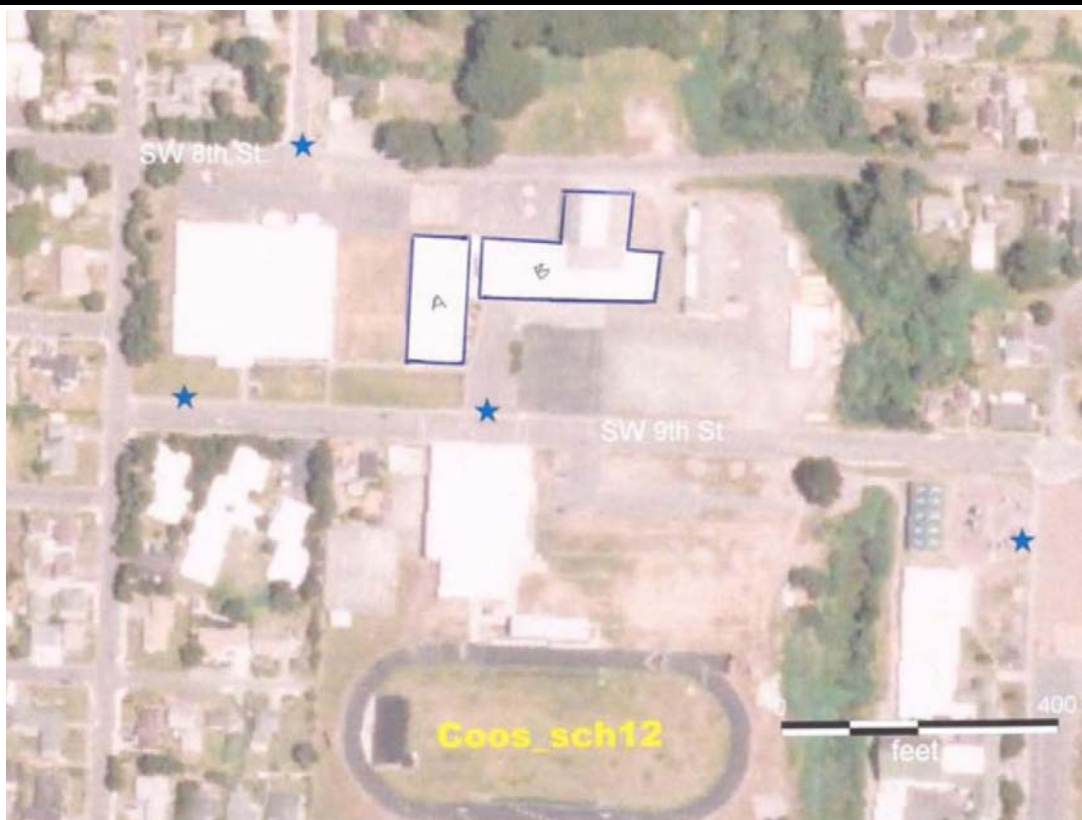
Coos\_sch12B

Type	Basic Score	Vert Irreg	Plan Irreg	Pre-Code	Post-Bench	Soil C	Soil D	Soil E	RVS Score
Primary	W2	3.8	0	-0.5	0	0	0	-0.8	0	2.5
Secondary	C2	2.8	0	-0.5	0	0	0	-0.6	0	1.7
Tertiary		0	0	0	0	0	0	0	0	0

C2

1.7

Moderate (>1%)

Falling Hazards	Poor Conditions
None	None
None	None
None	None
