Bandon Senior High School

Coos_sch14A

Rapid Visual Screening - Senate Bill #2 - Seismic Needs Assessment
Oregon Department of Geology and Mineral Industries

Coos_sch14B

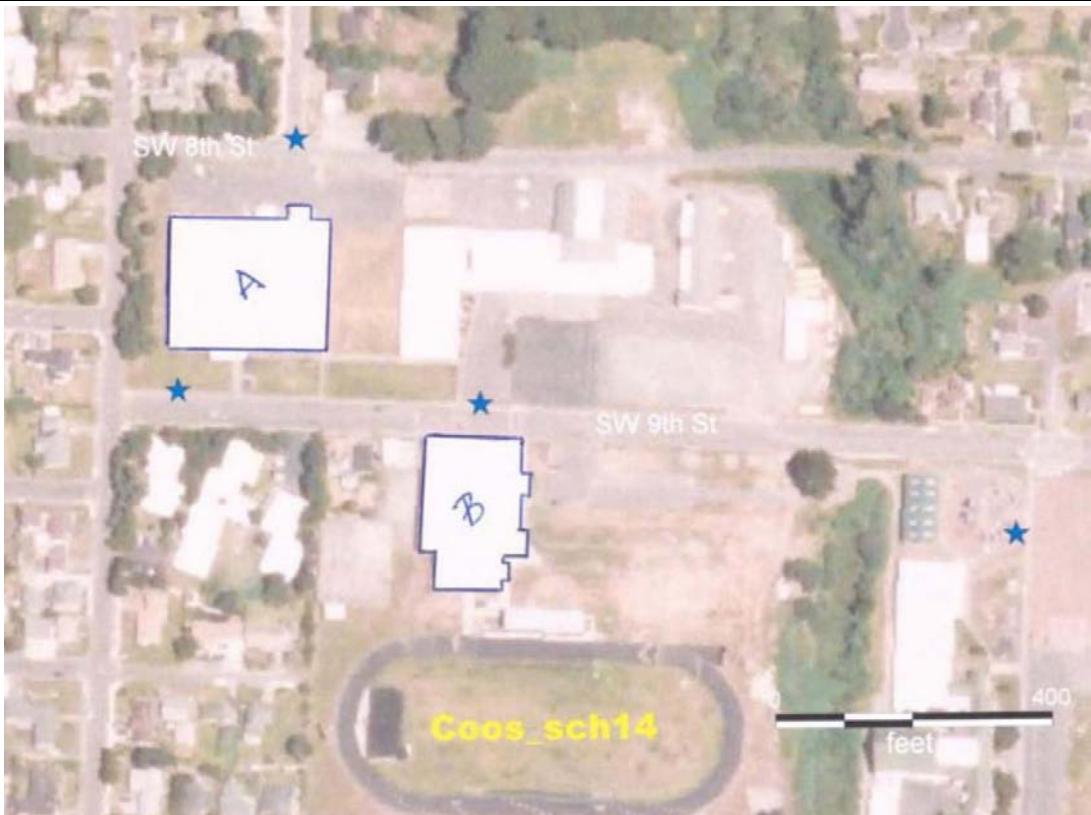
Enrollment 292	Year Built (Field Verified) 1975	Year Built (Alt. Source) 1970	Est. Decade Built 1970
Total Area (square ft) 60140	Number of Stories 1	Basement	Pounding Potential No
Plan Irregularities Reentrant Corners: Other None None		Vertical Irregularities Steps in Elevation View: 2 to 3 Changes None None	
Falling Hazards None None None		Poor Conditions None None None

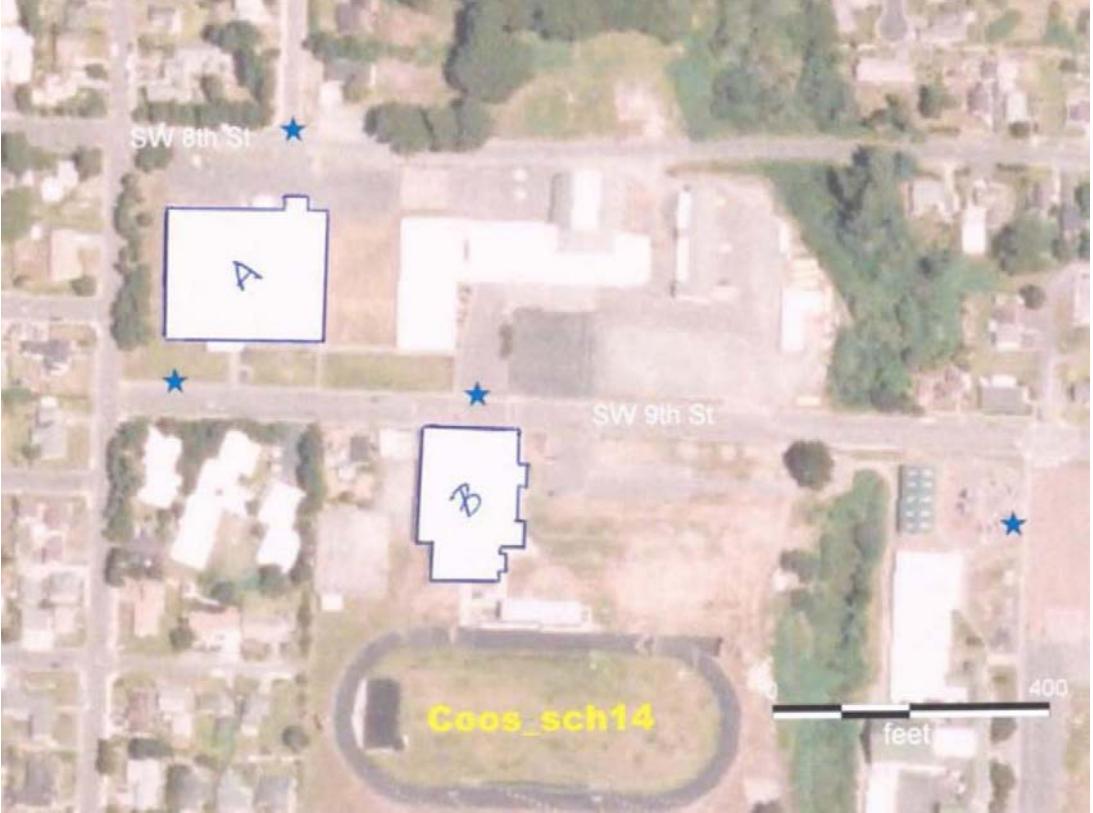
Enrollment 292	Year Built (Field Verified) 1975	Year Built (Alt. Source) 1970	Est. Decade Built 1970
Total Area (square ft) 60140	Number of Stories 1	Basement	Pounding Potential No
Plan Irregularities		Vertical Irregularities	
Reentrant Corners: Other		Steps in Elevation View: 2 to 3 Changes	
Out of Plane Lateral-Force-Resistance Elements		None	
None		None	
Falling Hazards		Poor Conditions	
None		None	
None		None	
None		None
