Black Butte RFPD

Desc_fir01A

FEMA 154 Rapid Visual Screening Score Card

Rapid Visual Screening - Senate Bill #2 - Seismic Needs Assessment
Oregon Department of Geology and Mineral Industries

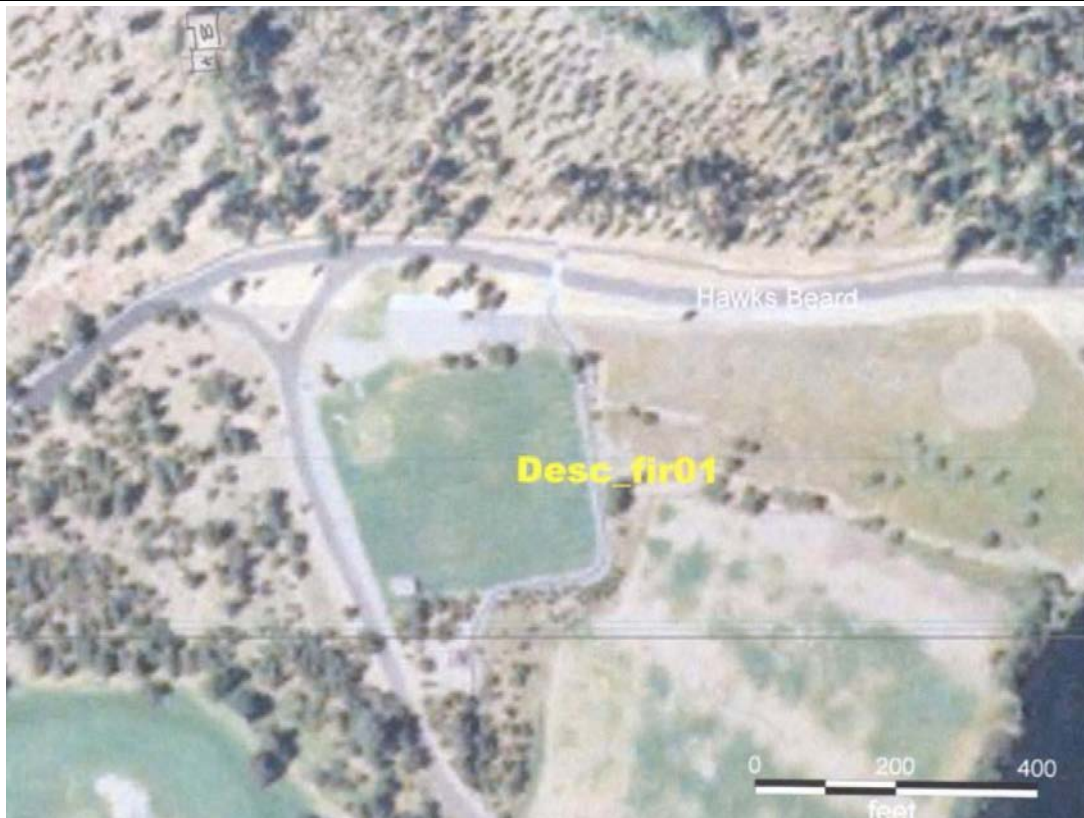
Enrollment	Year Built (Field Verified)	Year Built (Alt. Source)	Est. Decade Built
		1980	1980
Total Area (square ft)	Number of Stories	Basement	Pounding Potential
	2	No	No

Plan Irregularities	Vertical Irregularities
None	Steps in Elevation View: Single Change (Adjacent Building/Entity)
None	None
None	None

Falling Hazards	Poor Conditions
Other: General	None
None	None
None	None
