# Sisters-Camp Sherman RFPD

Desc\_fir05A

Building Type		County	
Fire - RFPD		Deschutes	
Street			
301 S Elm			
City	State	Zip	
Sisters	OR	97759	
Latitude		Longitude	
44.28942		121.55033	
Tracking Code		Inspection Date	
RVS in 2006		6/27/2006

Rapid Visual Screening - Senate Bill #2 - Seismic Needs Assessment  
Oregon Department of Geology and Mineral Industries

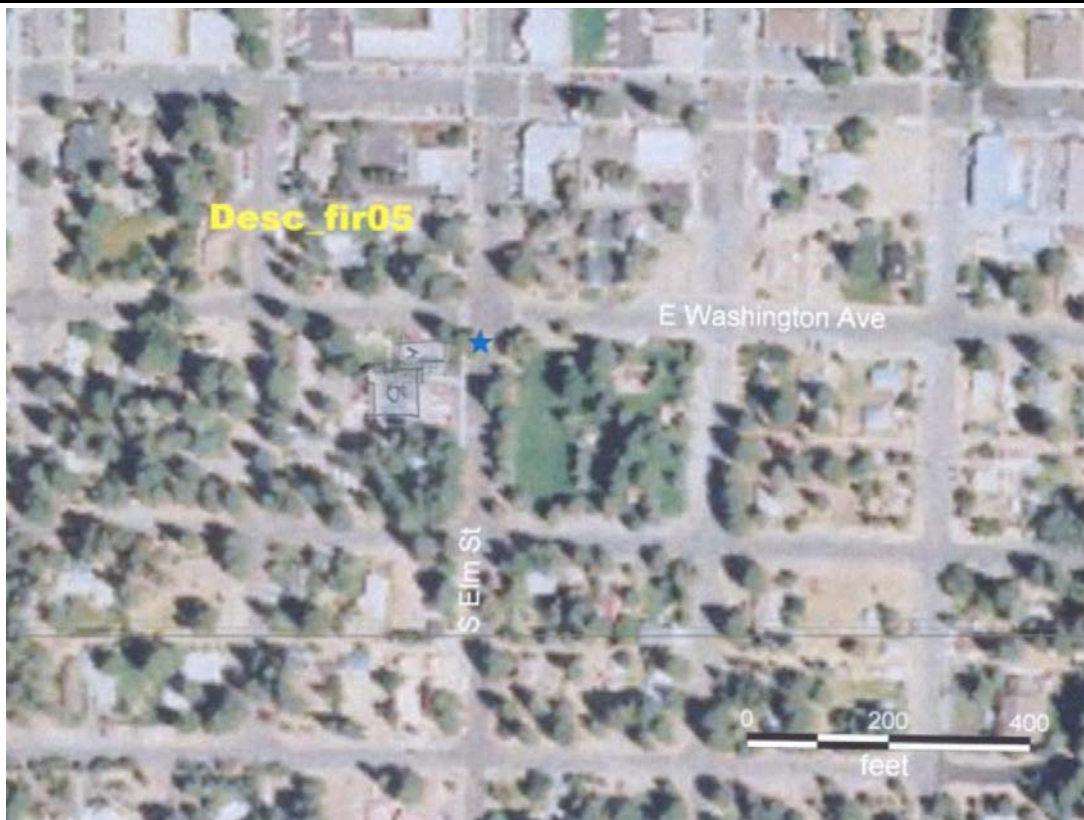
1

FEMA-154 Collapse Potential

High (>10%)

Plan Irregularities	Vertical Irregularities
Reentrant Corners: L Shaped	Steps in Elevation View: Single Change
None	None
None	None

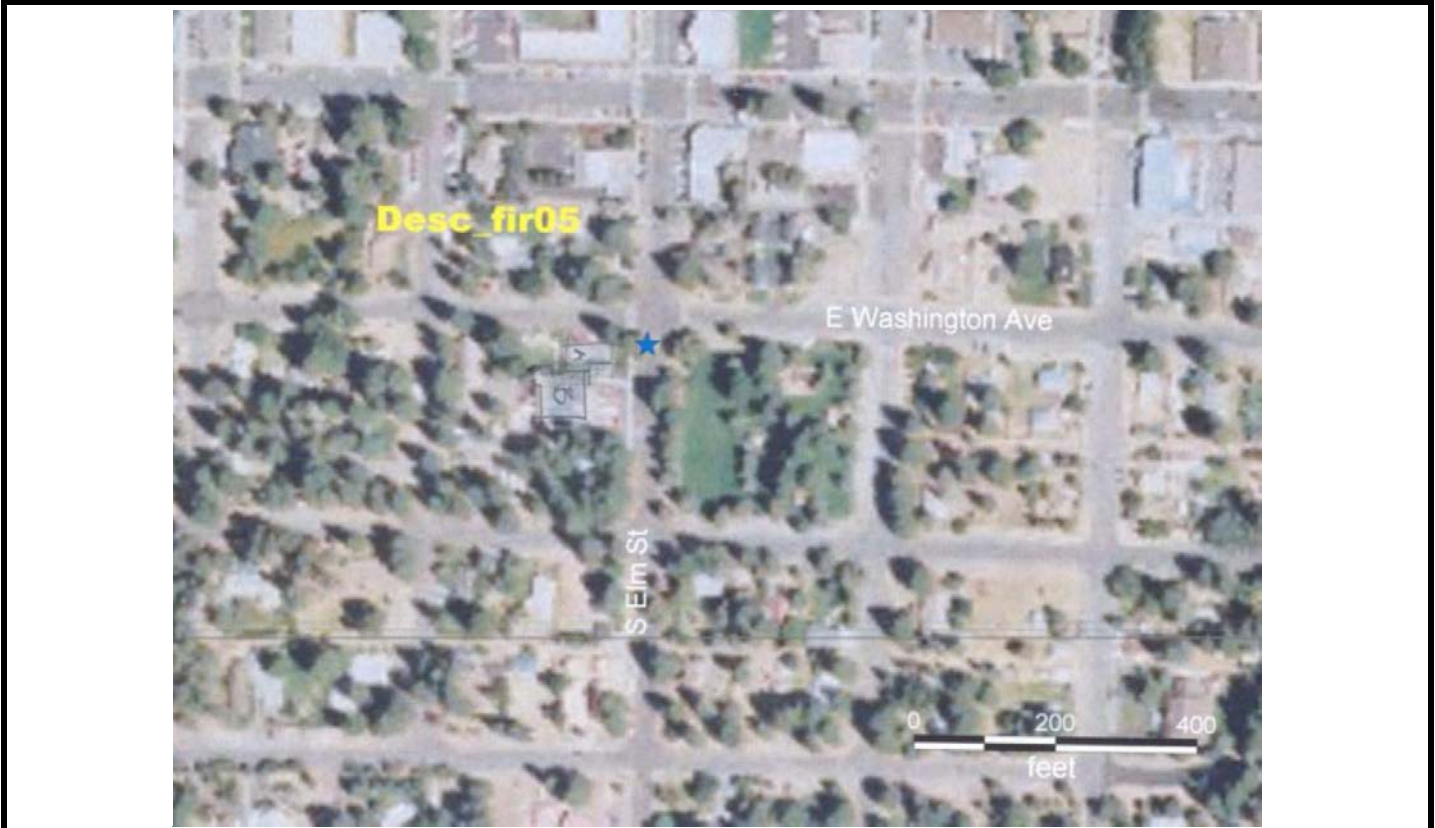
Seismicity Zone: Moderate											Sisters-Camp Sherman RFPD	
FEMA 154 Rapid Visual Screening Score Card											Final RVS Score	
	Type	Basic Score	Vert Irreg	Plan Irreg	Pre-Code	Post-Bench	Soil C	Soil D	Soil E	RVS Score	Final Type	Final Score
Primary	W1	5.2	-3.5	-0.5	0	0	-0.2	0	0	1	W1	1
Secondary		0	0	0	0	0	0	0	0	0		
Tertiary		0	0	0	0	0	0	0	0	0		
											FEMA-154 Collapse Potential	
											High (>10%)

Plan Irregularities	Vertical Irregularities
Out of Plane Lateral-Force-Resistance Elements	Steps in Elevation View: Single Change
Reentrant Corners: L Shaped	Steps in Elevation View: Single Change (Adjacent Building/Entity)
None	None
