Evergreen Elementary School

Redmond SD 2J

FEMA 154 Rapid Visual Screening Score Card

Rapid Visual Screening - Senate Bill #2 - Seismic Needs Assessment
Oregon Department of Geology and Mineral Industries

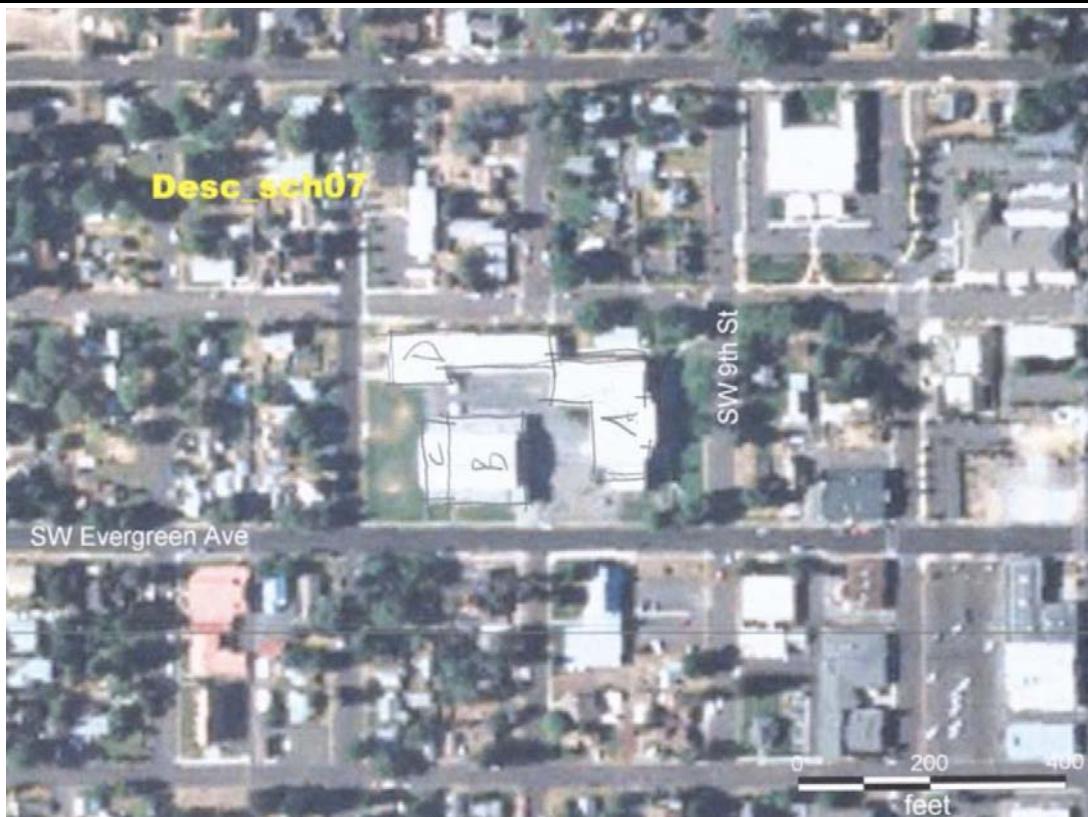
Desc_sch07A

Type	Basic Score	Vert Irreg	Plan Irreg	Pre-Code	Post-Bench	Soil C	Soil D	Soil E	RVS Score
Primary	URM	3.4	-1.5	-0.5	-0.4	0	-0.4	0	0	0.6
Secondary		0	0	0	0	0	0	0	0	0
Tertiary		0	0	0	0	0	0	0	0	0

Final Type	Final Score
URM	0.6

High (>10%)

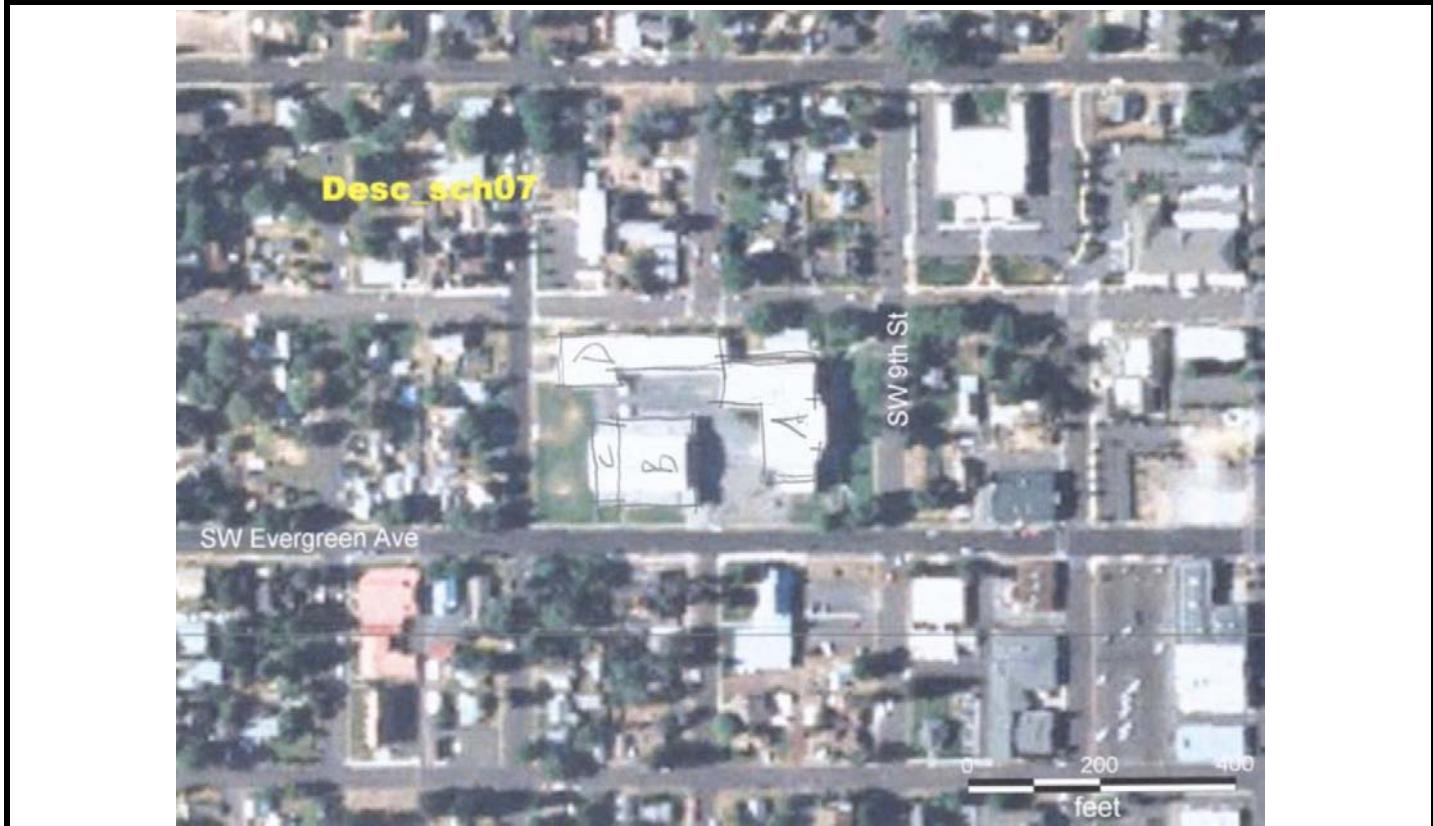
Desc_sch07B

Type	Basic Score	Vert Irreg	Plan Irreg	Pre-Code	Post-Bench	Soil C	Soil D	Soil E	RVS Score
Primary	C2	3.6	-2	0	0	0	-0.8	0	0	0.8
Secondary	RM1	3.6	-2	0	0	0	-0.8	0	0	0.8
Tertiary		0	0	0	0	0	0	0	0	0

Final Type	Final Score
C2	0.8

High (>10%)

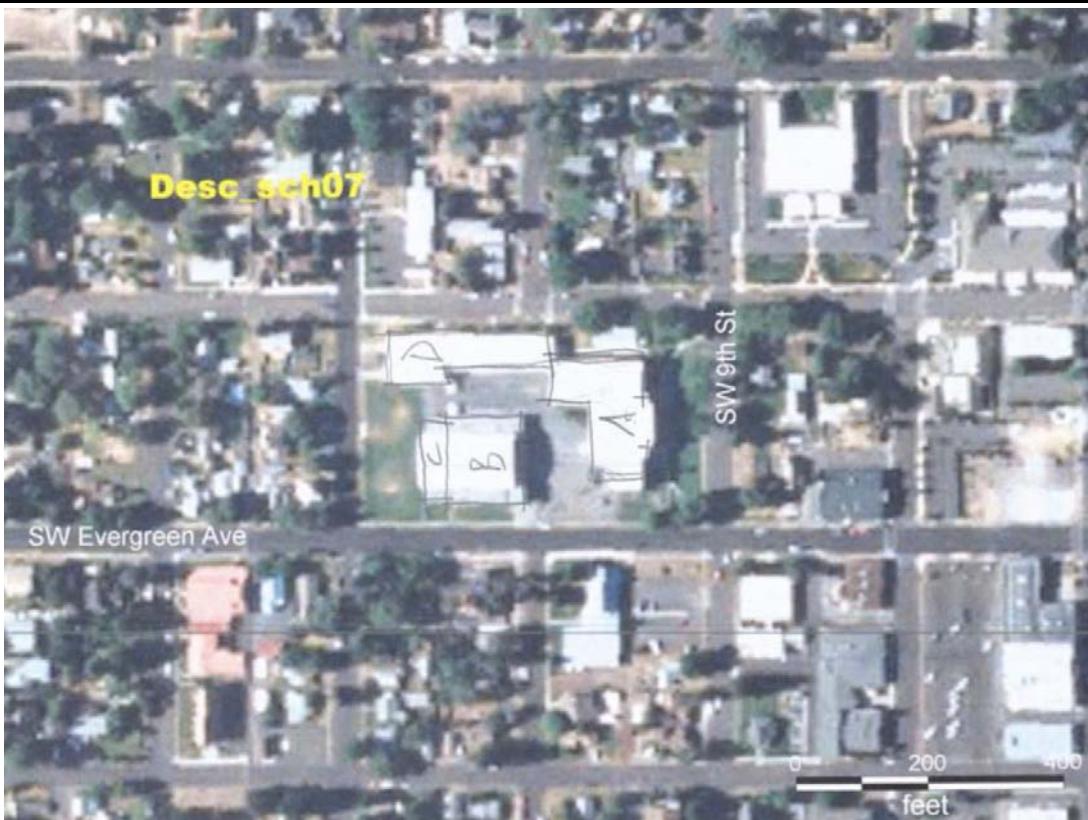
Desc_sch07C

Type	Basic Score	Vert Irreg	Plan Irreg	Pre-Code	Post-Bench	Soil C	Soil D	Soil E	RVS Score
Primary	C2	3.6	-2	0	0	0	-0.8	0	0	0.8
Secondary	RM1	3.6	-2	0	0	0	-0.8	0	0	0.8
Tertiary		0	0	0	0	0	0	0	0	0

Final Type	Final Score
C2	0.8

High (>10%)

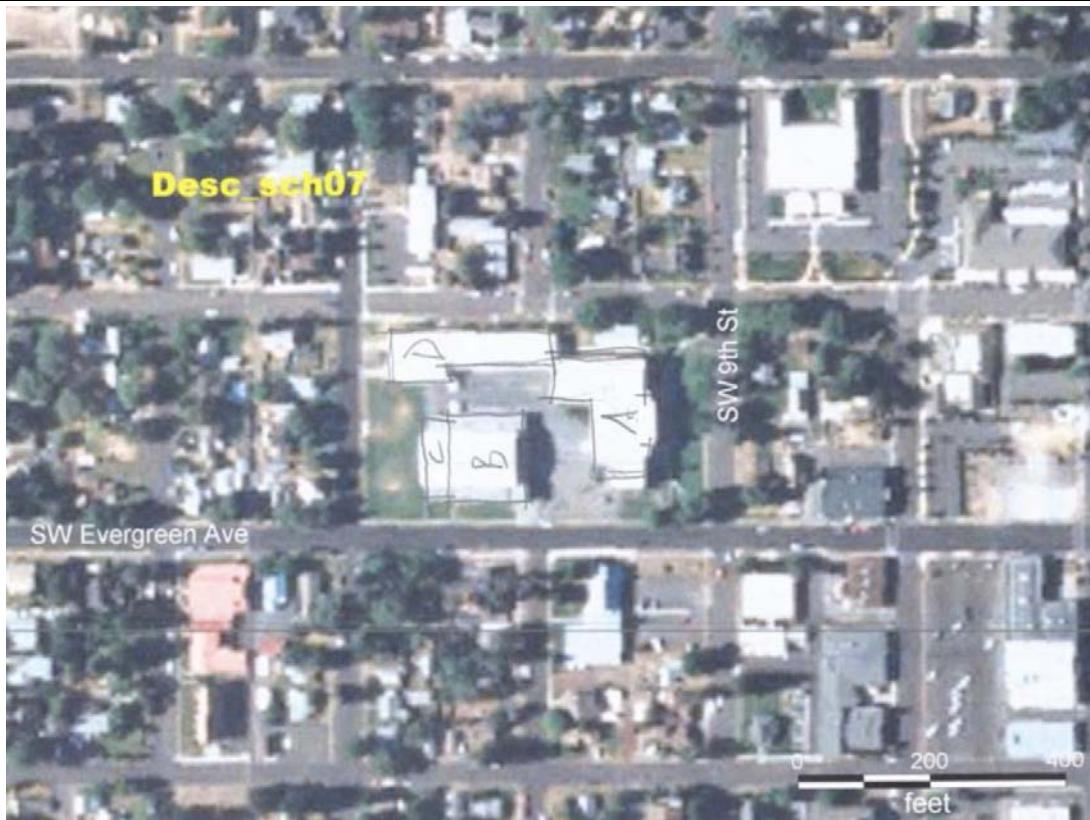
Desc_sch07D

Type	Basic Score	Vert Irreg	Plan Irreg	Pre-Code	Post-Bench	Soil C	Soil D	Soil E	RVS Score
Primary	RM1	3.6	0	-0.5	0	0	-0.8	0	0	2.3
Secondary		0	0	0	0	0	0	0	0	0
Tertiary		0	0	0	0	0	0	0	0	0

Final Type	Final Score
RM1	2.3

Low (<1%)
