# M A Lynch Elementary School

Redmond SD 2J

## FEMA 154 Rapid Visual Screening Score Card

Rapid Visual Screening - Senate Bill #2 - Seismic Needs Assessment  
Oregon Department of Geology and Mineral Industries

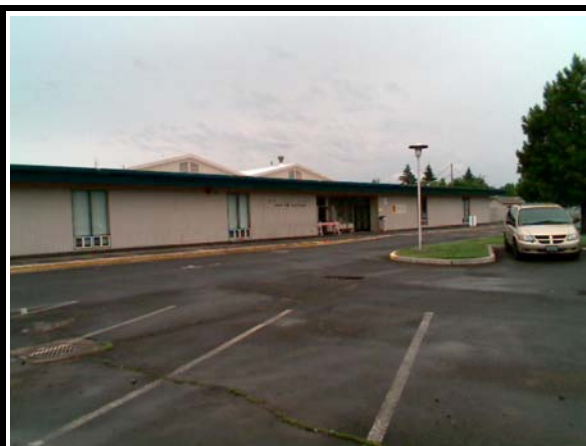
Seismicity Zone: Moderate

| | Type | Basic Score | Vert Irreg | Plan Irreg | Pre-Code | Post-Bench | Soil C | Soil D | Soil E | RVS Score |
|---|---|---|---|---|---|---|---|---|---|---|
| Primary | RM1 | 3.6 | -2 | -0.5 | 0 | 0 | 0 | 0 | 0 | 1.1 |

1.1

Moderate (>1%)

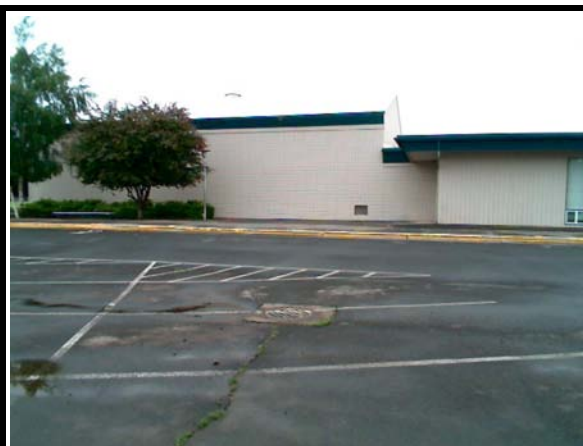
Seismicity Zone: Moderate

| | Type | Basic Score | Vert Irreg | Plan Irreg | Pre-Code | Post-Bench | Soil C | Soil D | Soil E | RVS Score |
|---|---|---|---|---|---|---|---|---|---|---|
| Primary | RM1 | 3.6 | -2 | -0.5 | 0 | 0 | 0 | 0 | 0 | 1.1 |

1.1

Moderate (>1%)
