# Sisters Middle School

Building Type		County	
School		Deschutes	
Street			
15200 Mckenzie Hwy			
City	State	Zip	
Sisters	OR	97759	
Latitude		Longitude	
44.29278		121.57132	
Tracking Code		Inspection Date	
RVS in 2006		6/28/2006

## FEMA 154 Rapid Visual Screening Score Card

Rapid Visual Screening - Senate Bill #2 - Seismic Needs Assessment  
Oregon Department of Geology and Mineral Industries

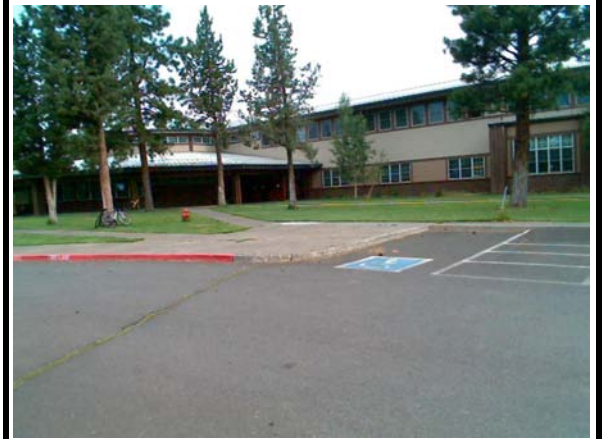
Seismicity Zone: Moderate

Type	Basic Score	Vert Irreg	Plan Irreg	Pre-Code	Post-Bench	Soil C	Soil D	Soil E	RVS Score
Primary	S2	3.6	-2	-0.5	0	0	0	-1.2	0	-0.1
Secondary	S1	3.6	-2	-0.5	0	0	0	-1	0	0.1
Tertiary	W2	4.8	-3	-0.5	0	1.6	0	-1.2	0	1.7

## Final RVS Score

S2

-0.1

## FEMA-154 Collapse Potential

Very High (100%)

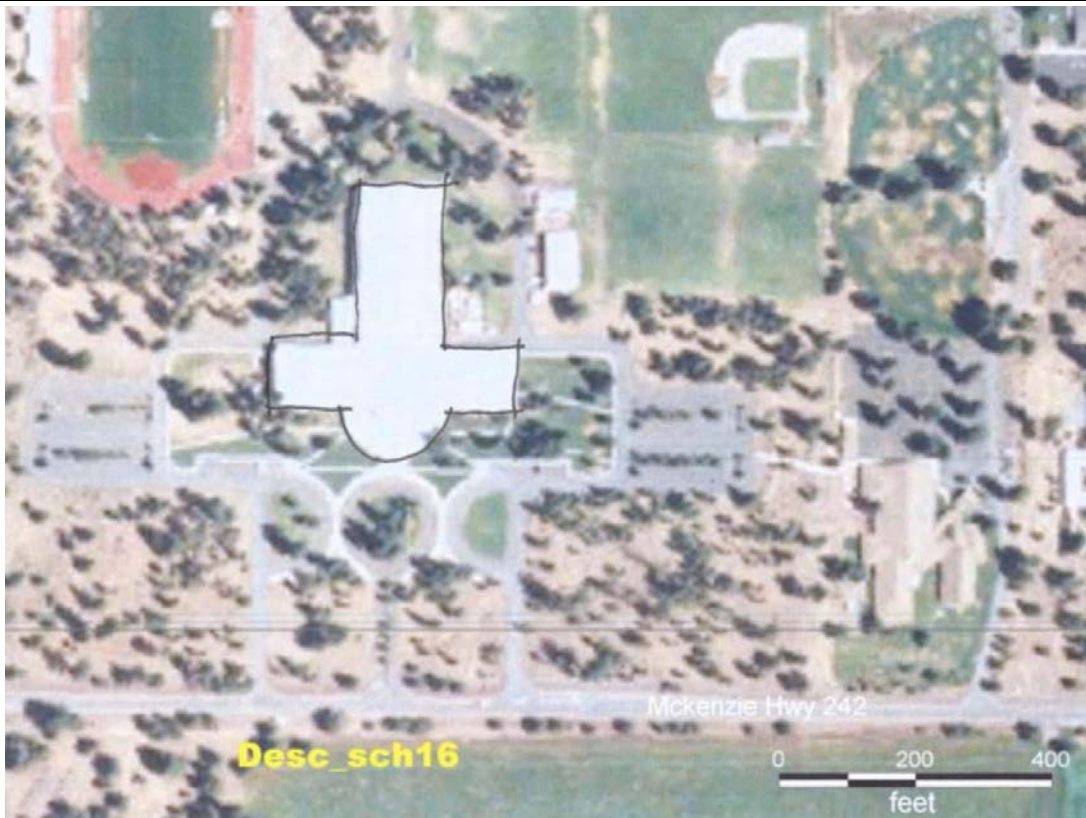
Enrollment	Year Built (Field Verified)	Year Built (Alt. Source)	Est. Decade Built
322		1992	1990
Total Area (square ft)	Number of Stories	Basement	Pounding Potential
96400	2	No	No

Plan Irregularities	Vertical Irregularities
Reentrant Corners: T shaped	Steps in Elevation View: 2 to 3 Changes
Large Diaphragm or Central Opening	None
None	None

Falling Hazards	Poor Conditions
None	None
None	None
None	None
