Douglas County Fire District 2 - Dixonville Station #1

Doug_fir01A

FEMA 154 Rapid Visual Screening Score Card

Rapid Visual Screening - Senate Bill #2 - Seismic Needs Assessment
Oregon Department of Geology and Mineral Industries

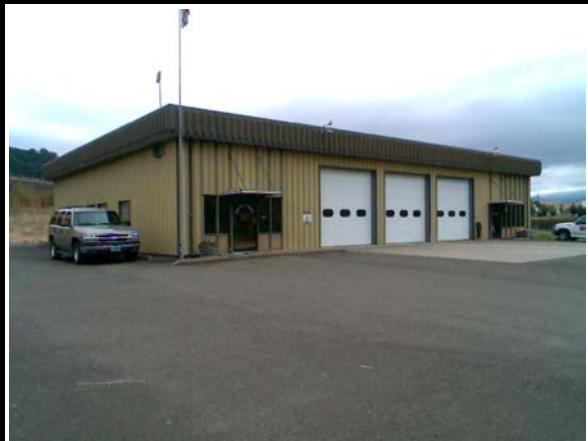
Type	Basic Score	Vert Irreg	Plan Irreg	Pre-Code	Post-Bench	Soil C	Soil D	Soil E	RVS Score
Primary	S3	3.2	0	0	0	0	-0.4	0	0	2.8
Secondary		0	0	0	0	0	0	0	0	0
Tertiary		0	0	0	0	0	0	0	0	0

Final Type	Final Score
S3	2.8

Low (<1%)

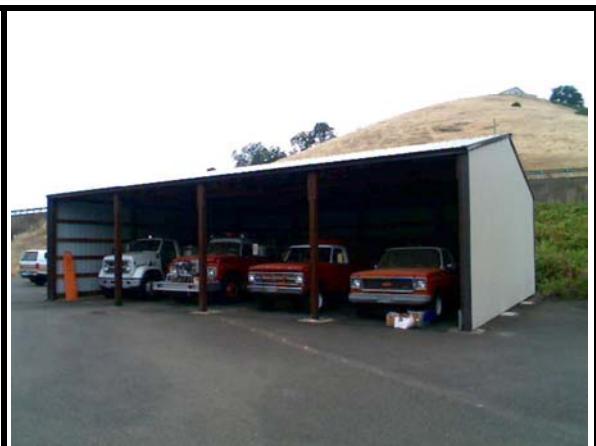
Doug_fir01B

Type	Basic Score	Vert Irreg	Plan Irreg	Pre-Code	Post-Bench	Soil C	Soil D	Soil E	RVS Score
Primary	S3	3.2	0	-0.5	0	0	-0.4	0	0	2.3
Secondary		0	0	0	0	0	0	0	0	0
Tertiary		0	0	0	0	0	0	0	0	0

Final Type	Final Score
S3	2.3

Low (<1%)

Enrollment	Year Built (Field Verified)	Year Built (Alt. Source)	Est. Decade Built
			1980
Total Area (square ft)	Number of Stories	Basement	Pounding Potential
	1	No	No
Plan Irregularities		Vertical Irregularities	
Torsion: Eccentric Stiffness		None	
None		None	
None		None	
Falling Hazards		Poor Conditions	
None		None	
None		None	
None		None
