North Douglas County Fire & EMS

Doug_fir02A

FEMA 154 Rapid Visual Screening Score Card

Rapid Visual Screening - Senate Bill #2 - Seismic Needs Assessment
Oregon Department of Geology and Mineral Industries

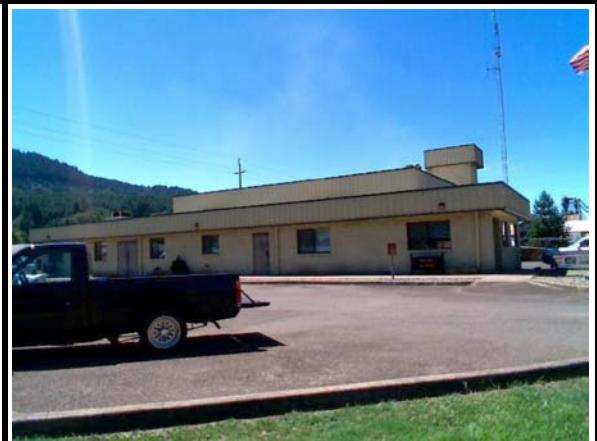
Seismicity Zone: High

Type	Basic Score	Vert Irreg	Plan Irreg	Pre-Code	Post-Bench	Soil C	Soil D	Soil E	RVS Score
Primary	RM1	2.8	-1	-0.5	0	0	-0.4	0	0	0.9
Secondary	S3	3.2	0	-0.5	0	0	-0.4	0	0	2.3
Tertiary		0	0	0	0	0	0	0	0	0

Final Type	Final Score
RM1	0.9

High (>10%)

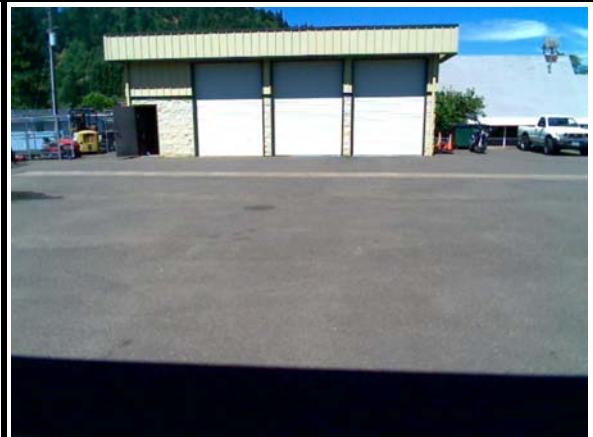
Doug_fir02B

Seismicity Zone: High
