# Fair Oaks RFPD

| RVS in 2006 | | 8/11/2006 | |

## FEMA 154 Rapid Visual Screening Score Card

Rapid Visual Screening - Senate Bill #2 - Seismic Needs Assessment  
Oregon Department of Geology and Mineral Industries

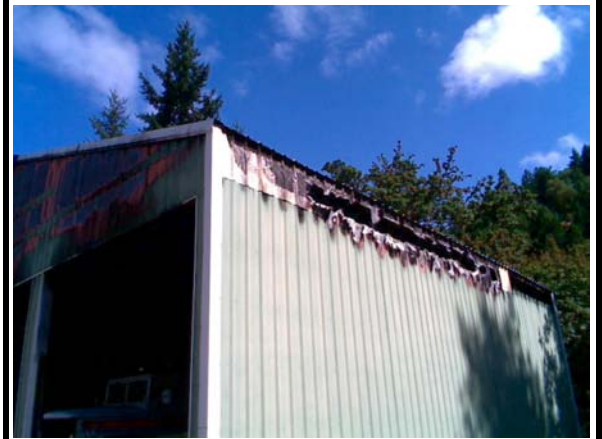
| | Type | Basic Score | Vert Irreg | Plan Irreg | Pre-Code | Post-Bench | Soil C | Soil D | Soil E | RVS Score |
|---|---|---|---|---|---|---|---|---|---|---|
| Primary | S3 | 3.2 | 0 | -0.5 | 0 | 0 | -0.4 | 0 | 0 | 2.3 |

2.3

Low (<1%)
