# Lookingglass VFD

## FEMA 154 Rapid Visual Screening Score Card

Rapid Visual Screening - Senate Bill #2 - Seismic Needs Assessment  
Oregon Department of Geology and Mineral Industries

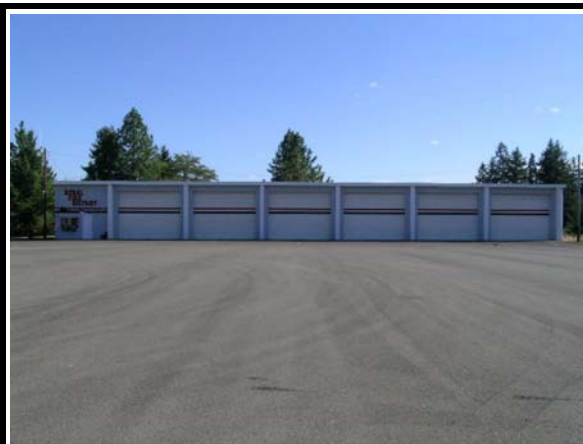
Seismicity Zone: High

| | Type | Basic Score | Vert Irreg | Plan Irreg | Pre-Code | Post-Bench | Soil C | Soil D | Soil E | RVS Score |
|---|---|---|---|---|---|---|---|---|---|---|
| Primary | RM1 | 2.8 | 0 | -0.5 | 0 | 0 | -0.4 | 0 | 0 | 1.9 |

RM1

1.9

FEMA-154 Collapse Potential

Moderate (>1%)
