Glendale FD #1

Doug_fir31A

FEMA 154 Rapid Visual Screening Score Card

Rapid Visual Screening - Senate Bill #2 - Seismic Needs Assessment
Oregon Department of Geology and Mineral Industries

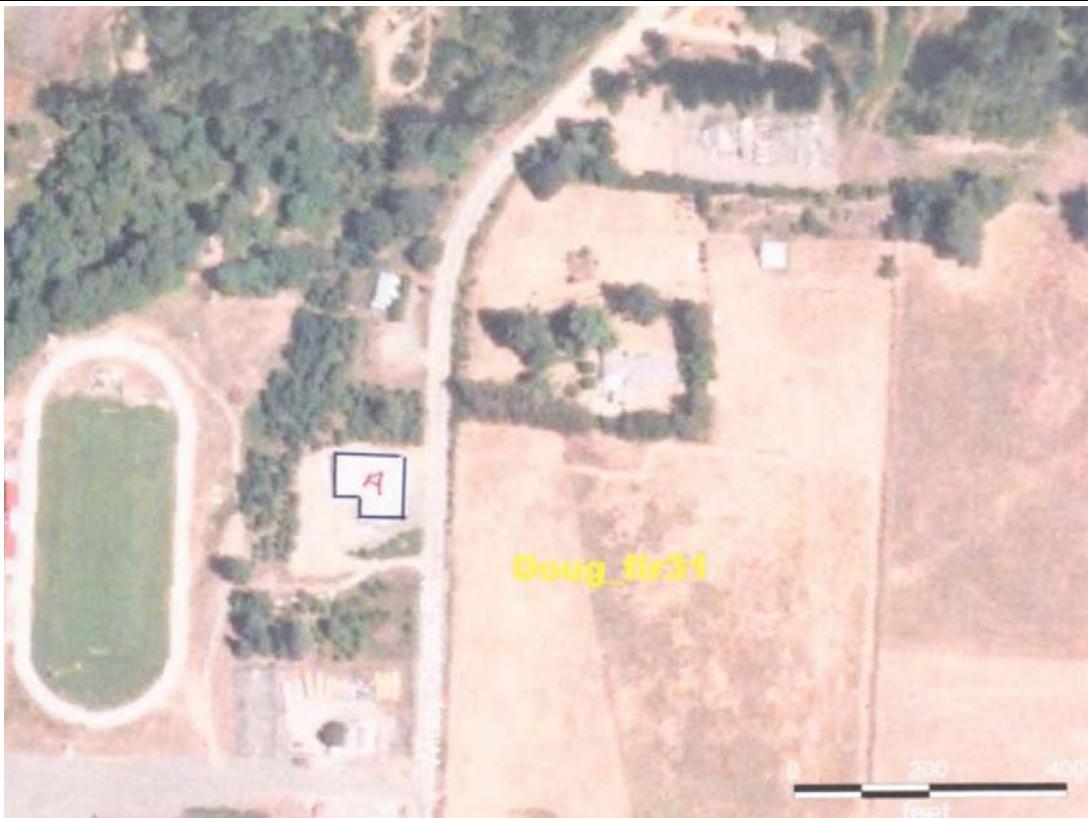
Enrollment	Year Built (Field Verified)	Year Built (Alt. Source)	Est. Decade Built
			2000
Total Area (square ft)	Number of Stories	Basement	Pounding Potential
	1	No	No
Plan Irregularities		Vertical Irregularities	
Reentrant Corners: L Shaped		None	
Torsion: Eccentric Stiffness		None	
None		None	
Falling Hazards		Poor Conditions	
None		None	
None		None	
None		None

SW Plan Irregularity Primary
