Rose Elementary School

Douglas County SD 4

FEMA 154 Rapid Visual Screening Score Card

Rapid Visual Screening - Senate Bill #2 - Seismic Needs Assessment
Oregon Department of Geology and Mineral Industries

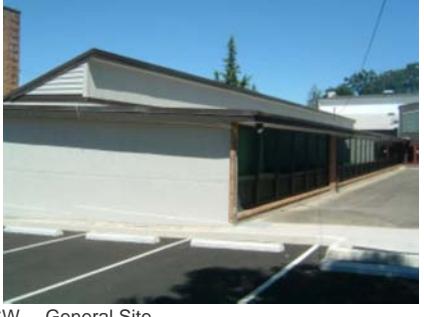
| | | | <p>NW Falling Hazard chimney reinforced?</p> <p>SW General Site</p> <p>S Plan Irregularity Primary step in elevation also</p> |

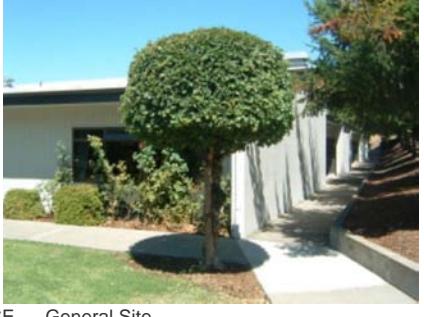
| SW Plan Irregularity Primary step in elevation also | | SE General Site | |
