Joseph Lane Middle School

| RVS in 2006 | | 8/25/2006 | |

FEMA 154 Rapid Visual Screening Score Card

Rapid Visual Screening - Senate Bill #2 - Seismic Needs Assessment
Oregon Department of Geology and Mineral Industries

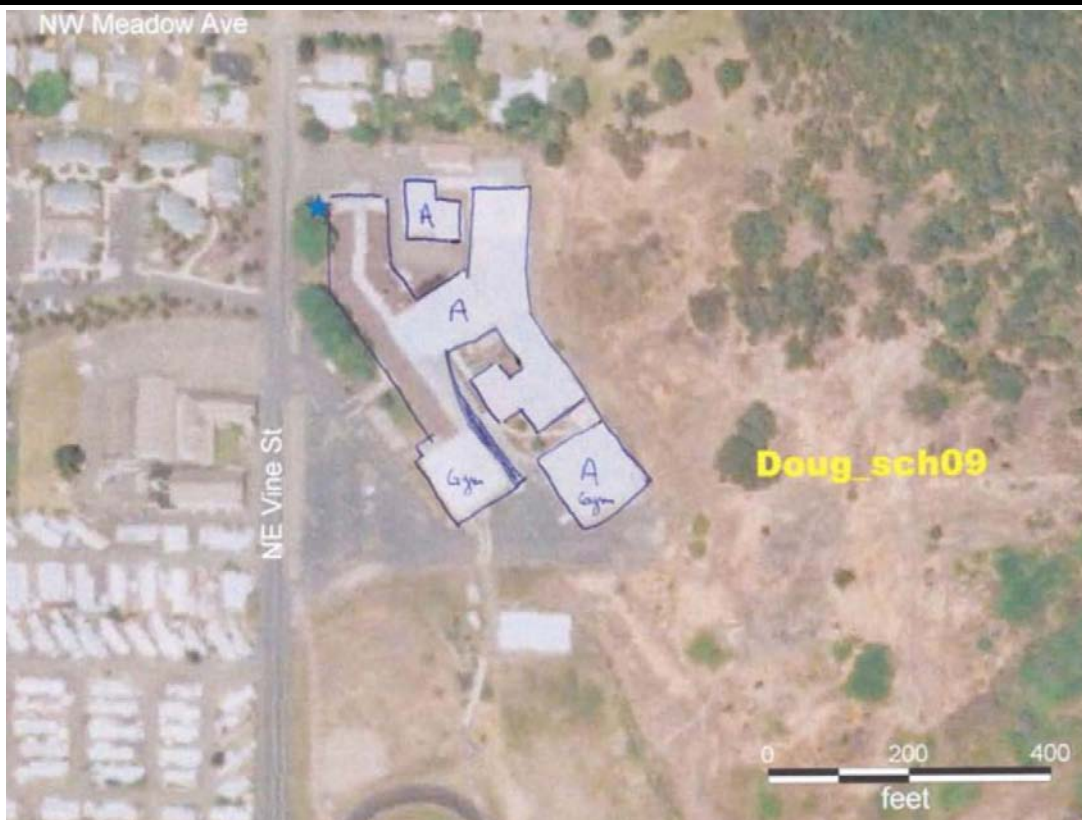
| | Type | Basic Score | Vert Irreg | Plan Irreg | Pre-Code | Post-Bench | Soil C | Soil D | Soil E | RVS Score |
|---|---|---|---|---|---|---|---|---|---|---|
| Primary | W2 | 3.8 | -2 | -0.5 | 0 | 0 | 0 | 0 | 0 | 1.3 |

Moderate (>1%)

W Falling Hazard
reinforced chimney?
