Glide Elementary School

Glide SD 12

FEMA 154 Rapid Visual Screening Score Card

Rapid Visual Screening - Senate Bill #2 - Seismic Needs Assessment
Oregon Department of Geology and Mineral Industries

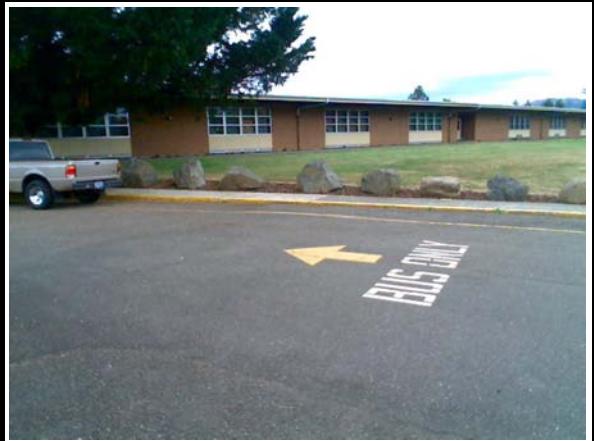
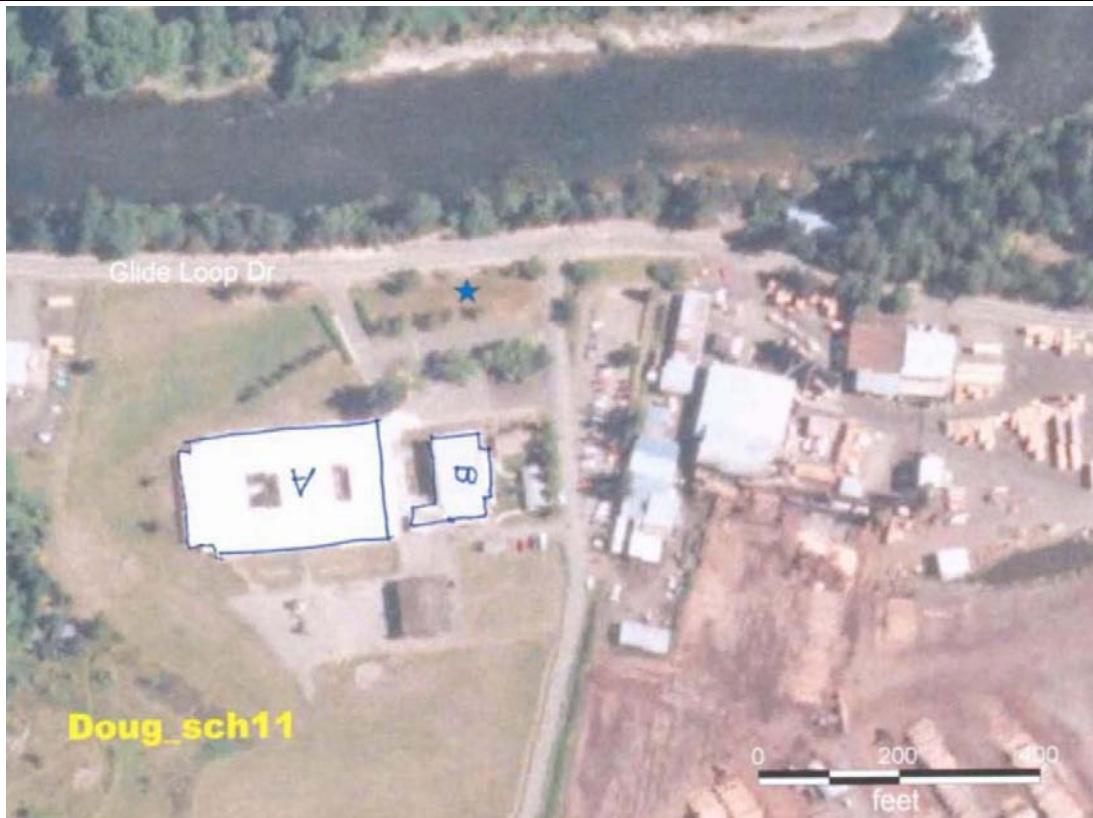
Doug_sch11A

Type	Basic Score	Vert Irreg	Plan Irreg	Pre-Code	Post-Bench	Soil C	Soil D	Soil E	RVS Score
Primary	RM1	2.8	0	0	0	0	-0.4	0	0	2.4
Secondary		0	0	0	0	0	0	0	0	0
Tertiary		0	0	0	0	0	0	0	0	0

Final Type	Final Score
RM1	2.4

Low (<1%)

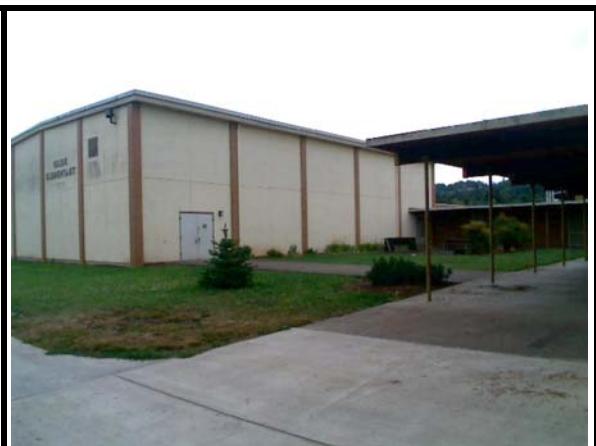
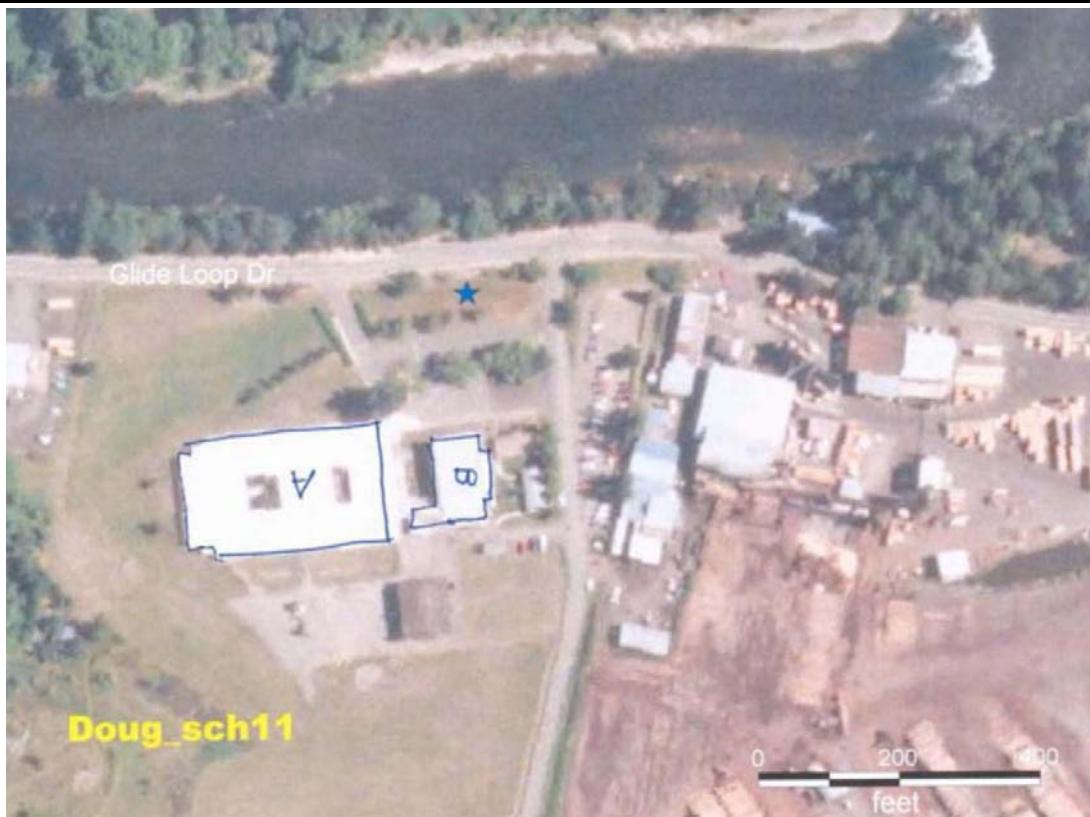
Doug_sch11B

Type	Basic Score	Vert Irreg	Plan Irreg	Pre-Code	Post-Bench	Soil C	Soil D	Soil E	RVS Score
Primary	RM1	2.8	-1	-0.5	0	0	-0.4	0	0	0.9
Secondary	PC1	2.6	0	-0.5	0	0	-0.4	0	0	1.7
Tertiary		0	0	0	0	0	0	0	0	0

Final Type	Final Score
RM1	0.9

High (>10%)
