# Canyonville School

Doug\_sch13A

## FEMA 154 Rapid Visual Screening Score Card

Rapid Visual Screening - Senate Bill #2 - Seismic Needs Assessment  
Oregon Department of Geology and Mineral Industries

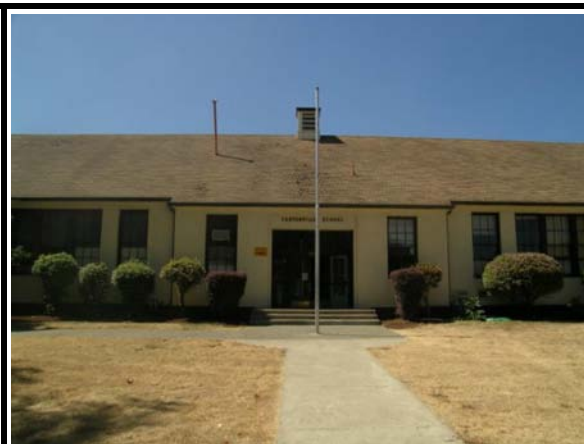
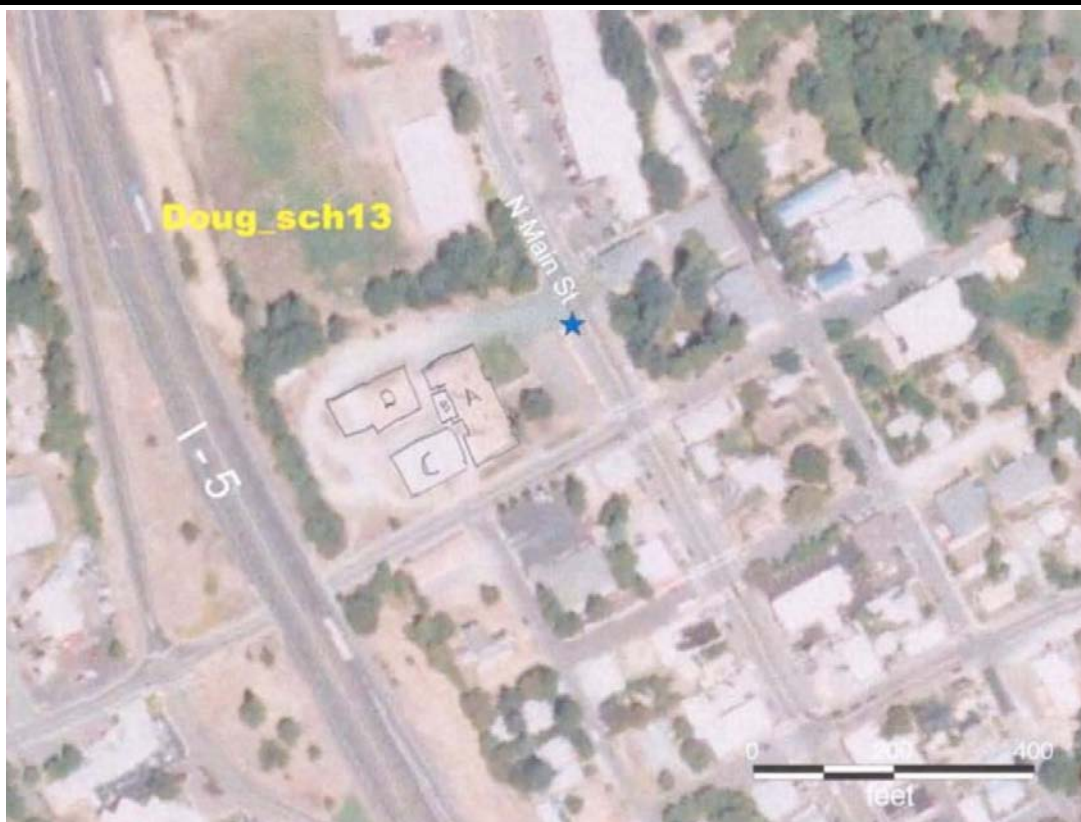
Type	Basic Score	Vert Irreg	Plan Irreg	Pre-Code	Post-Bench	Soil C	Soil D	Soil E	RVS Score
Primary	C2	2.8	-1	-0.5	-1	0	-0.4	0	0	-0.1
Secondary		0	0	0	0	0	0	0	0	0
Tertiary		0	0	0	0	0	0	0	0	0

-0.1

Very High (100%)

Plan Irregularities	Vertical Irregularities
Reentrant Corners: Other (Adjacent Build/Entity)	Steps in Elevation View: Single Change (Adjacent Building/Entity)
Reentrant Corners: Other	None
None	None

Falling Hazards	Poor Conditions
Unreinforced Chimneys	Open cracks in structural members
None	None
None	None

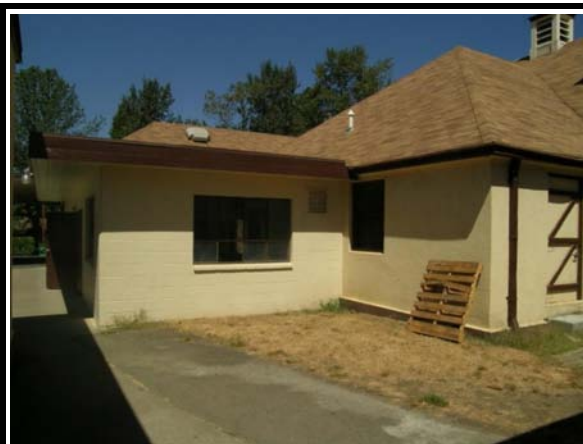
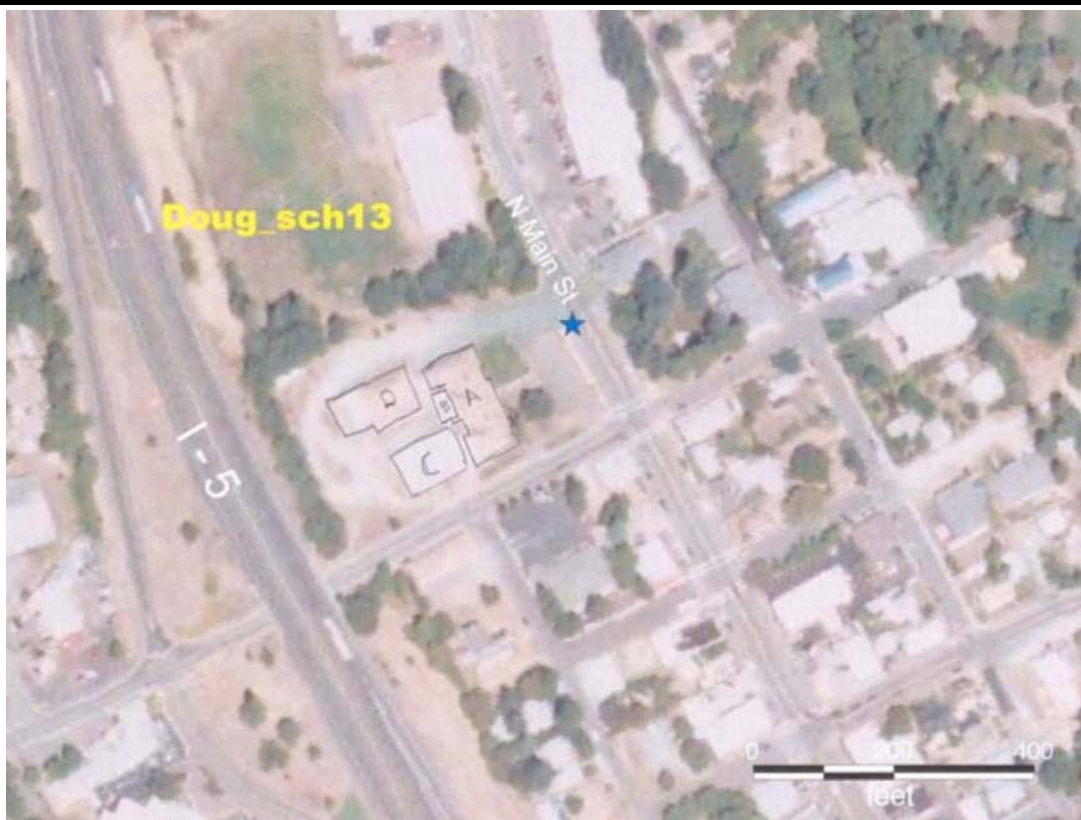
Doug\_sch13B

Type	Basic Score	Vert Irreg	Plan Irreg	Pre-Code	Post-Bench	Soil C	Soil D	Soil E	RVS Score
Primary	RM1	2.8	-1	-0.5	0	0	-0.4	0	0	0.9
Secondary		0	0	0	0	0	0	0	0	0
Tertiary		0	0	0	0	0	0	0	0	0

0.9

High (>10%)

Plan Irregularities	Vertical Irregularities
Reentrant Corners:Other (Adjacent Build/Entity)	Steps in Elevation View: Single Change (Adjacent Building/Entity)
None	None
None	None

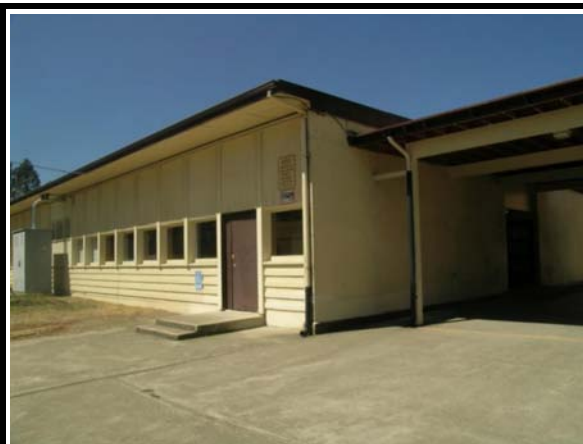
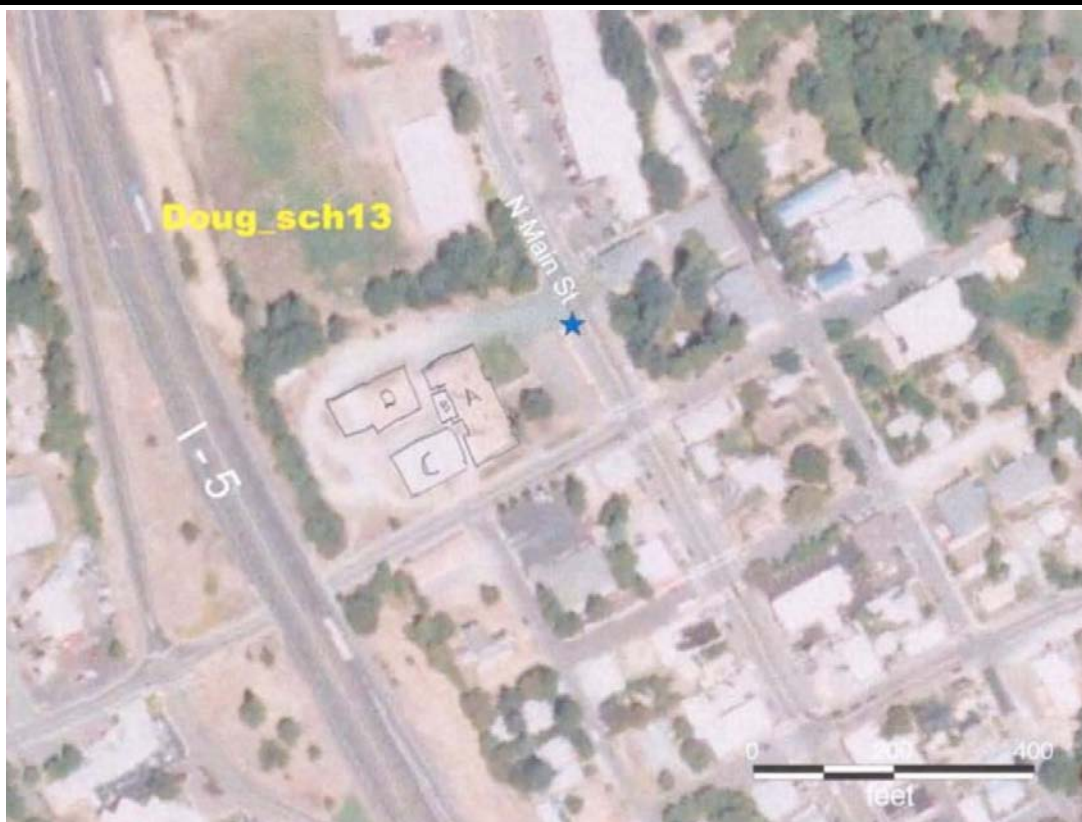
Doug\_sch13C

Type	Basic Score	Vert Irreg	Plan Irreg	Pre-Code	Post-Bench	Soil C	Soil D	Soil E	RVS Score
Primary	RM1	2.8	0	0	0	0	-0.4	0	0	2.4
Secondary		0	0	0	0	0	0	0	0	0
Tertiary		0	0	0	0	0	0	0	0	0

2.4

Low (<1%)

Falling Hazards	Poor Conditions
None	Cracks
None	None
None	None
