# Riddle High School

Doug\_sch21A

## FEMA 154 Rapid Visual Screening Score Card

Rapid Visual Screening - Senate Bill #2 - Seismic Needs Assessment  
Oregon Department of Geology and Mineral Industries

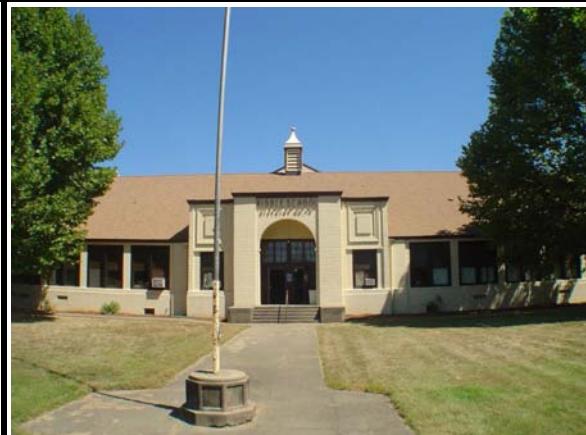
Type	Basic Score	Vert Irreg	Plan Irreg	Pre-Code	Post-Bench	Soil C	Soil D	Soil E	RVS Score
Primary	C2	2.8	-1	-0.5	-1	0	-0.4	0	0	-0.1
Secondary		0	0	0	0	0	0	0	0	0
Tertiary		0	0	0	0	0	0	0	0	0

Final Type	Final Score
C2	-0.1

Very High (100%)

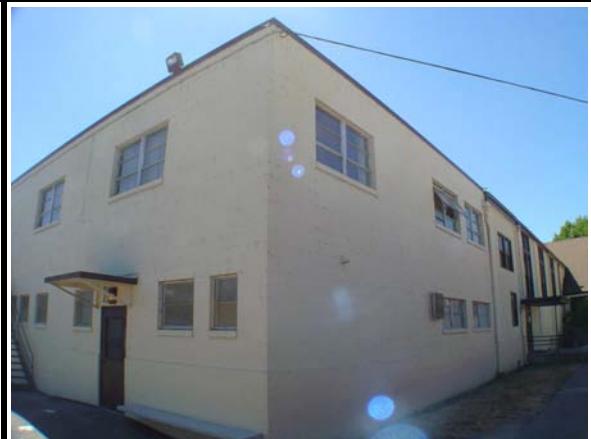
Doug\_sch21B

Type	Basic Score	Vert Irreg	Plan Irreg	Pre-Code	Post-Bench	Soil C	Soil D	Soil E	RVS Score
Primary	RM1	2.8	-1	-0.5	0	0	-0.4	0	0	0.9
Secondary		0	0	0	0	0	0	0	0	0
Tertiary		0	0	0	0	0	0	0	0	0

Final Type	Final Score
RM1	0.9

High (>10%)

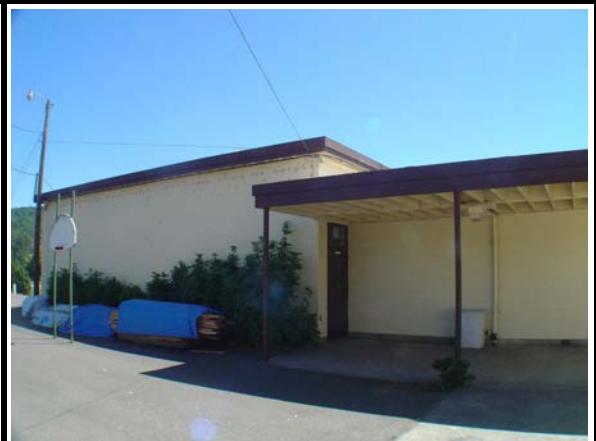
Doug\_sch21C

Type	Basic Score	Vert Irreg	Plan Irreg	Pre-Code	Post-Bench	Soil C	Soil D	Soil E	RVS Score
Primary	RM1	2.8	-1	-0.5	0	0	-0.4	0	0	0.9
Secondary		0	0	0	0	0	0	0	0	0
Tertiary		0	0	0	0	0	0	0	0	0

Final Type	Final Score
RM1	0.9

High (>10%)
