Glendale High School

Glendale SD 77

FEMA 154 Rapid Visual Screening Score Card

Rapid Visual Screening - Senate Bill #2 - Seismic Needs Assessment
Oregon Department of Geology and Mineral Industries

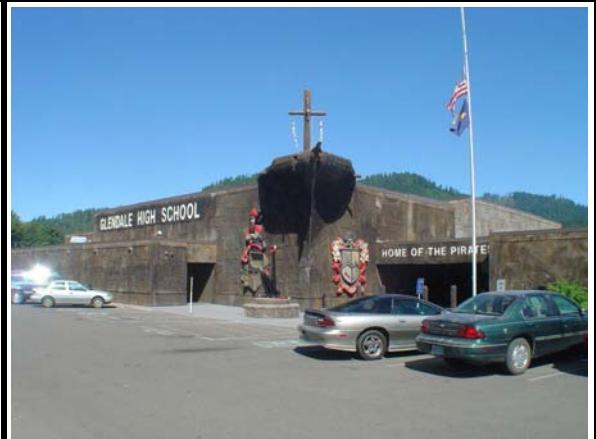
Doug_sch23A

Type	Basic Score	Vert Irreg	Plan Irreg	Pre-Code	Post-Bench	Soil C	Soil D	Soil E	RVS Score
Primary	W2	3.8	-2	-0.5	0	2.4	-0.4	0	0	3.3
Secondary		0	0	0	0	0	0	0	0	0
Tertiary		0	0	0	0	0	0	0	0	0

Final Type	Final Score
W2	3.3

Low (<1%)

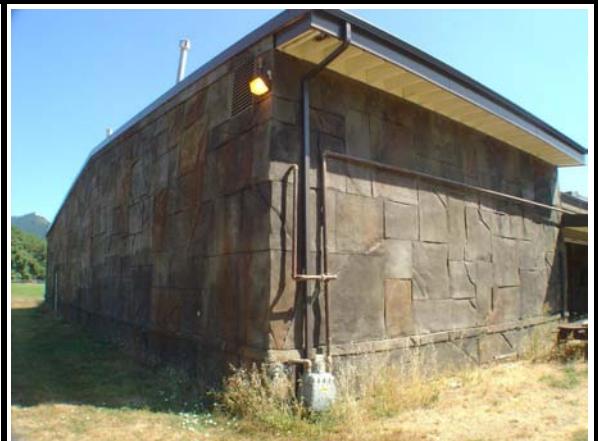
Doug_sch23B

Type	Basic Score	Vert Irreg	Plan Irreg	Pre-Code	Post-Bench	Soil C	Soil D	Soil E	RVS Score
Primary	W1	4.4	0	-0.5	0	2.4	0	0	0	6.3
Secondary		0	0	0	0	0	0	0	0	0
Tertiary		0	0	0	0	0	0	0	0	0

Final Type	Final Score
W1	6.3

Low (<1%)

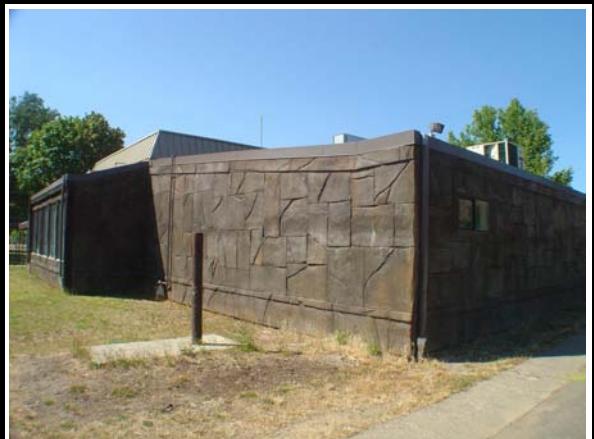
Type	Basic Score	Vert Irreg	Plan Irreg	Pre-Code	Post-Bench	Soil C	Soil D	Soil E	RVS Score
Primary	W1	4.4	0	-0.5	0	2.4	0	0	0	6.3
Secondary		0	0	0	0	0	0	0	0	0
Tertiary		0	0	0	0	0	0	0	0	0

Final Type	Final Score
W1	6.3

Low (<1%)

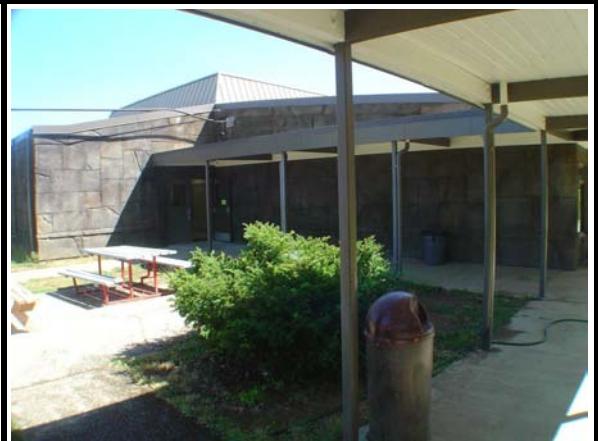
Doug_sch23D

Type	Basic Score	Vert Irreg	Plan Irreg	Pre-Code	Post-Bench	Soil C	Soil D	Soil E	RVS Score
Primary	W1	4.4	0	-0.5	0	2.4	0	0	0	6.3
Secondary		0	0	0	0	0	0	0	0	0
Tertiary		0	0	0	0	0	0	0	0	0

Final Type	Final Score
W1	6.3

Low (<1%)

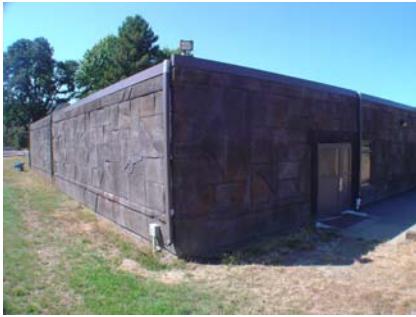
NE General Site

Enrollment 235	Year Built (Field Verified) 1976	Year Built (Alt. Source) 1976	Est. Decade Built 1980
Total Area (square ft) 54626	Number of Stories 1	Basement	Pounding Potential No
Plan Irregularities Reentrant Corners: T shaped None None		Vertical Irregularities None None None	
Falling Hazards Heavy Cladding (thick stone or concrete) None None		Poor Conditions None None None
