Reedsport Junior/High School

Doug_sch33A

FEMA 154 Rapid Visual Screening Score Card

Rapid Visual Screening - Senate Bill #2 - Seismic Needs Assessment
Oregon Department of Geology and Mineral Industries

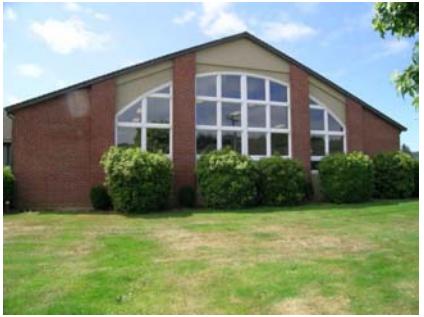
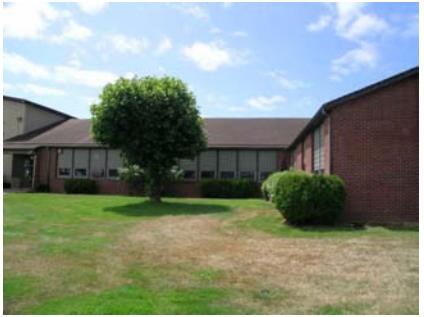
NE Vertical Irregularity Secondary and secondary plan irregularity building A is on the left and building B is on the right.	NW Elevation View	NW Plan Irregularity Primary
