# Melrose Elementary School

Douglas County SD 4

Doug\_sch34A

Rapid Visual Screening - Senate Bill #2 - Seismic Needs Assessment  
Oregon Department of Geology and Mineral Industries

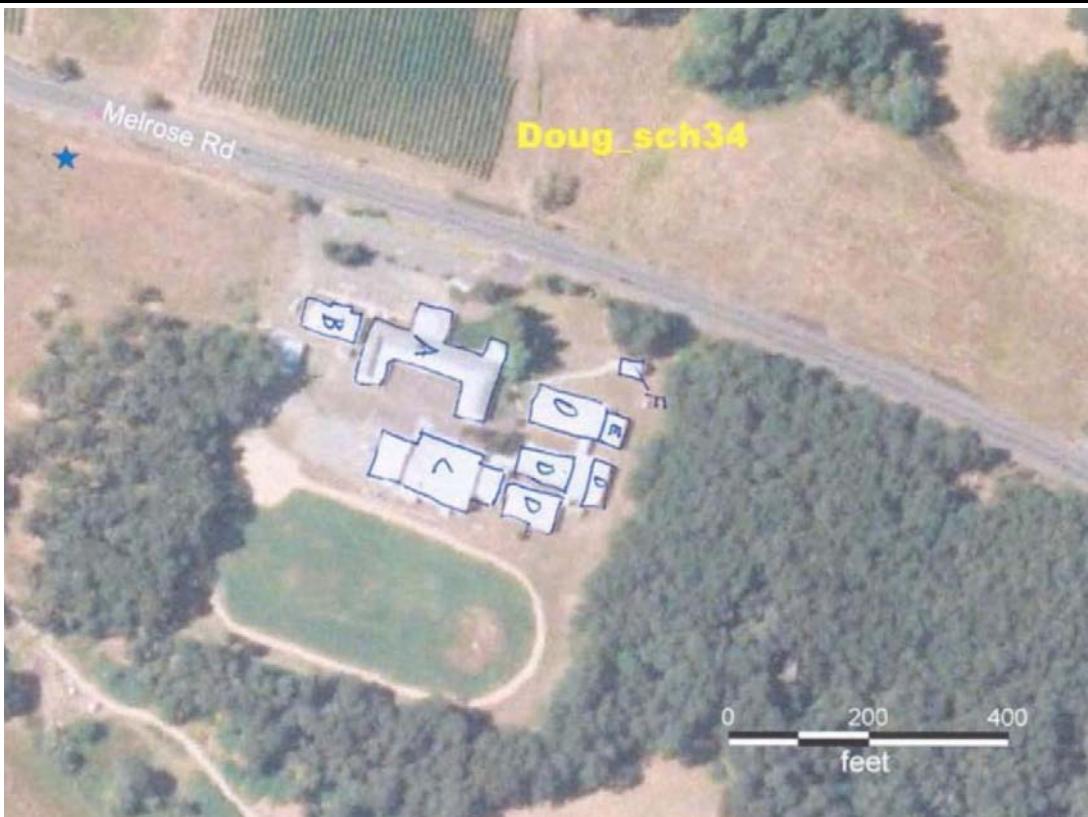
Type	Basic Score	Vert Irreg	Plan Irreg	Pre-Code	Post-Bench	Soil C	Soil D	Soil E	RVS Score
Primary	RM1	2.8	-1	-0.5	0	0	-0.4	0	0	0.9
Secondary	W1	4.4	-2.5	-0.5	0	0	0	0	0	1.4
Tertiary		0	0	0	0	0	0	0	0	0

Final Type	Final Score
RM1	0.9

High (>10%)

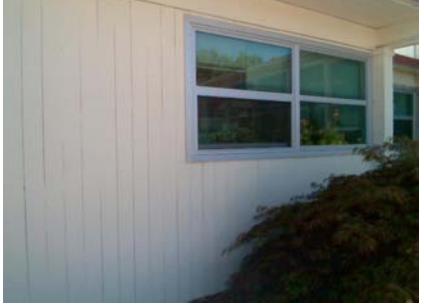
W Secondary Structural Type

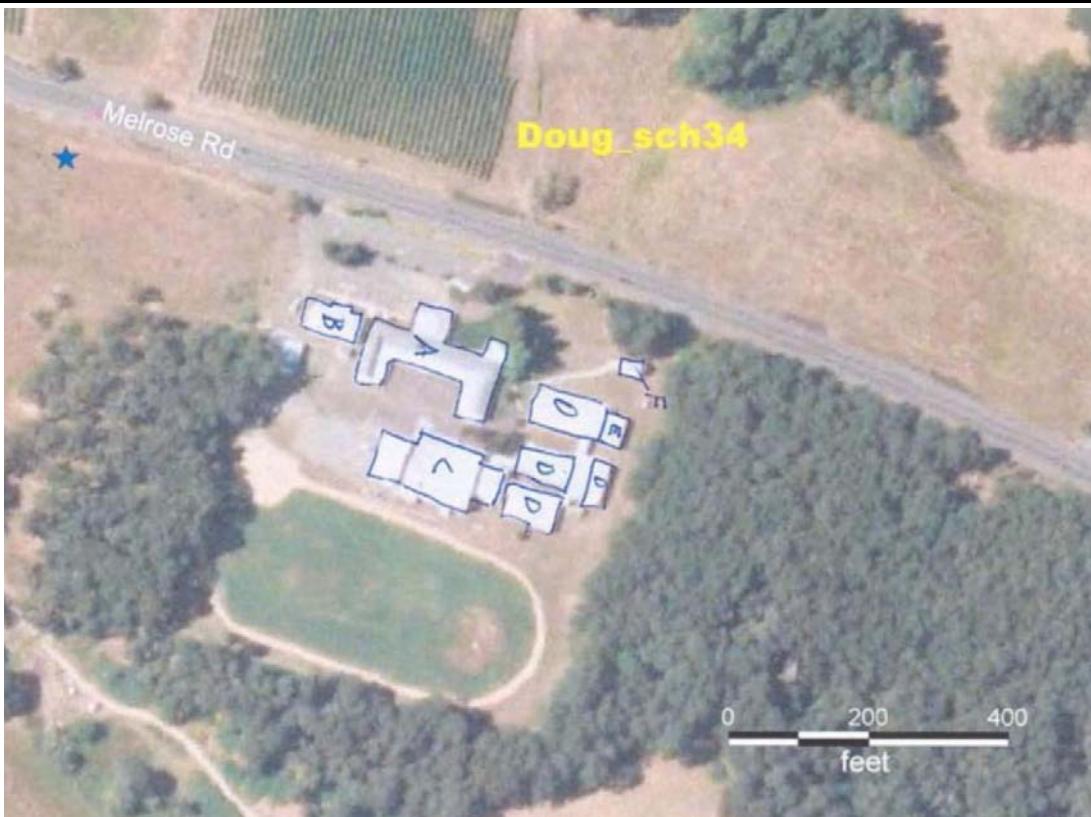
Type	Basic Score	Vert Irreg	Plan Irreg	Pre-Code	Post-Bench	Soil C	Soil D	Soil E	RVS Score
Primary	W2	3.8	0	-0.5	-1	0	-0.4	0	0	1.9
Secondary		0	0	0	0	0	0	0	0	0
Tertiary		0	0	0	0	0	0	0	0	0

Final Type	Final Score
W2	1.9

Moderate (>1%)

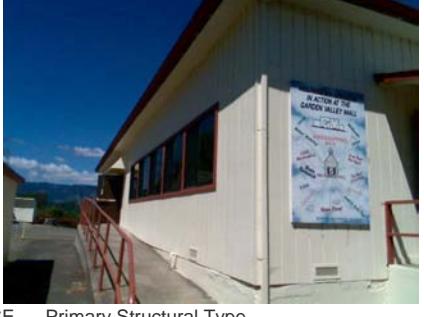
SE Primary Structural Type
