McGovern Elementary School

Doug_sch35A

FEMA 154 Rapid Visual Screening Score Card

Rapid Visual Screening - Senate Bill #2 - Seismic Needs Assessment
Oregon Department of Geology and Mineral Industries

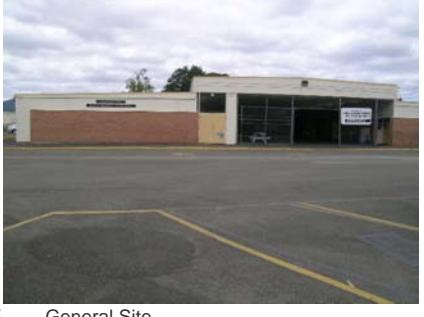
<p>NE Vertical Irregularity Primary and reentrant corner</p> <p>E General Site</p> <p>S Vertical Irregularity Primary</p>
