Camas Valley School

Camas Valley SD 21J

FEMA 154 Rapid Visual Screening Score Card

Rapid Visual Screening - Senate Bill #2 - Seismic Needs Assessment
Oregon Department of Geology and Mineral Industries

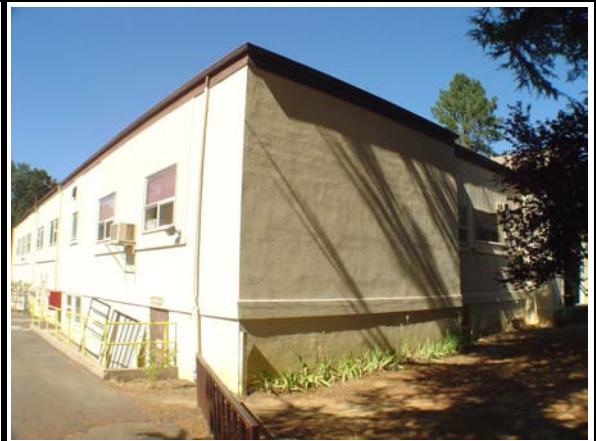
Doug_sch40A

Type	Basic Score	Vert Irreg	Plan Irreg	Pre-Code	Post-Bench	Soil C	Soil D	Soil E	RVS Score
Primary	C2	2.8	0	-0.5	-1	0	-0.4	0	0	0.9
Secondary		0	0	0	0	0	0	0	0	0
Tertiary		0	0	0	0	0	0	0	0	0

Final Type	Final Score
C2	0.9

High (>10%)

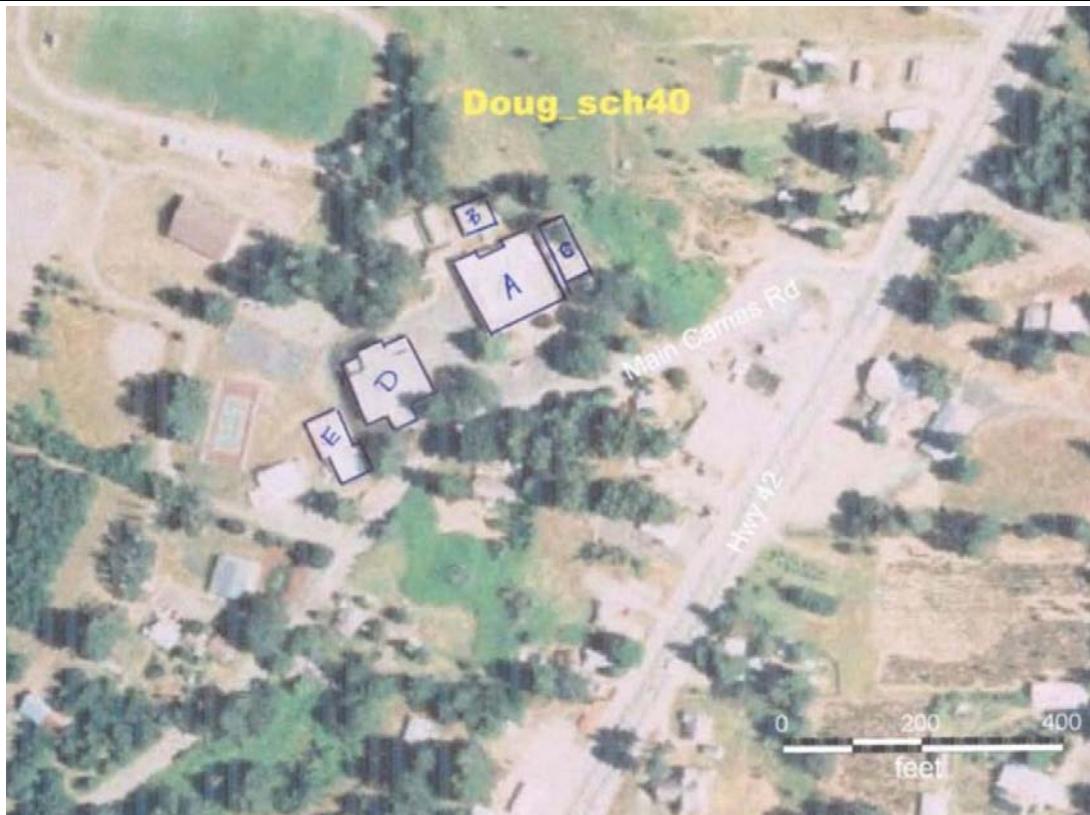
Doug_sch40A

Enrollment 162	Year Built (Field Verified) 1928	Year Built (Alt. Source) 1928	Est. Decade Built 1920
Total Area (square ft) 39030	Number of Stories 2	Basement	Pounding Potential No
Plan Irregularities Out of Plane Lateral-Force-Resistance Elements None None		Vertical Irregularities None None None	
Falling Hazards None None None		Poor Conditions None None None

N Plan Irregularity Primary

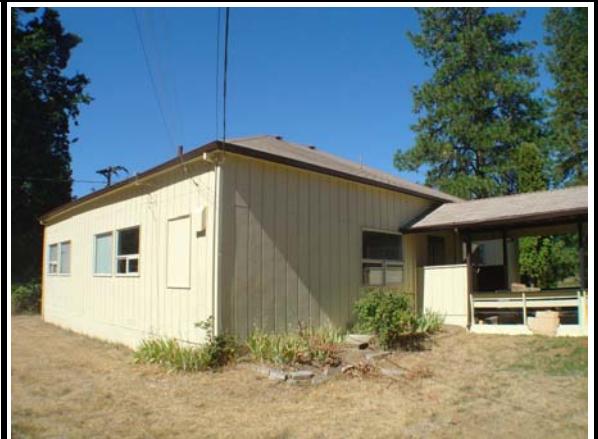
Doug_sch40B

Type	Basic Score	Vert Irreg	Plan Irreg	Pre-Code	Post-Bench	Soil C	Soil D	Soil E	RVS Score
Primary	W1	4.4	0	0	0	0	0	0	0	4.4
Secondary		0	0	0	0	0	0	0	0	0
Tertiary		0	0	0	0	0	0	0	0	0

Final Type	Final Score
W1	4.4

Low (<1%)

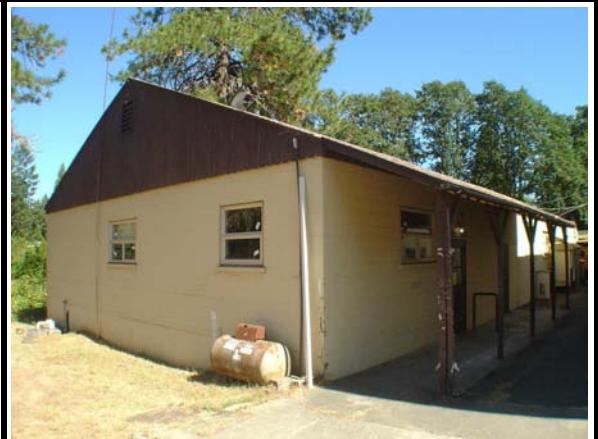
Doug_sch40C

Type	Basic Score	Vert Irreg	Plan Irreg	Pre-Code	Post-Bench	Soil C	Soil D	Soil E	RVS Score
Primary	RM1	2.8	0	0	0	0	-0.4	0	0	2.4
Secondary		0	0	0	0	0	0	0	0	0
Tertiary		0	0	0	0	0	0	0	0	0

Final Type	Final Score
RM1	2.4

Low (<1%)

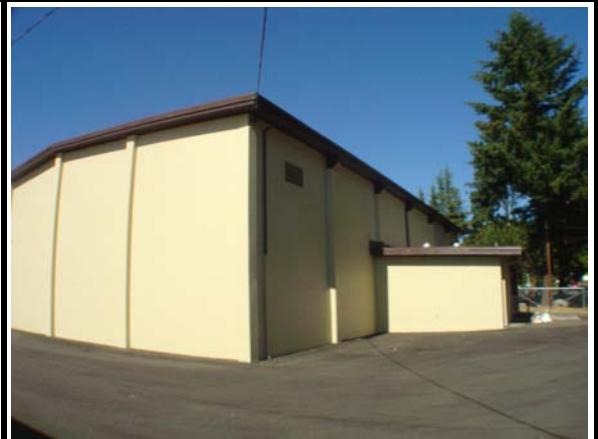
Doug_sch40D

Type	Basic Score	Vert Irreg	Plan Irreg	Pre-Code	Post-Bench	Soil C	Soil D	Soil E	RVS Score
Primary	PC1	2.6	0	-0.5	0	0	-0.4	0	0	1.7
Secondary		0	0	0	0	0	0	0	0	0
Tertiary		0	0	0	0	0	0	0	0	0

Final Type	Final Score
PC1	1.7

Moderate (>1%)

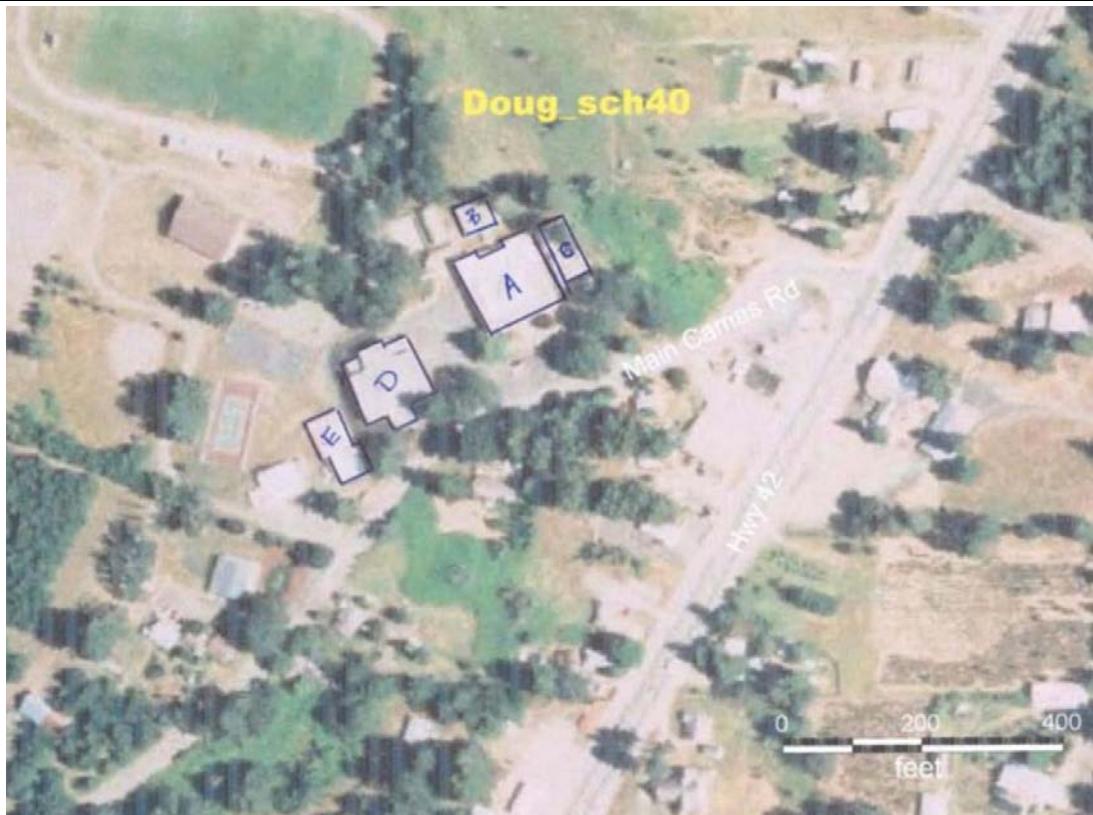
Doug_sch40D

Enrollment 162	Year Built (Field Verified) 1970	Year Built (Alt. Source) 1928	Est. Decade Built 1970
Total Area (square ft) 39030	Number of Stories 1	Basement	Pounding Potential No
Plan Irregularities		Vertical Irregularities	
Reentrant Corners: Other		Steps in Elevation View: 2 to 3 Changes	
Out of Plane Lateral-Force-Resistance Elements		None	
None		None	
Falling Hazards		Poor Conditions	
None		None	
None		None	
None		None

E Vertical Irregularity Primary		N Plan Irregularity Secondary

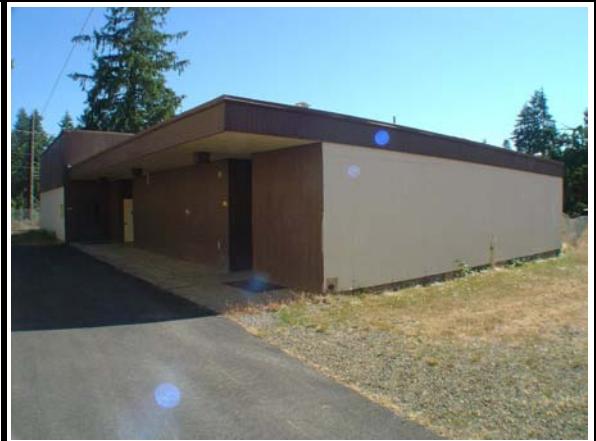
Doug_sch40E

Type	Basic Score	Vert Irreg	Plan Irreg	Pre-Code	Post-Bench	Soil C	Soil D	Soil E	RVS Score
Primary	W1	4.4	-2.5	-0.5	0	0	0	0	0	1.4
Secondary		0	0	0	0	0	0	0	0	0
Tertiary		0	0	0	0	0	0	0	0	0

Final Type	Final Score
W1	1.4

Moderate (>1%)

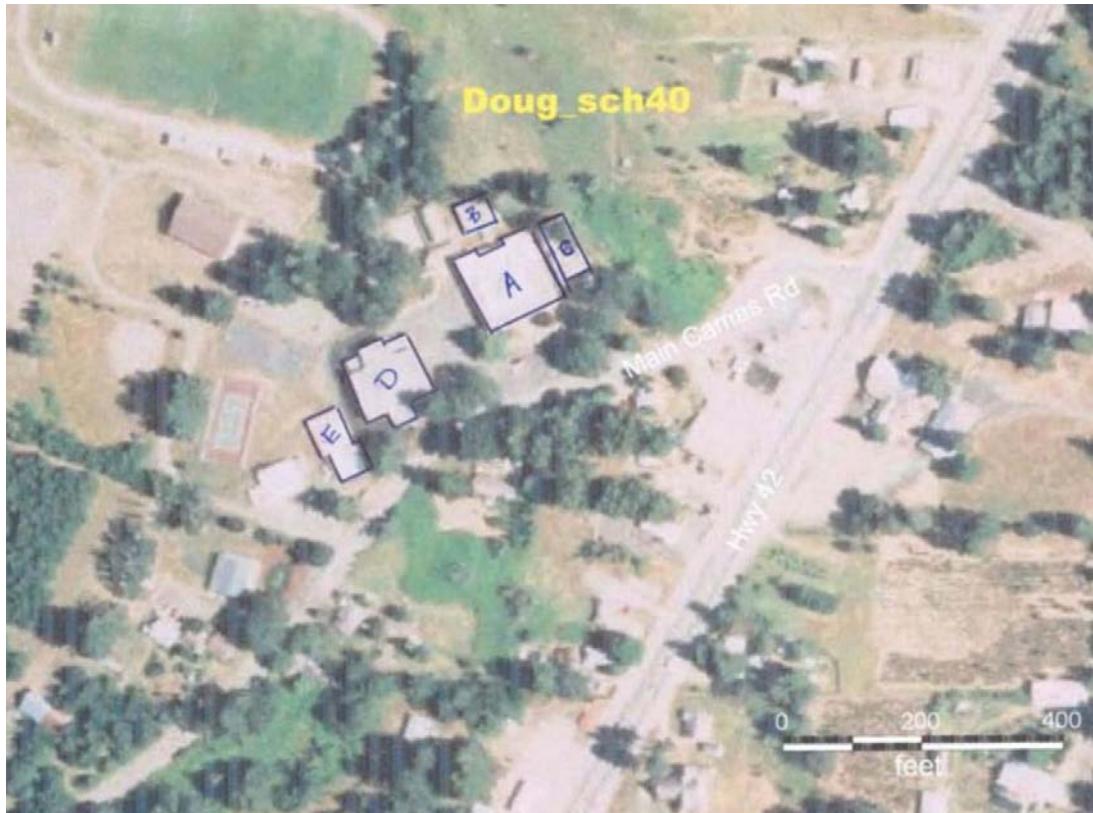
Enrollment 162	Year Built (Field Verified) 1978	Year Built (Alt. Source) 1928	Est. Decade Built 1970
Total Area (square ft) 39030	Number of Stories 1	Basement	Pounding Potential No
Plan Irregularities Out of Plane Lateral-Force-Resistance Elements None None		Vertical Irregularities Steps in Elevation View: Single Change None None	
Falling Hazards None None None		Poor Conditions None None None
