Grant Union High School

Gran_sch05A

FEMA 154 Rapid Visual Screening Score Card

Rapid Visual Screening - Senate Bill #2 - Seismic Needs Assessment
Oregon Department of Geology and Mineral Industries

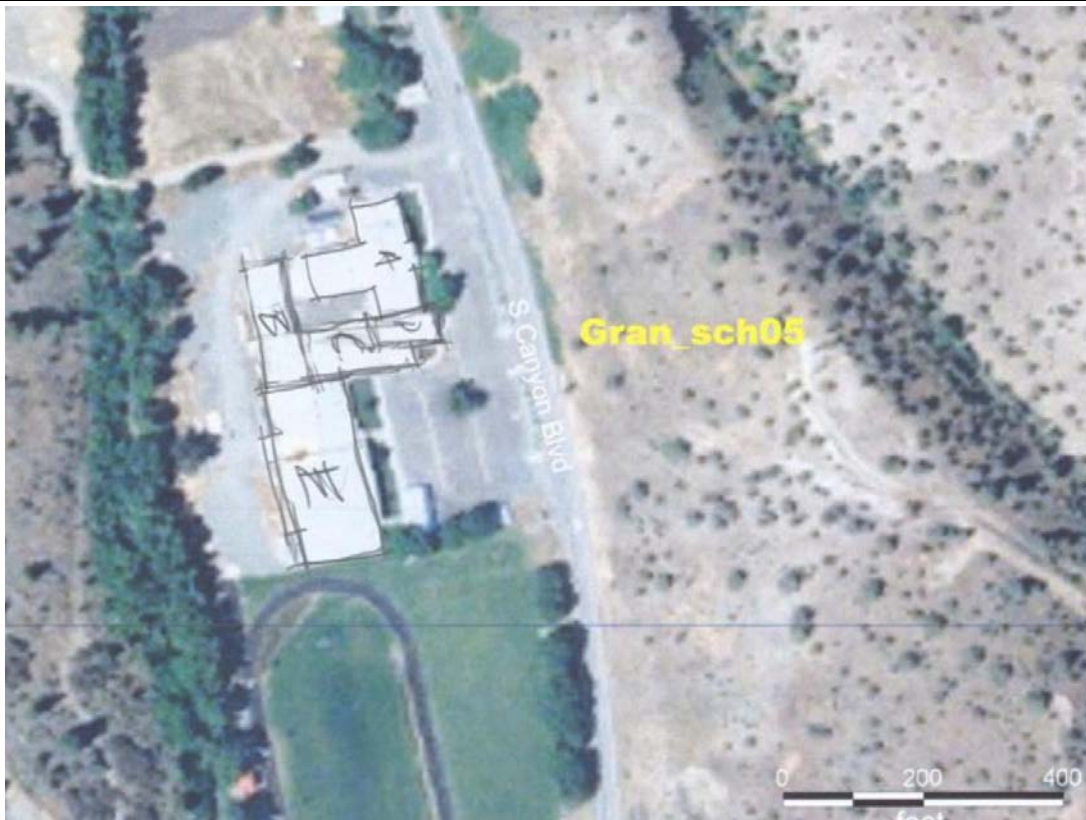
Type	Basic Score	Vert Irreg	Plan Irreg	Pre-Code	Post-Bench	Soil C	Soil D	Soil E	RVS Score
Primary	C2	3.6	-2	-0.5	-0.4	0	0	-1.2	0	-0.5
Secondary	URM	3.4	-1.5	-0.5	-0.4	0	0	-0.8	0	0.2
Tertiary		0	0	0	0	0	0	0	0	0

Very High (100%)

Plan Irregularities	Vertical Irregularities
Reentrant Corners: T shaped	Steps in Elevation View: Very Irregular Changes
Reentrant Corners: Other	Steps in Elevation View: Single Change (Adjacent Building/Entity)
None	Internal Discontinuous Diaphragm (large internal opening)

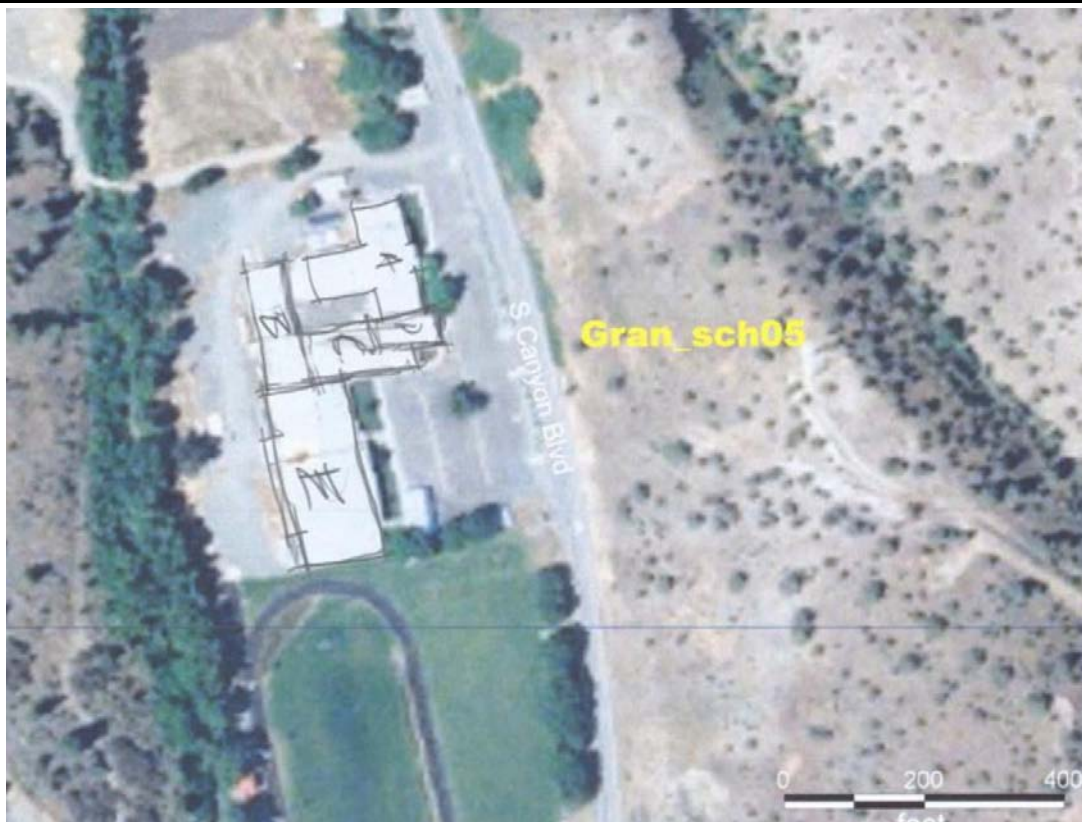
Gran_sch05D

Type	Basic Score	Vert Irreg	Plan Irreg	Pre-Code	Post-Bench	Soil C	Soil D	Soil E	RVS Score
Primary	RM1	3.6	-2	-0.5	-0.4	0	0	-1.2	0	-0.5
Secondary	C2	3.6	-2	-0.5	-0.4	0	0	-1.2	0	-0.5
Tertiary		0	0	0	0	0	0	0	0	0

Very High (100%)

Plan Irregularities	Vertical Irregularities
Reentrant Corners: Other (Adjacent Build/Entity)	Steps in Elevation View: 2 to 3 Changes (Adjacent Building/Entity)
None	None
None	None

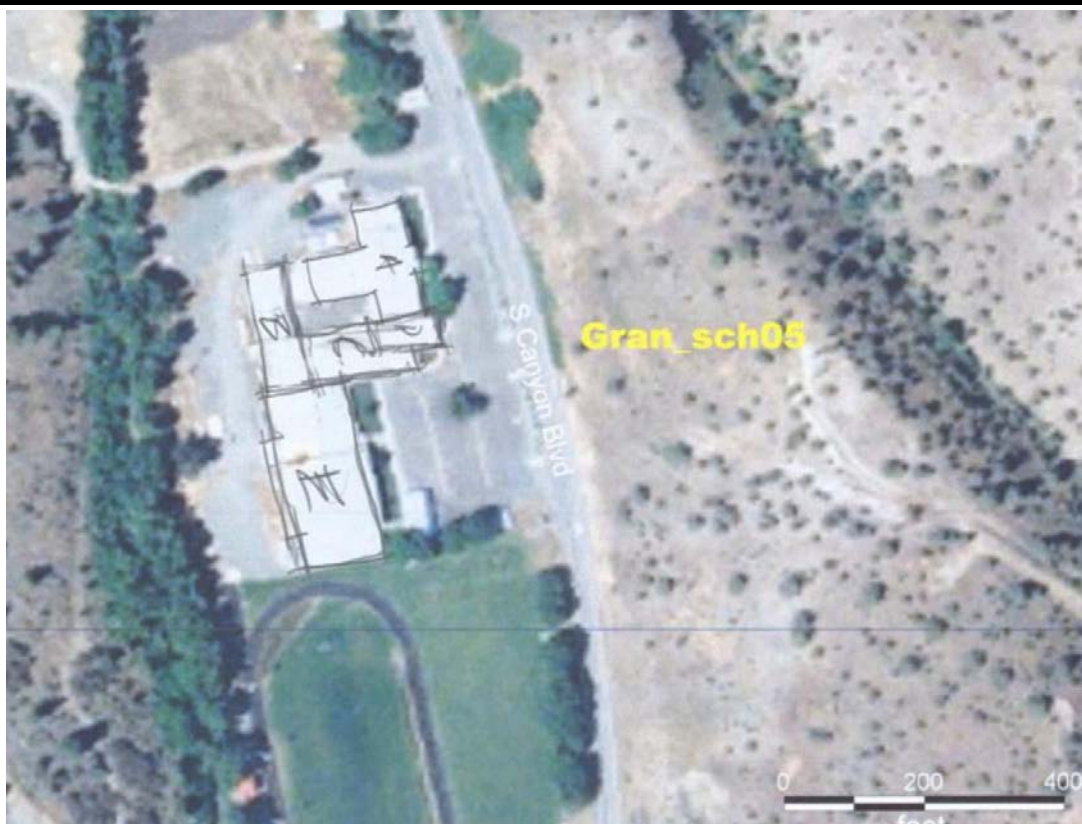
Gran_sch05E

Type	Basic Score	Vert Irreg	Plan Irreg	Pre-Code	Post-Bench	Soil C	Soil D	Soil E	RVS Score
Primary	RM1	3.6	-2	-0.5	0	0	0	-1.2	0	-0.1
Secondary	C2	3.6	-2	-0.5	0	0	0	-1.2	0	-0.1
Tertiary		0	0	0	0	0	0	0	0	0

Very High (100%)
