# Seneca Elementary School

John Day SD 3

Gran\_sch07A

Rapid Visual Screening - Senate Bill #2 - Seismic Needs Assessment  
Oregon Department of Geology and Mineral Industries

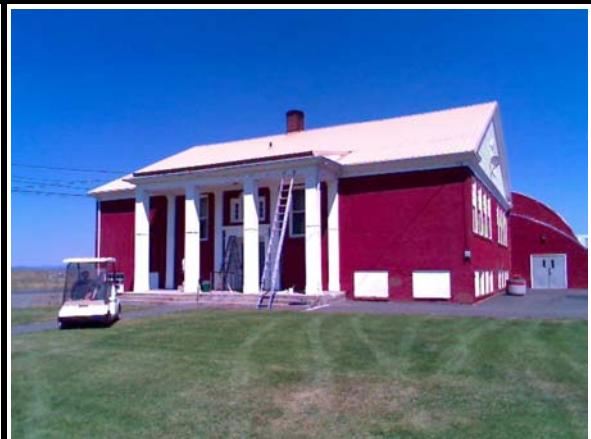
Type	Basic Score	Vert Irreg	Plan Irreg	Pre-Code	Post-Bench	Soil C	Soil D	Soil E	RVS Score
Primary	C2	3.6	-2	-0.5	-0.4	0	0	-1.2	0	-0.5
Secondary	URM	3.4	-1.5	-0.5	-0.4	0	0	-0.8	0	0.2
Tertiary		0	0	0	0	0	0	0	0	0

Final Type	Final Score
C2	-0.5

Very High (100%)

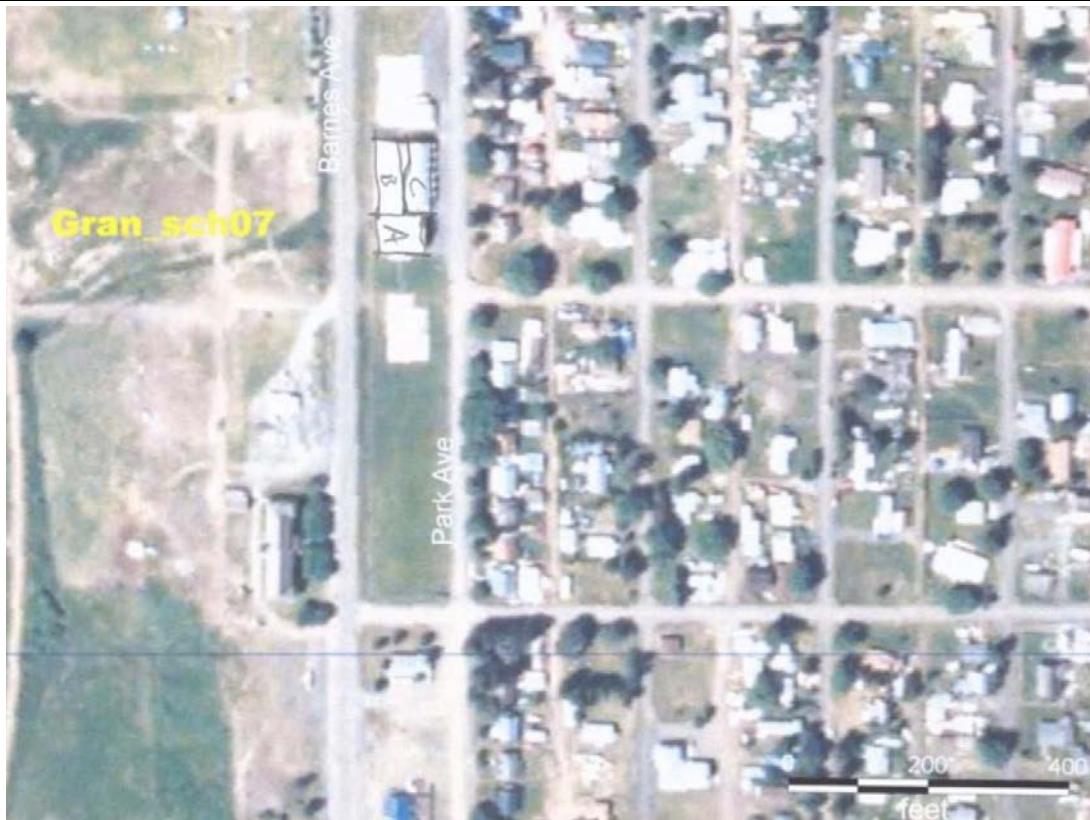
Gran\_sch07A

Enrollment 61	Year Built (Field Verified) 1932	Year Built (Alt. Source) 1930	Est. Decade Built 1930
Total Area (square ft) 13674	Number of Stories 1	Basement	Pounding Potential No
Plan Irregularities Reentrant Corners:U shaped (Adjacent Build/Entity) None None		Vertical Irregularities Steps in Elevation View: 2 to 3 Changes (Adjacent Building/Entity) None None	
Falling Hazards None None None		Poor Conditions None None None

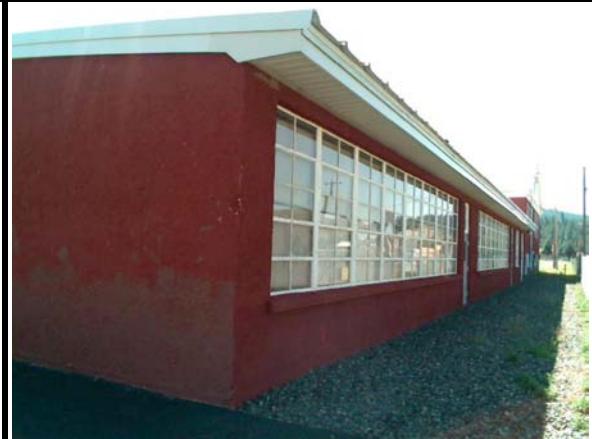
Gran\_sch07B

Type	Basic Score	Vert Irreg	Plan Irreg	Pre-Code	Post-Bench	Soil C	Soil D	Soil E	RVS Score
Primary	C2	3.6	-2	0	-0.4	0	0	-1.2	0	0
Secondary	RM1	3.6	-2	0	-0.4	0	0	-1.2	0	0
Tertiary		0	0	0	0	0	0	0	0	0

Final Type	Final Score
C2	0

Very High (100%)

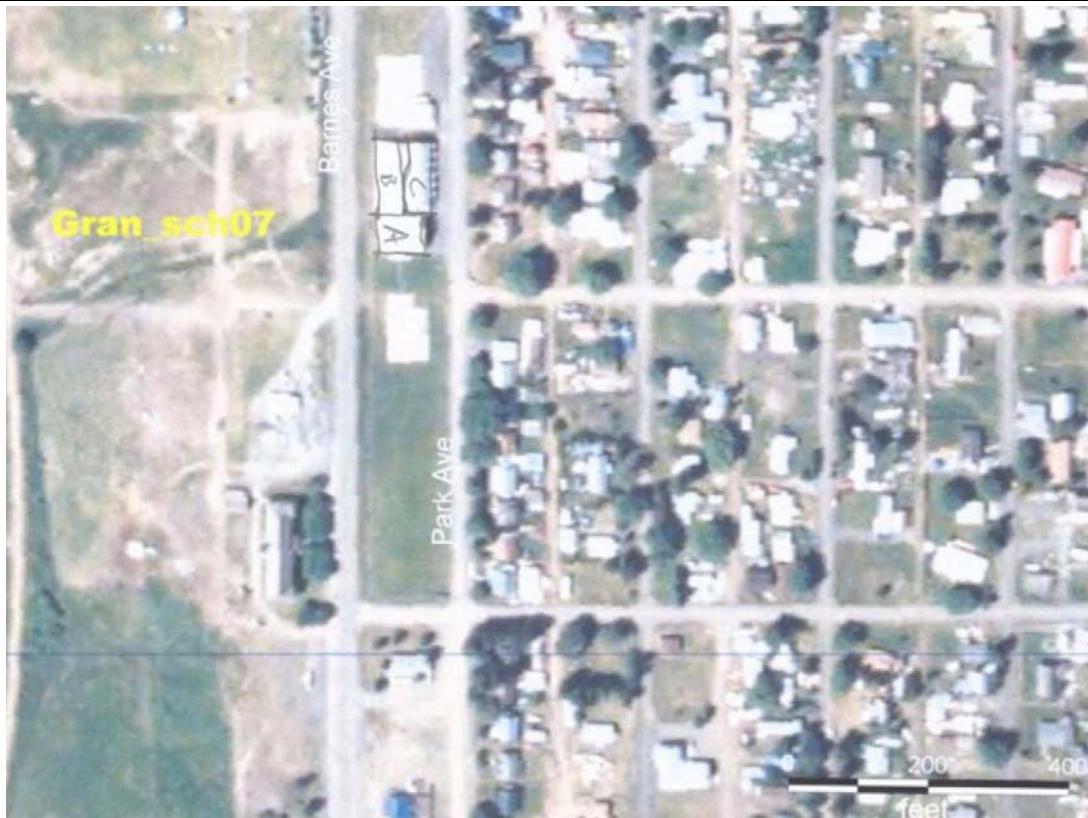
Gran\_sch07B

Enrollment 61	Year Built (Field Verified) 1932	Year Built (Alt. Source) 1940	Est. Decade Built 1940
Total Area (square ft) 13674	Number of Stories 1	Basement	Pounding Potential No
Plan Irregularities None None None		Vertical Irregularities Steps in Elevation View: 2 to 3 Changes (Adjacent Building/Entity) None None	
Falling Hazards None None None		Poor Conditions None None None

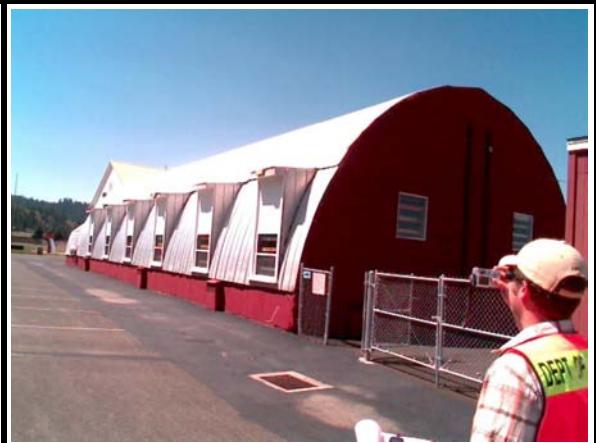
Gran\_sch07C

Enrollment 61	Year Built (Field Verified) 1932	Year Built (Alt. Source) 1950	Est. Decade Built 1950
Total Area (square ft) 13674	Number of Stories 1	Basement	Pounding Potential No
Plan Irregularities Reentrant Corners:L shaped (Adjacent Build/Entity) None None		Vertical Irregularities Steps in Elevation View: 2 to 3 Changes (Adjacent Building/Entity) Steps in Elevation View: Single Change None	
Falling Hazards None None None		Poor Conditions None None None
