Crane Union High School

Harn_sch01A

FEMA 154 Rapid Visual Screening Score Card

Rapid Visual Screening - Senate Bill #2 - Seismic Needs Assessment
Oregon Department of Geology and Mineral Industries

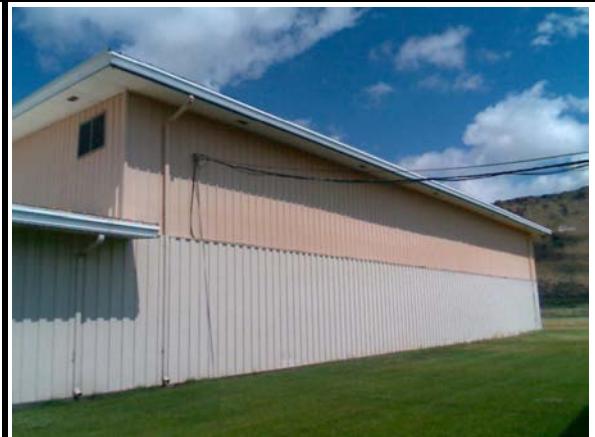
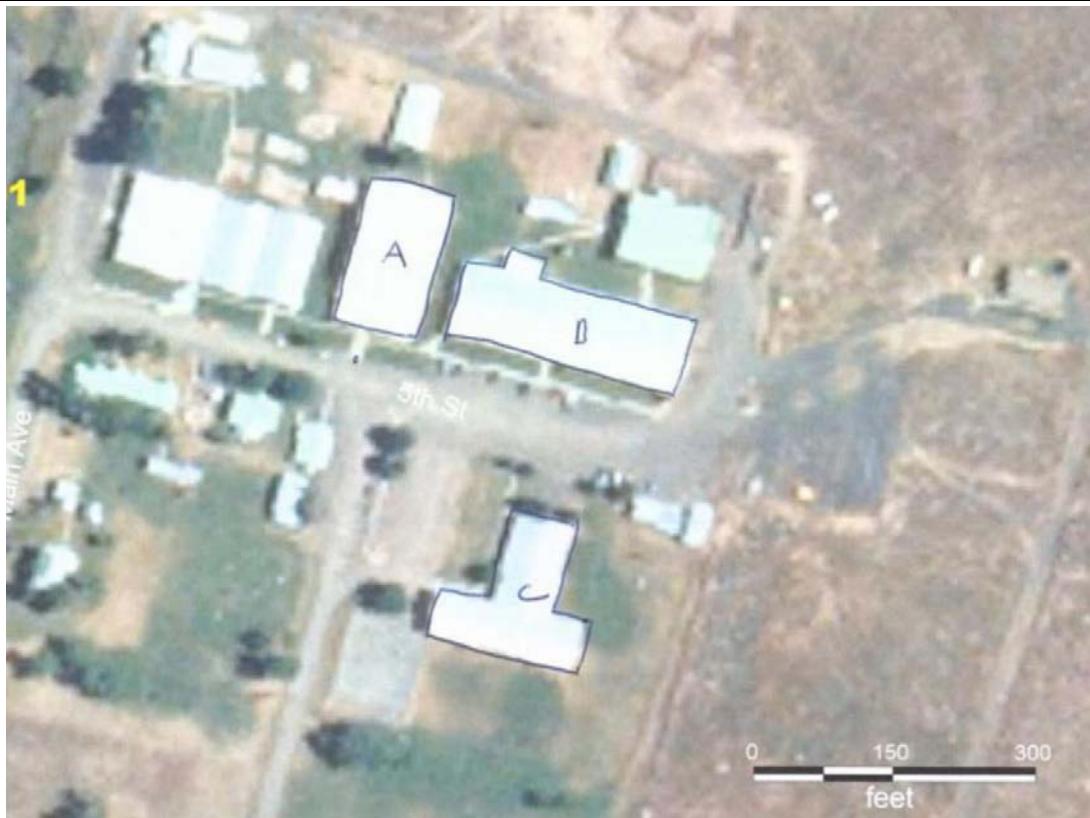
Type	Basic Score	Vert Irreg	Plan Irreg	Pre-Code	Post-Bench	Soil C	Soil D	Soil E	RVS Score
Primary	W2	4.8	-3	0	0	0	0	-1.2	0	0.6
Secondary	S3	3.8	0	0	0	0	0	-1	0	2.8
Tertiary		0	0	0	0	0	0	0	0	0

Final Type	Final Score
W2	0.6

High (>10%)

Enrollment 84	Year Built (Field Verified) 1972	Year Built (Alt. Source) 1950	Est. Decade Built 1970
Total Area (square ft) 38432	Number of Stories 1	Basement	Pounding Potential No
Plan Irregularities None None None		Vertical Irregularities Steps in Elevation View: Single Change None None	
Falling Hazards None None None		Poor Conditions None None None

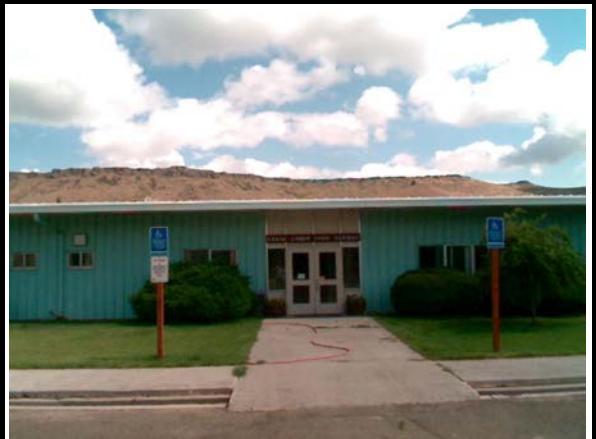
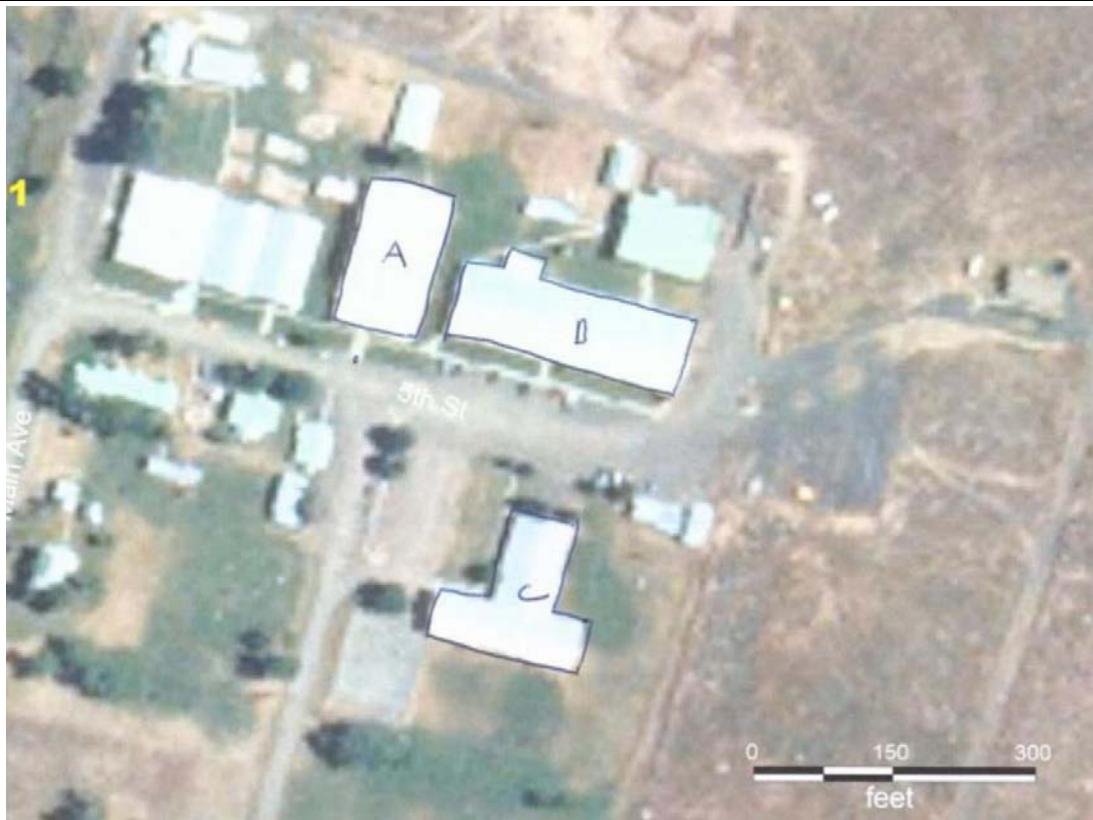
Harn_sch01B

Type	Basic Score	Vert Irreg	Plan Irreg	Pre-Code	Post-Bench	Soil C	Soil D	Soil E	RVS Score
Primary	S3	3.8	0	0	0	0	0	-1	0	2.8
Secondary	W2	4.8	0	0	0	0	0	-1.2	0	3.6
Tertiary		0	0	0	0	0	0	0	0	0

Final Type	Final Score
S3	2.8

Low (<1%)

Enrollment 84	Year Built (Field Verified) 1972	Year Built (Alt. Source) 1950	Est. Decade Built 1970
Total Area (square ft) 38432	Number of Stories 1	Basement	Pounding Potential No
Plan Irregularities None None None		Vertical Irregularities None None None	
Falling Hazards None None None		Poor Conditions None None None

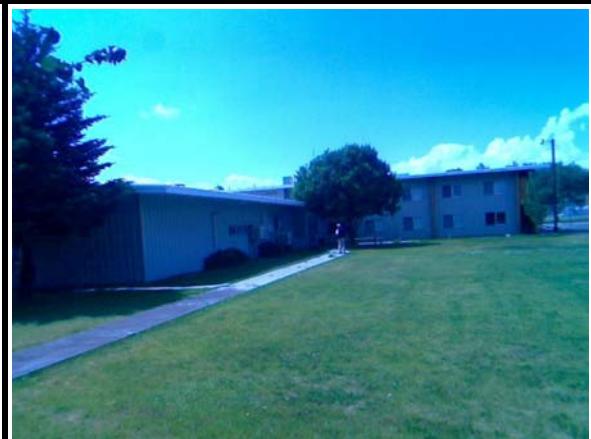
Harn_sch01C

Enrollment 84	Year Built (Field Verified) 1972	Year Built (Alt. Source) 1950	Est. Decade Built 1970
Total Area (square ft) 38432	Number of Stories 2	Basement	Pounding Potential No
Plan Irregularities Reentrant Corners: T shaped None None		Vertical Irregularities Steps in Elevation View: Single Change None None	
Falling Hazards None None None		Poor Conditions None None None
