Rogue Valley International-Medford

Jack_fir18A

FEMA 154 Rapid Visual Screening Score Card

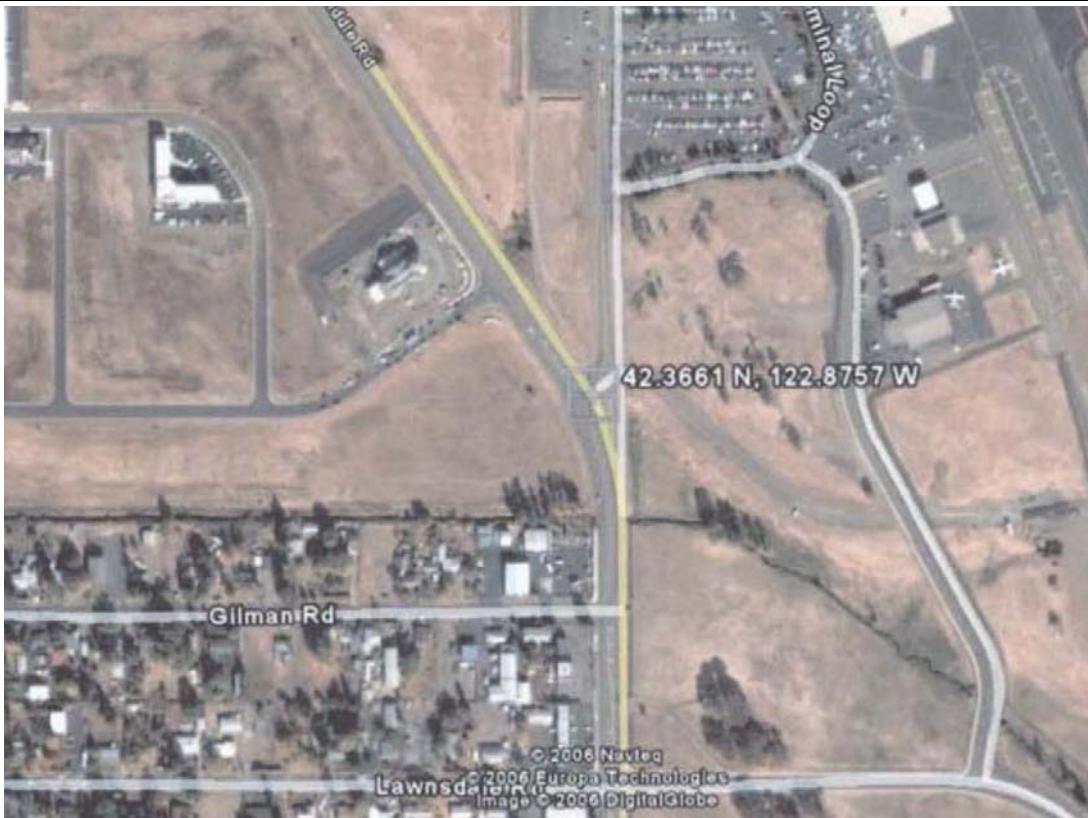
Enrollment	Year Built (Field Verified)	Year Built (Alt. Source)	Est. Decade Built
			1970
Total Area (square ft)	Number of Stories	Basement	Pounding Potential
	1	No	No
Plan Irregularities		Vertical Irregularities	
Out of Plane Lateral-Force-Resistance Elements		Steps in Elevation View: 2 to 3 Changes	
None		None	
None		None	
Falling Hazards		Poor Conditions	
None		Cracks	
None		None	
None		None
