Patrick Elementary School

Central Point SD 6

FEMA 154 Rapid Visual Screening Score Card

Rapid Visual Screening - Senate Bill #2 - Seismic Needs Assessment
Oregon Department of Geology and Mineral Industries

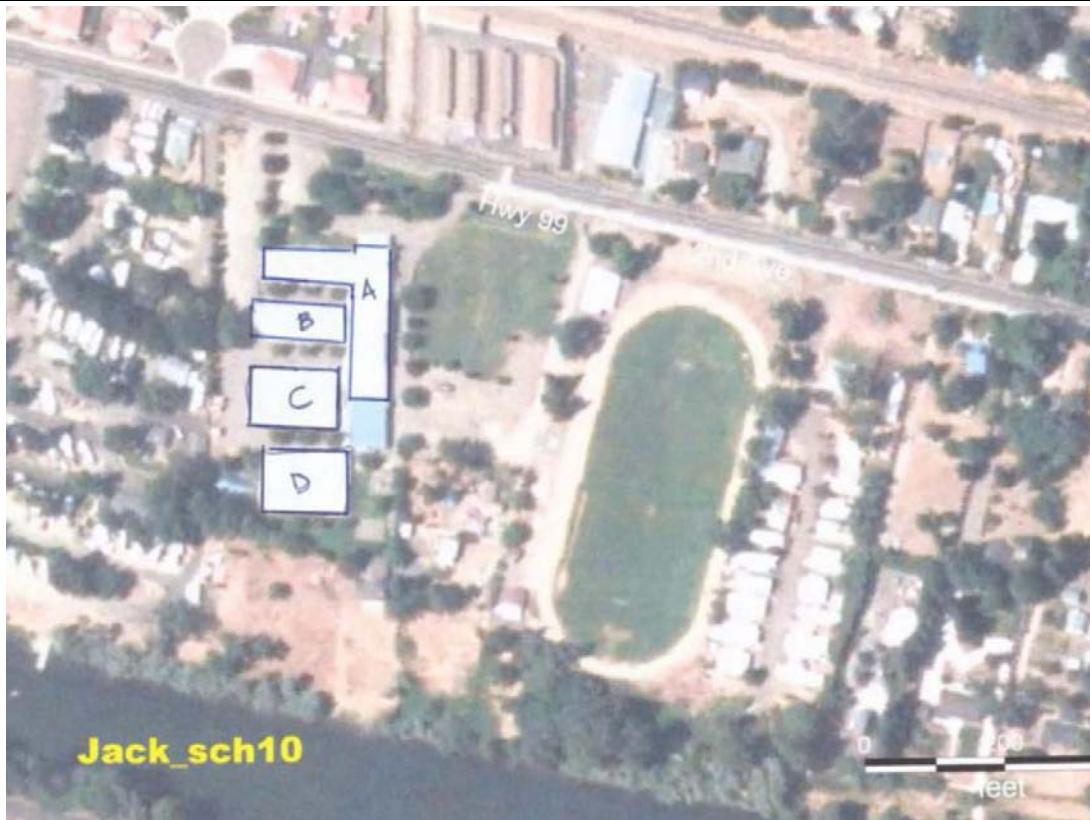
Final Type	Final Score
RM1	0.3

High (>10%)

Enrollment 268	Year Built (Field Verified) 1956	Year Built (Alt. Source) 1956	Est. Decade Built 1950
Total Area (square ft) 35004	Number of Stories 1	Basement	Pounding Potential No
Plan Irregularities		Vertical Irregularities	
Reentrant Corners: L Shaped		Steps in Elevation View: Very Irregular Changes	
Out of Plane Lateral-Force-Resistance Elements		None	
None		None	
Falling Hazards		Poor Conditions	
None		None	
None		None	
None		None

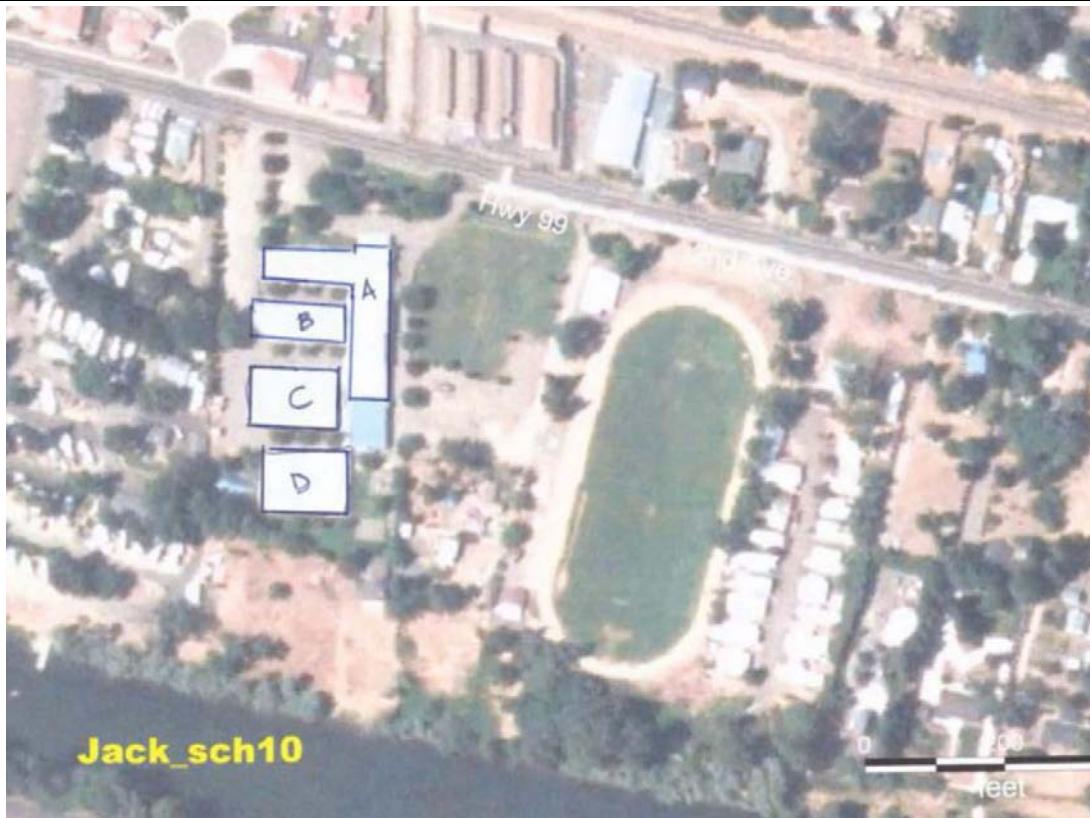
Final Type	Final Score
RM1	2.3

Low (<1%)

Enrollment 268	Year Built (Field Verified) 1956	Year Built (Alt. Source) 1956	Est. Decade Built 1950
Total Area (square ft) 35004	Number of Stories 1	Basement	Pounding Potential No
Plan Irregularities Torsion: Eccentric Stiffness None None		Vertical Irregularities None None None	
Falling Hazards None None None		Poor Conditions None None None

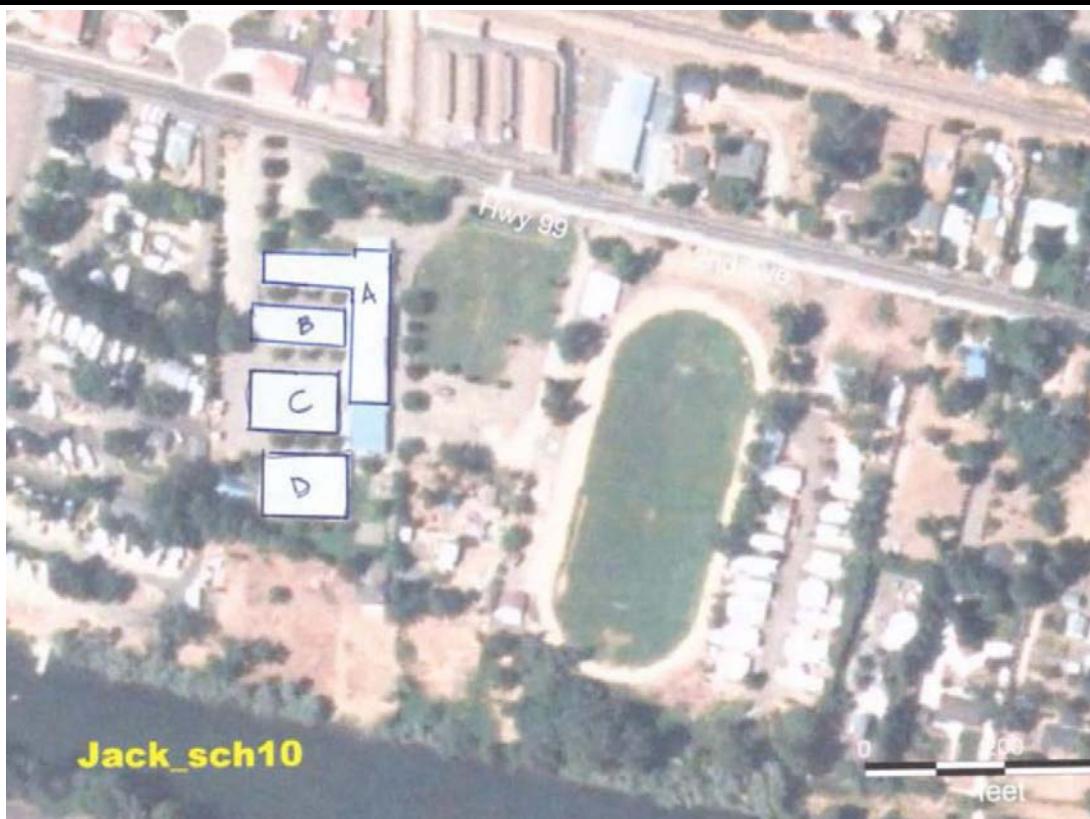
Final Type	Final Score
RM1	2.8

Low (<1%)

Enrollment 268	Year Built (Field Verified) 1956	Year Built (Alt. Source) 1956	Est. Decade Built 1950
Total Area (square ft) 35004	Number of Stories 1	Basement No	Pounding Potential No
Plan Irregularities None None None		Vertical Irregularities None None None	
Falling Hazards None None None		Poor Conditions None None None

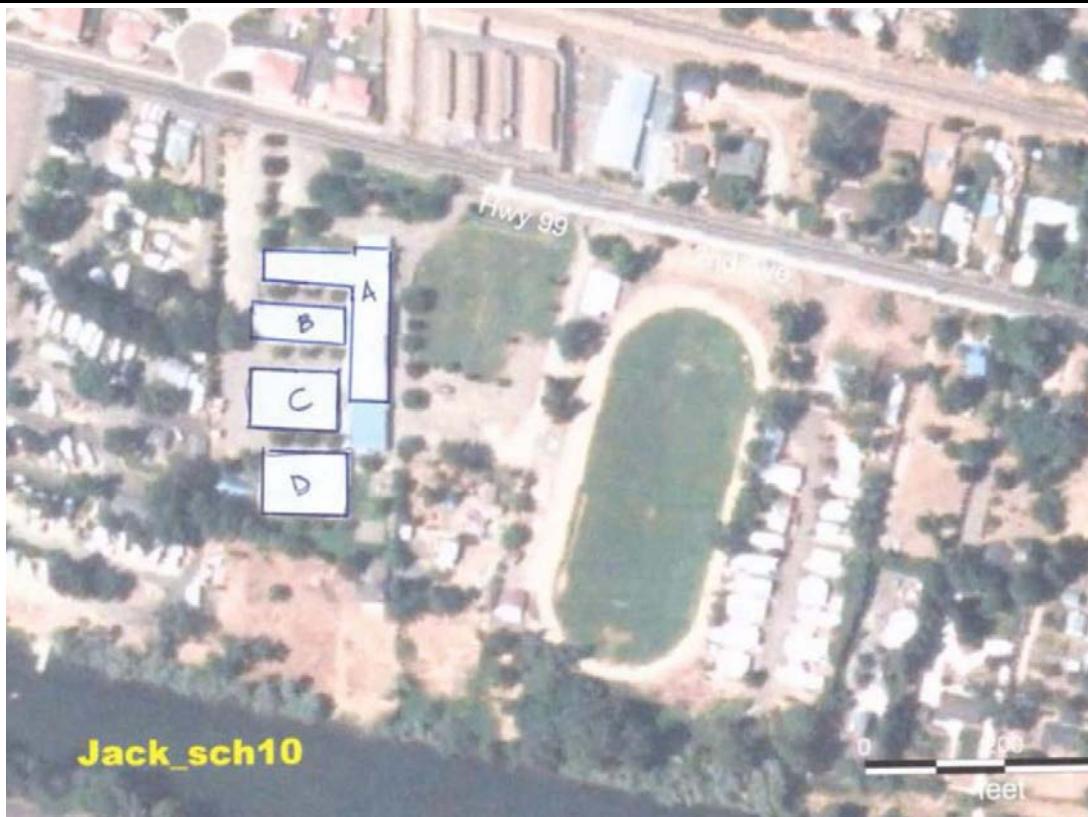
Final Type	Final Score
RM1	2.8

Low (<1%)

Enrollment 268	Year Built (Field Verified) 1956	Year Built (Alt. Source) 1956	Est. Decade Built 1950
Total Area (square ft) 35004	Number of Stories 1	Basement No	Pounding Potential No
Plan Irregularities None None None		Vertical Irregularities None None None	
Falling Hazards None None None		Poor Conditions None None None
