Crater High School

Central Point SD 6

FEMA 154 Rapid Visual Screening Score Card

Rapid Visual Screening - Senate Bill #2 - Seismic Needs Assessment
Oregon Department of Geology and Mineral Industries

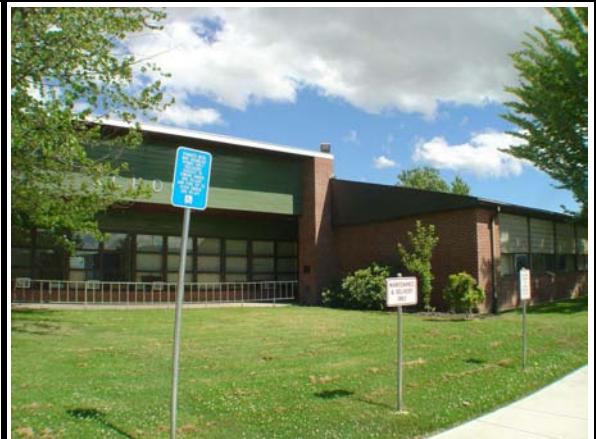
Jack_sch15A

Type	Basic Score	Vert Irreg	Plan Irreg	Pre-Code	Post-Bench	Soil C	Soil D	Soil E	RVS Score
Primary	W2	4.8	0	-0.5	0	0	-0.8	0	0	3.5
Secondary		0	0	0	0	0	0	0	0	0
Tertiary		0	0	0	0	0	0	0	0	0

Final Type	Final Score
W2	3.5

Low (<1%)

Enrollment 1494	Year Built (Field Verified) 1950	Year Built (Alt. Source) 1950	Est. Decade Built 1950
Total Area (square ft) 138718	Number of Stories 1	Basement	Pounding Potential No
Plan Irregularities Reentrant Corners: Other None None		Vertical Irregularities None None None	
Falling Hazards Other: Brick Veneer None None		Poor Conditions None None None

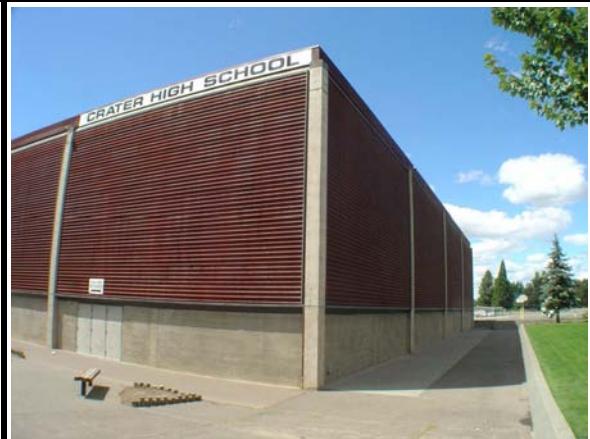
Jack_sch15B

Type	Basic Score	Vert Irreg	Plan Irreg	Pre-Code	Post-Bench	Soil C	Soil D	Soil E	RVS Score
Primary	C1	3	-2	0	0	0	-0.6	0	0	0.4
Secondary	C2	3.6	-2	0	0	0	-0.8	0	0	0.8
Tertiary	S3	3.8	0	0	0	0	-0.6	0	0	3.2

Final Type	Final Score
C1	0.4

High (>10%)

Enrollment 1494	Year Built (Field Verified) 1950	Year Built (Alt. Source) 1950	Est. Decade Built 1950
Total Area (square ft) 138718	Number of Stories 2	Basement No	Pounding Potential No
Plan Irregularities None None None		Vertical Irregularities Building On Hill or Sloped Site None None	
Falling Hazards None None None		Poor Conditions None None None

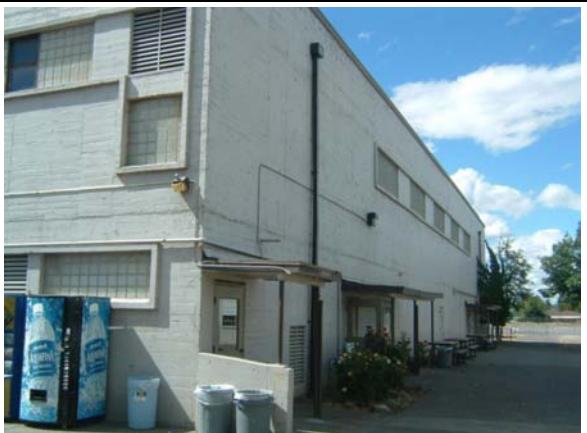
Jack_sch15C

Type	Basic Score	Vert Irreg	Plan Irreg	Pre-Code	Post-Bench	Soil C	Soil D	Soil E	RVS Score
Primary	C2	3.6	-2	-0.5	0	0	-0.8	0	0	0.3
Secondary		0	0	0	0	0	0	0	0	0
Tertiary		0	0	0	0	0	0	0	0	0

Final Type	Final Score
C2	0.3

High (>10%)

Enrollment 1494	Year Built (Field Verified) 1950	Year Built (Alt. Source) 1950	Est. Decade Built 1940
Total Area (square ft) 138718	Number of Stories 3	Basement	Pounding Potential No
Plan Irregularities Reentrant Corners:Other (Adjacent Build/Entity) None None		Vertical Irregularities Steps in Elevation View: Single Change (Adjacent Building/Entity) None None	
Falling Hazards Unreinforced Chimneys None None		Poor Conditions None None None

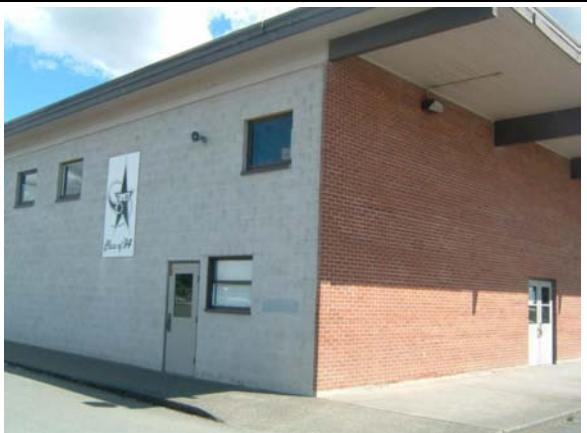
Jack_sch15D

Type	Basic Score	Vert Irreg	Plan Irreg	Pre-Code	Post-Bench	Soil C	Soil D	Soil E	RVS Score
Primary	RM1	3.6	0	0	0	0	-0.8	0	0	2.8
Secondary		0	0	0	0	0	0	0	0	0
Tertiary		0	0	0	0	0	0	0	0	0

Final Type	Final Score
RM1	2.8

Low (<1%)

Enrollment 1494	Year Built (Field Verified) 1950	Year Built (Alt. Source) 1950	Est. Decade Built 1970
Total Area (square ft) 138718	Number of Stories 2	Basement No	Pounding Potential No
Plan Irregularities None None None		Vertical Irregularities None None None	
Falling Hazards Other: Brick Veneer		Poor Conditions None None None

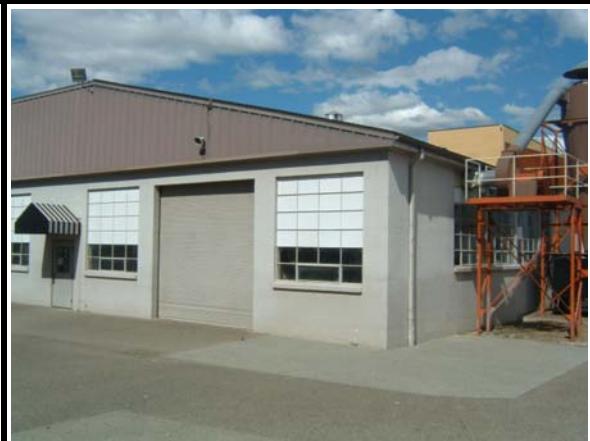
Jack_sch15E

Type	Basic Score	Vert Irreg	Plan Irreg	Pre-Code	Post-Bench	Soil C	Soil D	Soil E	RVS Score
Primary	C2	3.6	-2	-0.5	0	0	-0.8	0	0	0.3
Secondary		0	0	0	0	0	0	0	0	0
Tertiary		0	0	0	0	0	0	0	0	0

Final Type	Final Score
C2	0.3

High (>10%)

Enrollment 1494	Year Built (Field Verified) 1950	Year Built (Alt. Source) 1950	Est. Decade Built 1960
Total Area (square ft) 138718	Number of Stories 1	Basement	Pounding Potential No
Plan Irregularities Reentrant Corners:Other (Adjacent Build/Entity) None None		Vertical Irregularities Steps in Elevation View: Single Change (Adjacent Building/Entity) None None	
Falling Hazards None None None		Poor Conditions None None None

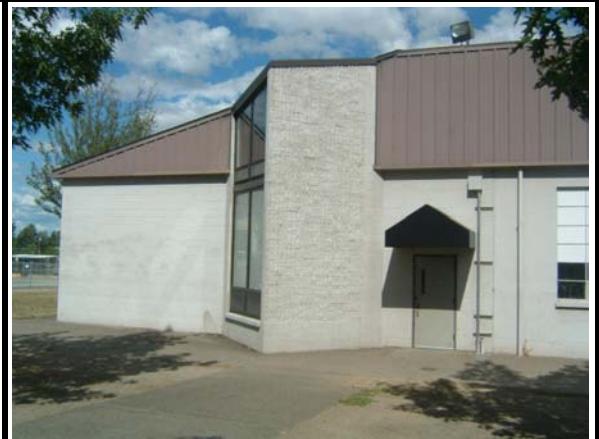
Jack_sch15F

Type	Basic Score	Vert Irreg	Plan Irreg	Pre-Code	Post-Bench	Soil C	Soil D	Soil E	RVS Score
Primary	RM1	3.6	-2	-0.5	0	0	-0.8	0	0	0.3
Secondary		0	0	0	0	0	0	0	0	0
Tertiary		0	0	0	0	0	0	0	0	0

Final Type	Final Score
RM1	0.3

High (>10%)

Enrollment	Year Built (Field Verified)	Year Built (Alt. Source)	Est. Decade Built
1494		1950	1970
Total Area (square ft)	Number of Stories	Basement	Pounding Potential
138718	1	No	No
Plan Irregularities		Vertical Irregularities	
Non-Parallel System		Steps in Elevation View: Single Change (Adjacent Building/Entity)	
Reentrant Corners: Other		Steps in Elevation View: Single Change	
Reentrant Corners: Other		None	
Falling Hazards		Poor Conditions	
None		None	
None		None	
None		None

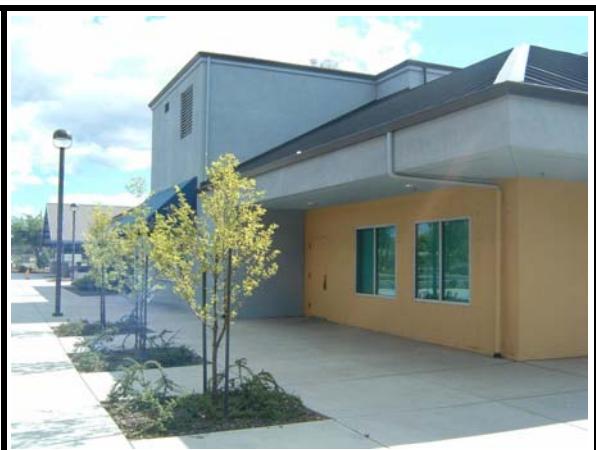
Jack_sch15G

Type	Basic Score	Vert Irreg	Plan Irreg	Pre-Code	Post-Bench	Soil C	Soil D	Soil E	RVS Score
Primary	RM1	3.6	-2	-0.5	0	0	-0.8	0	0	0.3
Secondary		0	0	0	0	0	0	0	0	0
Tertiary		0	0	0	0	0	0	0	0	0

High (>10%)

Enrollment 1494	Year Built (Field Verified) 1950	Year Built (Alt. Source) 1950	Est. Decade Built 1980
Total Area (square ft) 138718	Number of Stories 2	Basement No	Pounding Potential No
Plan Irregularities Out of Plane Lateral-Force-Resistance Elements None None		Vertical Irregularities Steps in Elevation View: Single Change None None	
Falling Hazards None None None		Poor Conditions None None None

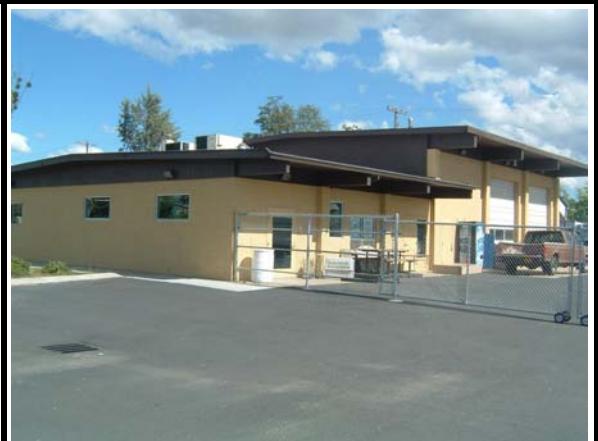
Jack_sch15H

Enrollment 1494	Year Built (Field Verified) 1950	Year Built (Alt. Source) 1950	Est. Decade Built 1960
Total Area (square ft) 138718	Number of Stories 1	Basement	Pounding Potential No
Plan Irregularities		Vertical Irregularities	
Reentrant Corners: Other		Steps in Elevation View: Single Change	
Out of Plane Lateral-Force-Resistance Elements		None	
None		None	
Falling Hazards		Poor Conditions	
None		None	
None		None	
None		None
