# Rogue River High School

Jack\_sch22A

## FEMA 154 Rapid Visual Screening Score Card

Rapid Visual Screening - Senate Bill #2 - Seismic Needs Assessment  
Oregon Department of Geology and Mineral Industries

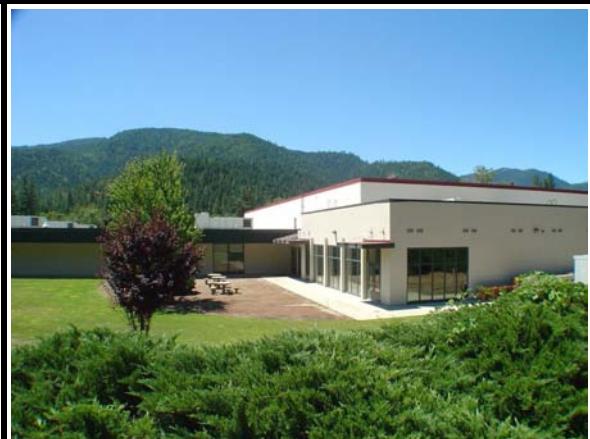
Type	Basic Score	Vert Irreg	Plan Irreg	Pre-Code	Post-Bench	Soil C	Soil D	Soil E	RVS Score
Primary	RM1	2.8	-1	-0.5	0	0	0	0	0	1.3
Secondary		0	0	0	0	0	0	0	0	0
Tertiary		0	0	0	0	0	0	0	0	0

Final Type	Final Score
RM1	1.3

Moderate (>1%)

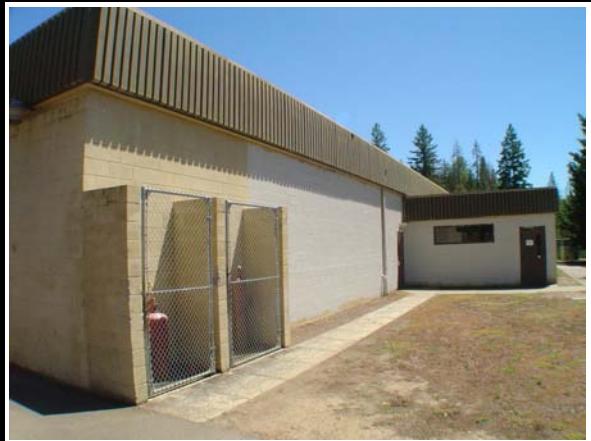
Jack\_sch22B

Type	Basic Score	Vert Irreg	Plan Irreg	Pre-Code	Post-Bench	Soil C	Soil D	Soil E	RVS Score
Primary	RM1	2.8	-1	-0.5	0	0	0	0	0	1.3
Secondary		0	0	0	0	0	0	0	0	0
Tertiary		0	0	0	0	0	0	0	0	0

Final Type	Final Score
RM1	1.3

Moderate (>1%)
