# Griffin Creek Elementary School

Medford SD 549C

## FEMA 154 Rapid Visual Screening Score Card

Rapid Visual Screening - Senate Bill #2 - Seismic Needs Assessment  
Oregon Department of Geology and Mineral Industries

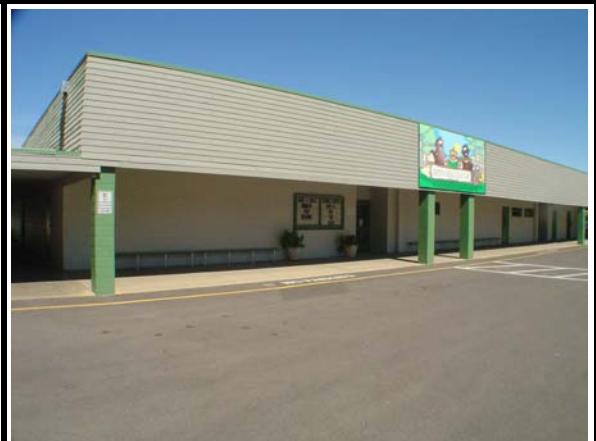
Jack\_sch23A

Type	Basic Score	Vert Irreg	Plan Irreg	Pre-Code	Post-Bench	Soil C	Soil D	Soil E	RVS Score
Primary	RM1	3.6	0	0	0	0	-0.8	0	0	2.8
Secondary		0	0	0	0	0	0	0	0	0
Tertiary		0	0	0	0	0	0	0	0	0

Final Type	Final Score
RM1	2.8

Low (<1%)

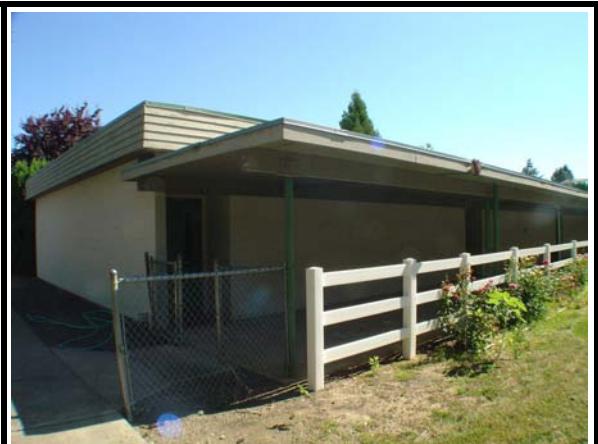
Jack\_sch23B

Type	Basic Score	Vert Irreg	Plan Irreg	Pre-Code	Post-Bench	Soil C	Soil D	Soil E	RVS Score
Primary	RM1	3.6	0	-0.5	0	0	-0.8	0	0	2.3
Secondary	W2	4.8	0	-0.5	0	0	-0.8	0	0	3.5
Tertiary		0	0	0	0	0	0	0	0	0

Final Type	Final Score
RM1	2.3

Low (<1%)

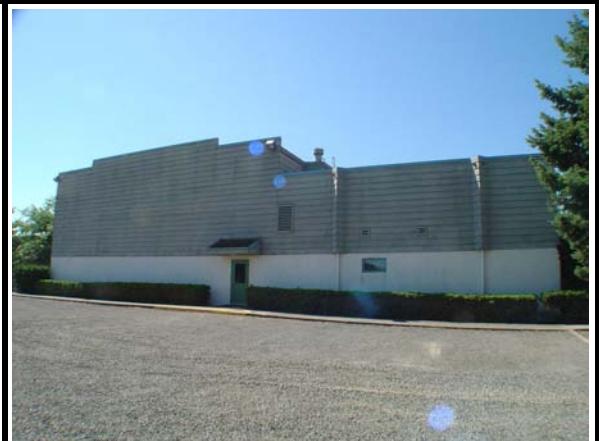
Jack\_sch23C

Type	Basic Score	Vert Irreg	Plan Irreg	Pre-Code	Post-Bench	Soil C	Soil D	Soil E	RVS Score
Primary	W2	4.8	-3	0	0	1.6	-0.8	0	0	2.6
Secondary		0	0	0	0	0	0	0	0	0
Tertiary		0	0	0	0	0	0	0	0	0

Final Type	Final Score
W2	2.6

Low (<1%)

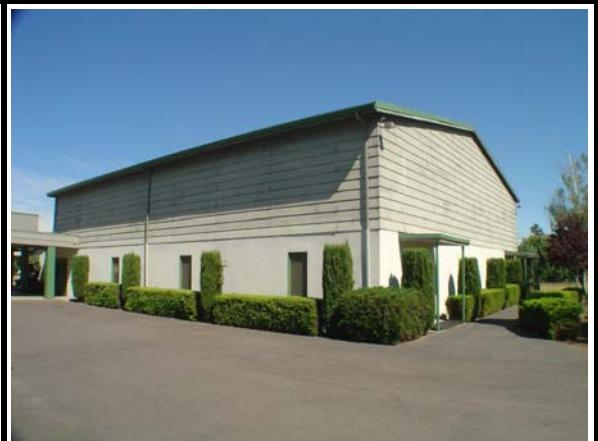
Jack\_sch23D

Type	Basic Score	Vert Irreg	Plan Irreg	Pre-Code	Post-Bench	Soil C	Soil D	Soil E	RVS Score
Primary	W2	4.8	0	0	0	0	-0.8	0	0	4
Secondary		0	0	0	0	0	0	0	0	0
Tertiary		0	0	0	0	0	0	0	0	0

Final Type	Final Score
W2	4

Low (<1%)

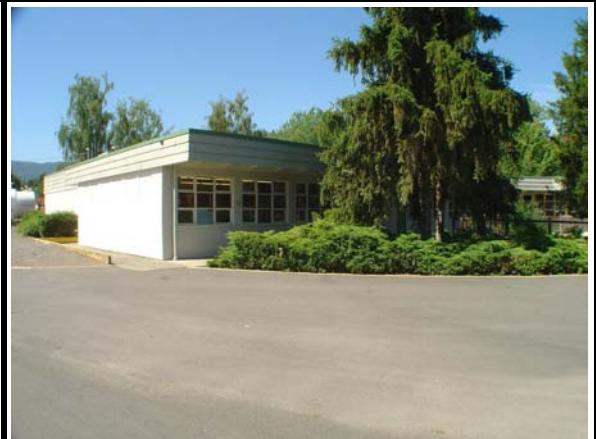
Jack\_sch23E

Seismicity Zone: Moderate										
FEMA 154 Rapid Visual Screening Score Card										
	Type	Basic Score	Vert Irreg	Plan Irreg	Pre-Code	Post-Bench	Soil C	Soil D	Soil E	RVS Score
Primary	C2	3.6	-2	-0.5	0	0	-0.8	0	0	0.3
Secondary	RM1	3.6	-2	-0.5	0	0	-0.8	0	0	0.3
Tertiary	W2	4.8	-3	-0.5	0	0	-0.8	0	0	0.5

Final Type	Final Score
C2	0.3

High (>10%)
-------------

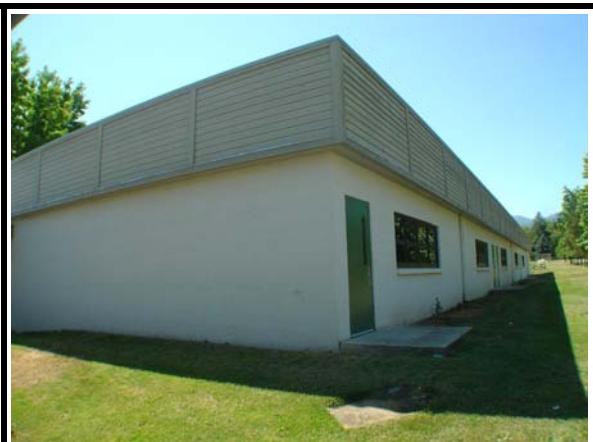
Jack\_sch23F

Type	Basic Score	Vert Irreg	Plan Irreg	Pre-Code	Post-Bench	Soil C	Soil D	Soil E	RVS Score
Primary	RM1	3.6	0	0	0	0	-0.8	0	0	2.8
Secondary		0	0	0	0	0	0	0	0	0
Tertiary		0	0	0	0	0	0	0	0	0

Final Type	Final Score
RM1	2.8

Low (<1%)
