Hoover Elementary School

Medford SD 549C

FEMA 154 Rapid Visual Screening Score Card

Rapid Visual Screening - Senate Bill #2 - Seismic Needs Assessment
Oregon Department of Geology and Mineral Industries

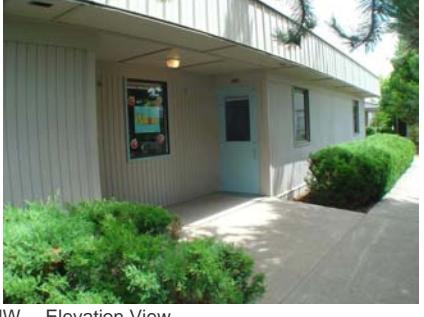
Enrollment 484	Year Built (Field Verified) 1958	Year Built (Alt. Source) 1958	Est. Decade Built 1970
Total Area (square ft) 51611	Number of Stories 1	Basement	Pounding Potential No
Plan Irregularities None None None		Vertical Irregularities None None None	
Falling Hazards None None None		Poor Conditions None None None
