North Medford High School

Medford SD 549C

FEMA 154 Rapid Visual Screening Score Card

Rapid Visual Screening - Senate Bill #2 - Seismic Needs Assessment
Oregon Department of Geology and Mineral Industries

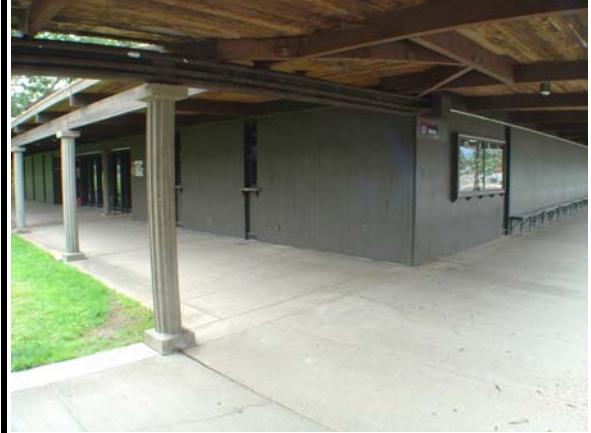
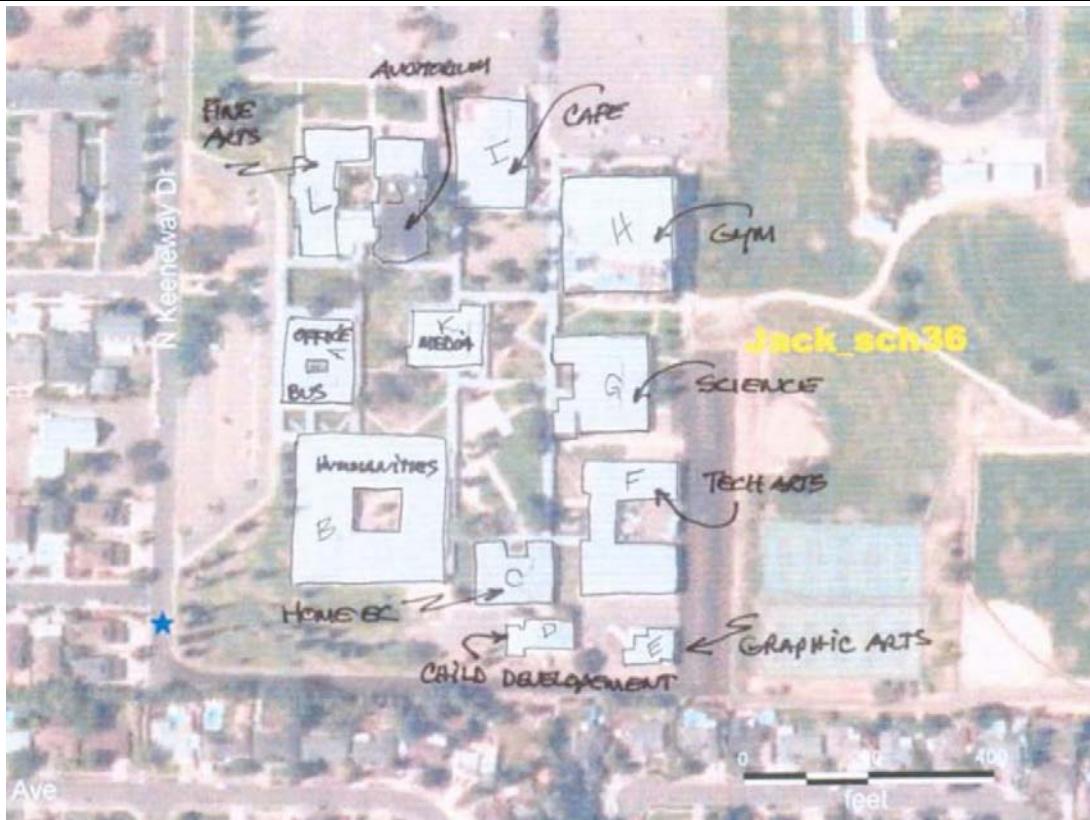
Jack_sch36A

Type	Basic Score	Vert Irreg	Plan Irreg	Pre-Code	Post-Bench	Soil C	Soil D	Soil E	RVS Score
Primary	W2	4.8	0	0	0	0	-0.8	0	0	4
Secondary		0	0	0	0	0	0	0	0	0
Tertiary		0	0	0	0	0	0	0	0	0

Low (<1%)

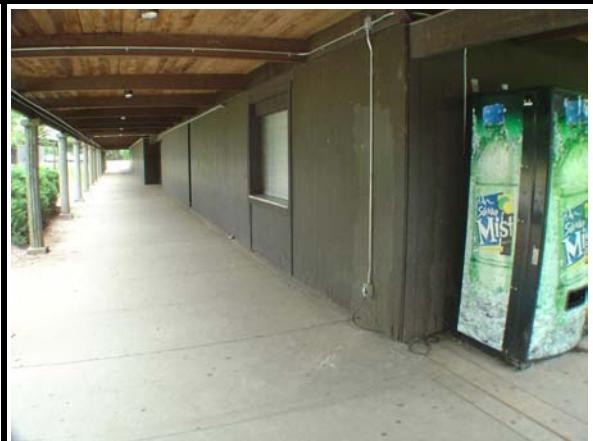
Jack_sch36B

Type	Basic Score	Vert Irreg	Plan Irreg	Pre-Code	Post-Bench	Soil C	Soil D	Soil E	RVS Score
Primary	W2	4.8	0	-0.5	0	0	-0.8	0	0	3.5
Secondary		0	0	0	0	0	0	0	0	0
Tertiary		0	0	0	0	0	0	0	0	0

Low (<1%)

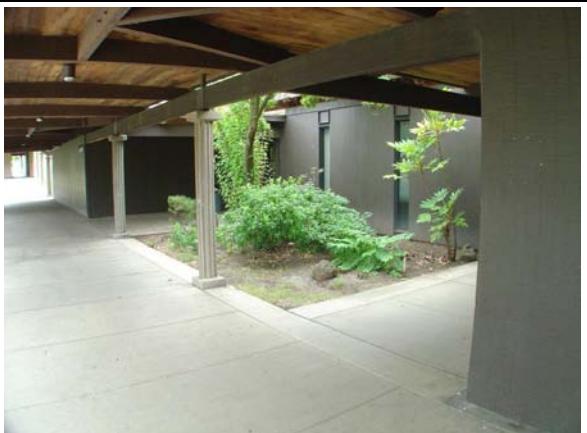
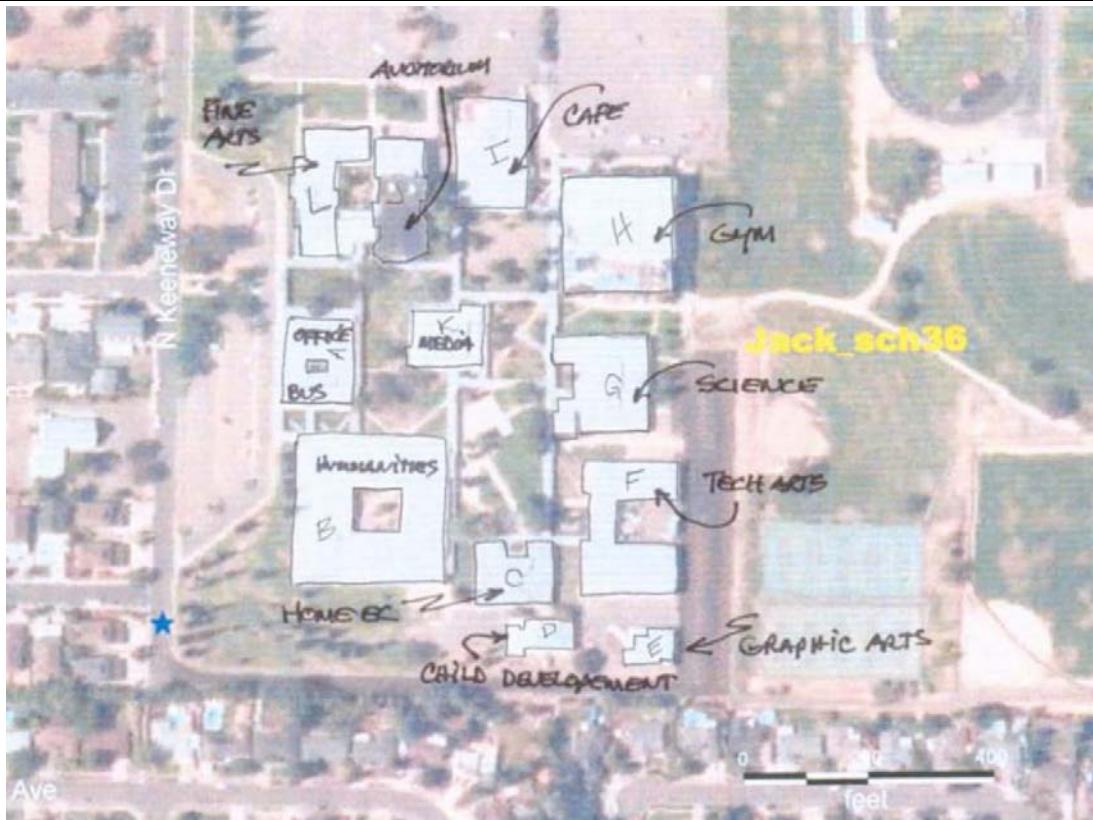
Jack_sch36C

Type	Basic Score	Vert Irreg	Plan Irreg	Pre-Code	Post-Bench	Soil C	Soil D	Soil E	RVS Score
Primary	W2	4.8	0	0	0	0	-0.8	0	0	4
Secondary		0	0	0	0	0	0	0	0	0
Tertiary		0	0	0	0	0	0	0	0	0

Low (<1%)

Enrollment 1941	Year Built (Field Verified) 1967	Year Built (Alt. Source) 1967	Est. Decade Built 1960
Total Area (square ft) 192822	Number of Stories 1	Basement	Pounding Potential No
Plan Irregularities Reentrant Corners: U shaped None None		Vertical Irregularities None None None	
Falling Hazards None None None		Poor Conditions None None None

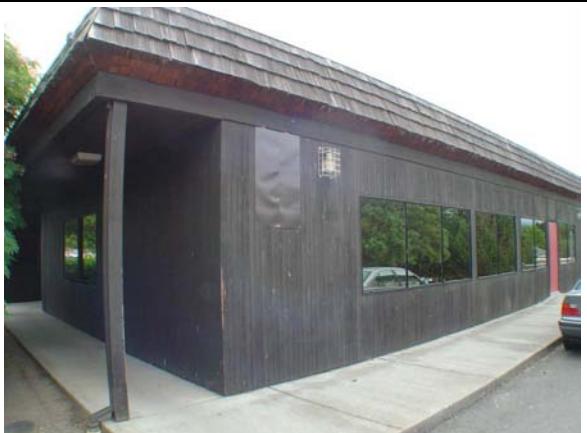
Jack_sch36D

Type	Basic Score	Vert Irreg	Plan Irreg	Pre-Code	Post-Bench	Soil C	Soil D	Soil E	RVS Score
Primary	W2	4.8	0	-0.5	0	0	-0.8	0	0	3.5
Secondary		0	0	0	0	0	0	0	0	0
Tertiary		0	0	0	0	0	0	0	0	0

Low (<1%)

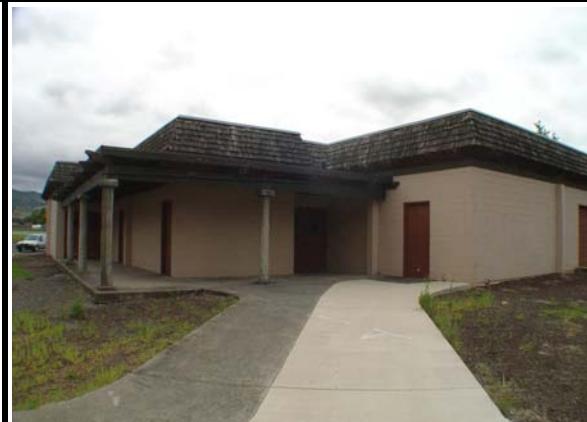
Jack_sch36E

Type	Basic Score	Vert Irreg	Plan Irreg	Pre-Code	Post-Bench	Soil C	Soil D	Soil E	RVS Score
Primary	RM1	3.6	0	-0.5	0	0	-0.8	0	0	2.3
Secondary		0	0	0	0	0	0	0	0	0
Tertiary		0	0	0	0	0	0	0	0	0

Low (<1%)

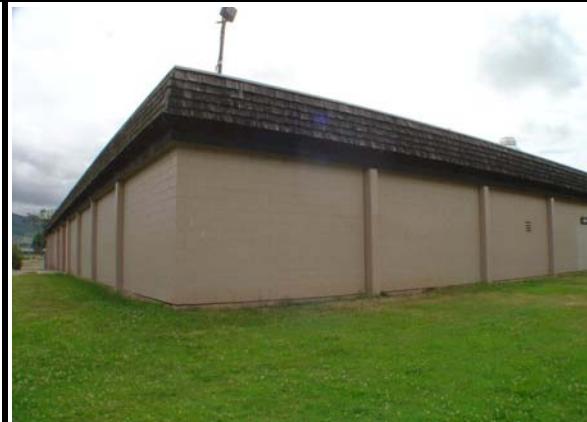
Jack_sch36F

Enrollment 1941	Year Built (Field Verified) 1967	Year Built (Alt. Source) 1967	Est. Decade Built 1960
Total Area (square ft) 192822	Number of Stories 1	Basement	Pounding Potential No
Plan Irregularities Reentrant Corners: U shaped None None		Vertical Irregularities None None None	
Falling Hazards None None None		Poor Conditions None None None

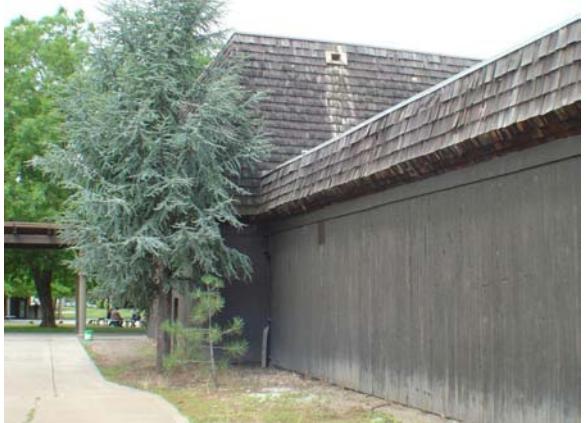
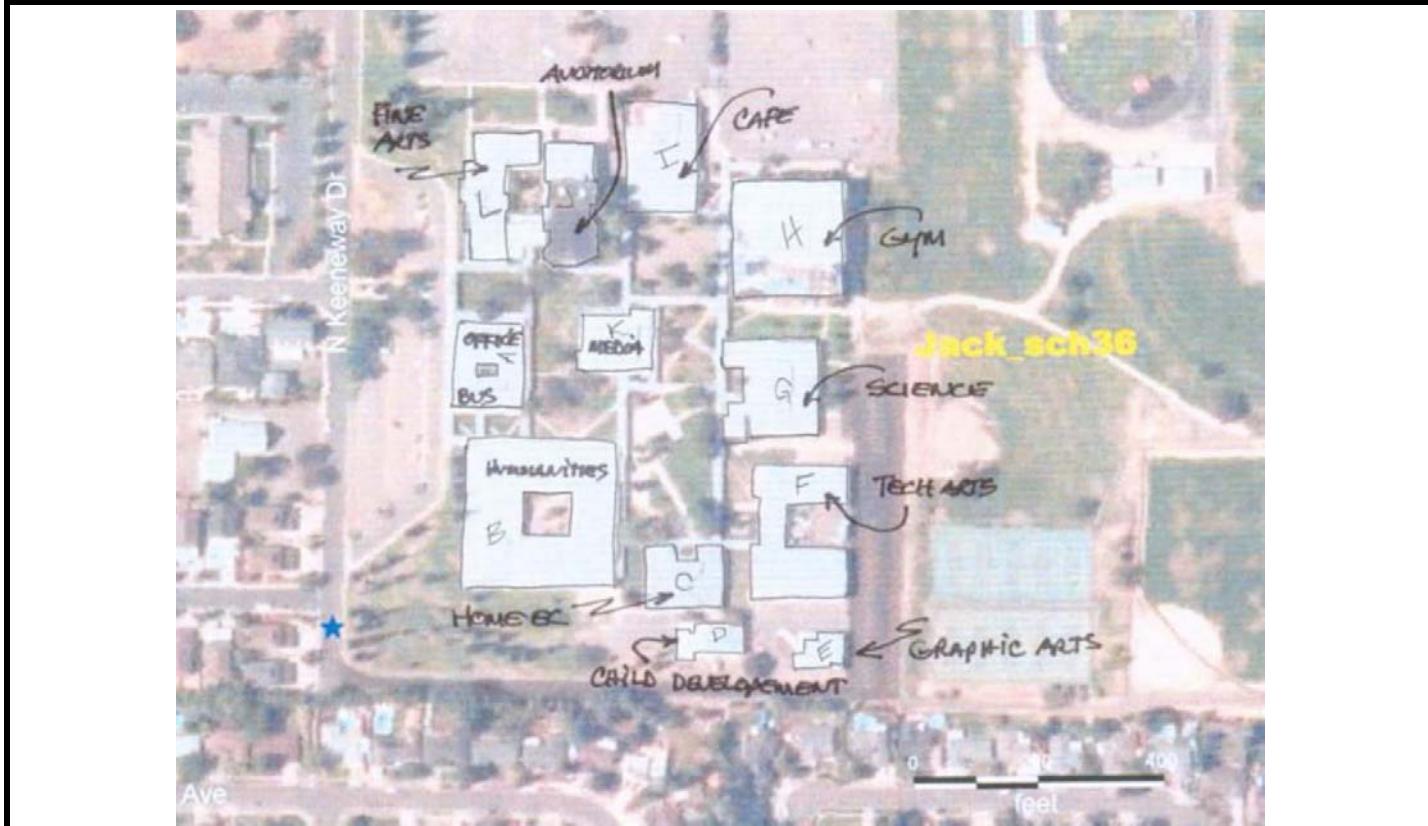
Jack_sch36G

Low (<1%)

Enrollment 1941	Year Built (Field Verified) 1967	Year Built (Alt. Source) 1967	Est. Decade Built 1960
Total Area (square ft) 192822	Number of Stories 1	Basement	Pounding Potential No
Plan Irregularities Reentrant Corners: U shaped Reentrant Corners: U shaped None		Vertical Irregularities None None None	
Falling Hazards None None None		Poor Conditions None None None

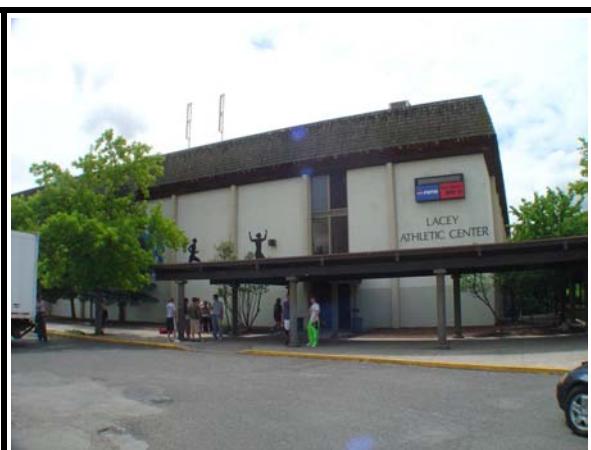
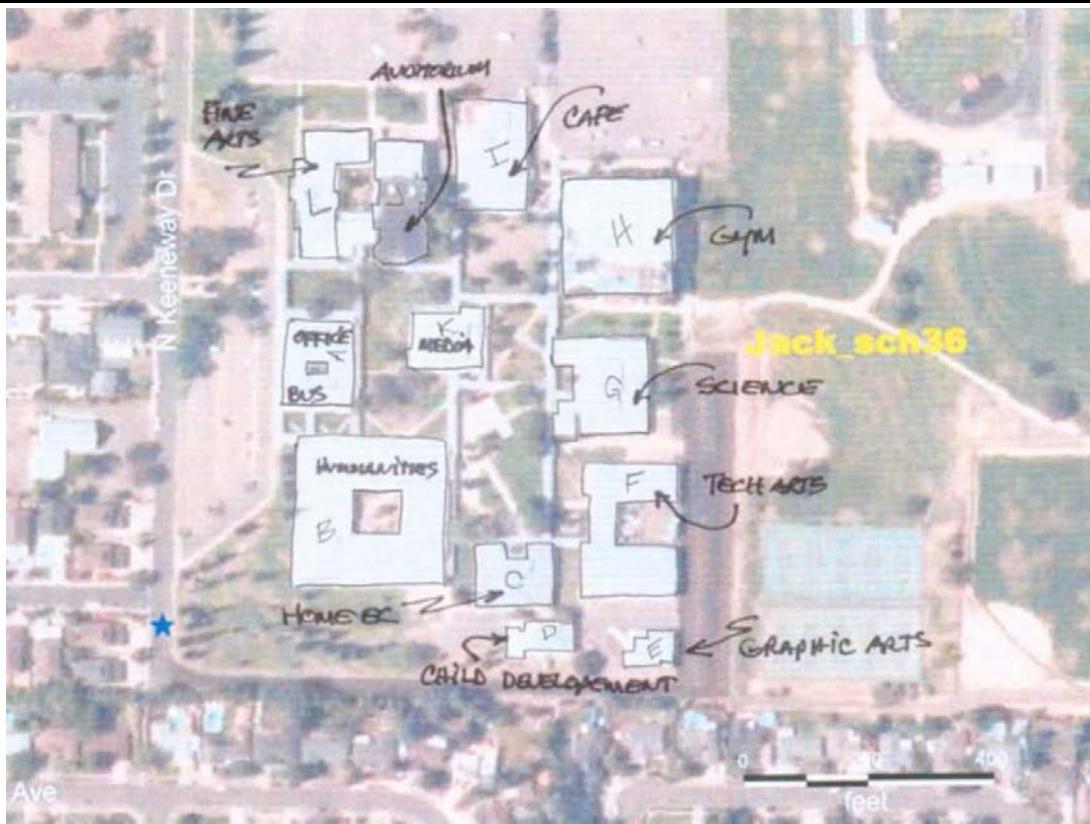
Jack_sch36H

High (>10%)

Enrollment 1941	Year Built (Field Verified) 1967	Year Built (Alt. Source) 1967	Est. Decade Built 1960
Total Area (square ft) 192822	Number of Stories 2	Basement	Pounding Potential No
Plan Irregularities None None None		Vertical Irregularities Internal Discontinuous Diaphram (large internal opening) None None	
Falling Hazards None None None		Poor Conditions None None None

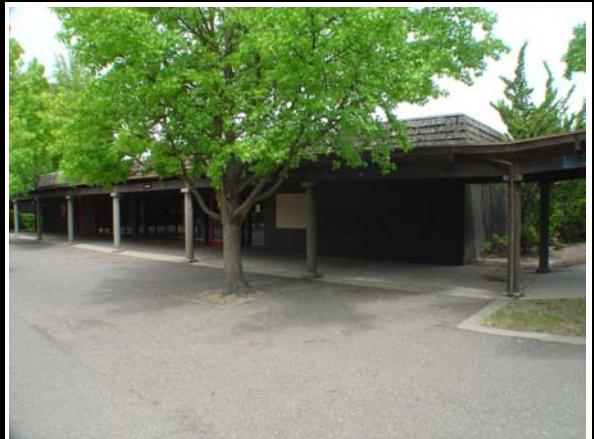
Jack_sch36I

Enrollment 1941	Year Built (Field Verified) 1967	Year Built (Alt. Source) 1967	Est. Decade Built 1960
Total Area (square ft) 192822	Number of Stories 1	Basement	Pounding Potential No
Plan Irregularities None None None		Vertical Irregularities None None None	
Falling Hazards None None None		Poor Conditions None None None

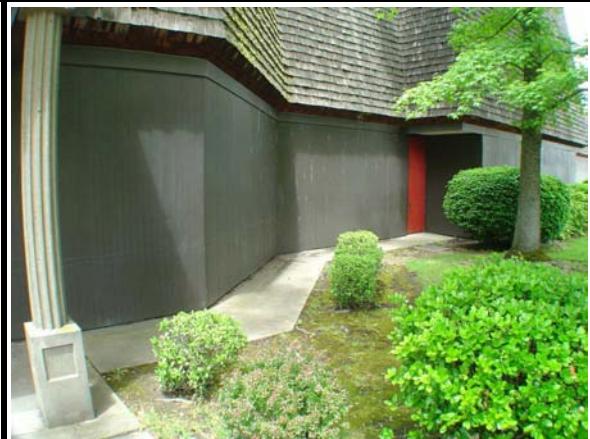
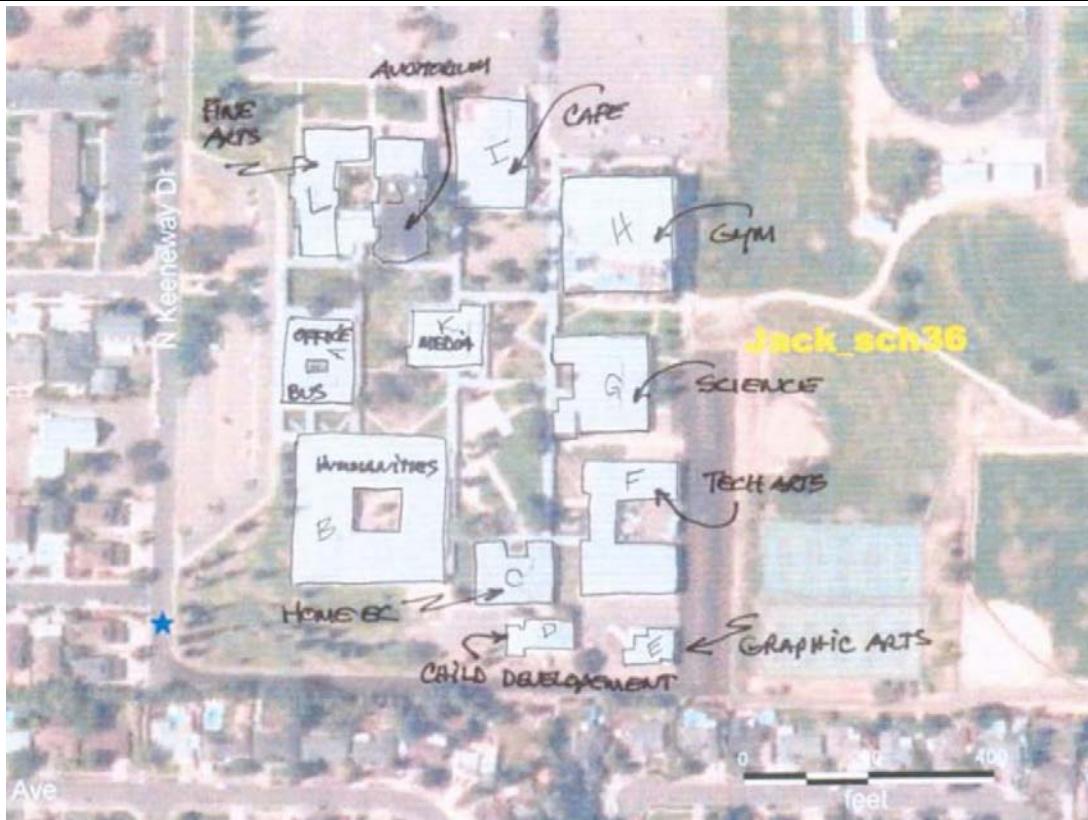
Jack_sch36J

High (>10%)

Enrollment 1941	Year Built (Field Verified) 1967	Year Built (Alt. Source) 1967	Est. Decade Built 1960
Total Area (square ft) 192822	Number of Stories 1	Basement	Pounding Potential No
Plan Irregularities		Vertical Irregularities	
Out of Plane Lateral-Force-Resistance Elements		Steps in Elevation View: Very Irregular Changes	
Non-Parallel System		None	
None		None	
Falling Hazards		Poor Conditions	
None		None	
None		None	
None		None

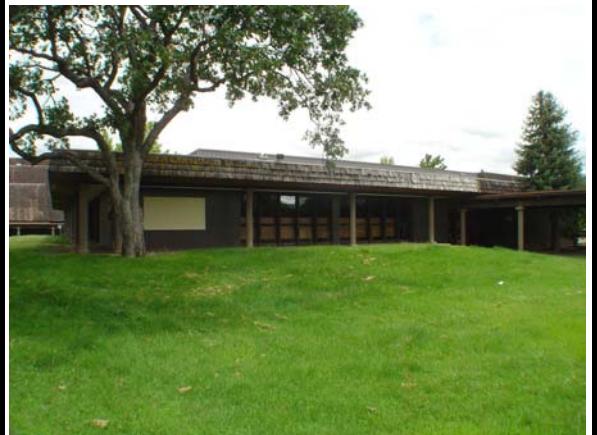
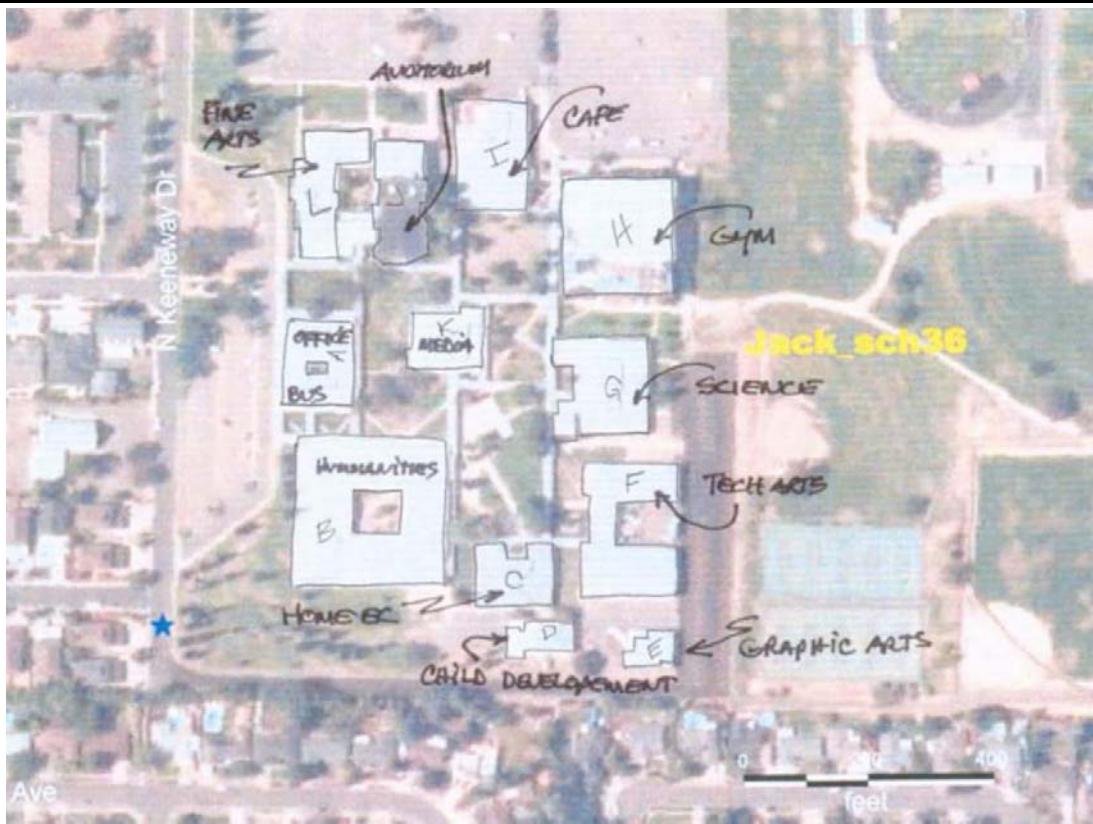
Jack_sch36K

Low (<1%)

Enrollment 1941	Year Built (Field Verified) 1967	Year Built (Alt. Source) 1967	Est. Decade Built 1960
Total Area (square ft) 192822	Number of Stories 1	Basement	Pounding Potential No
Plan Irregularities Out of Plane Lateral-Force-Resistance Elements None None		Vertical Irregularities None None None	
Falling Hazards None None None		Poor Conditions None None None

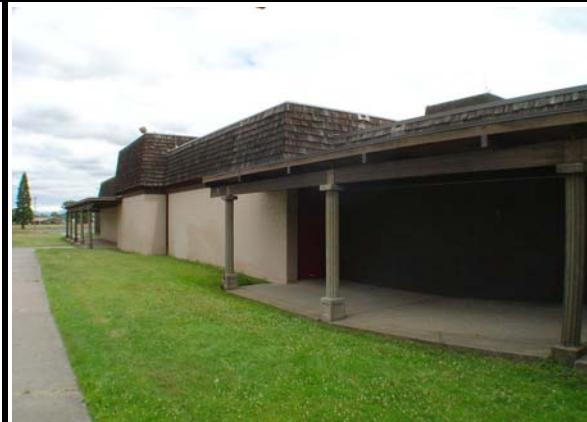
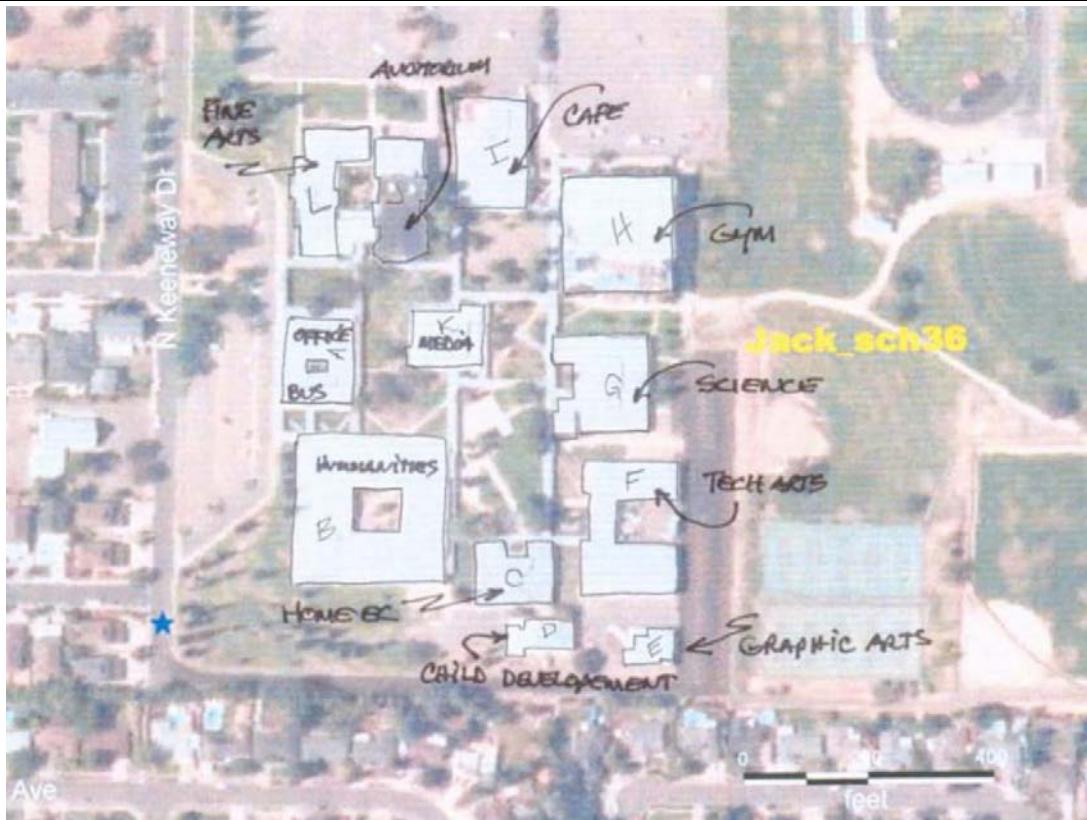
Jack_sch36L

High (>10%)

Enrollment 1941	Year Built (Field Verified) 1967	Year Built (Alt. Source) 1967	Est. Decade Built 1960
Total Area (square ft) 192822	Number of Stories 1	Basement	Pounding Potential No
Plan Irregularities		Vertical Irregularities	
Out of Plane Lateral-Force-Resistance Elements		Steps in Elevation View: Very Irregular Changes	
Reentrant Corners: Other		None	
None		None	
Falling Hazards		Poor Conditions	
None		None	
None		None	
None		None
