Orchard Hill Elementary School

Phoenix-Talent SD 4

FEMA 154 Rapid Visual Screening Score Card

Rapid Visual Screening - Senate Bill #2 - Seismic Needs Assessment
Oregon Department of Geology and Mineral Industries

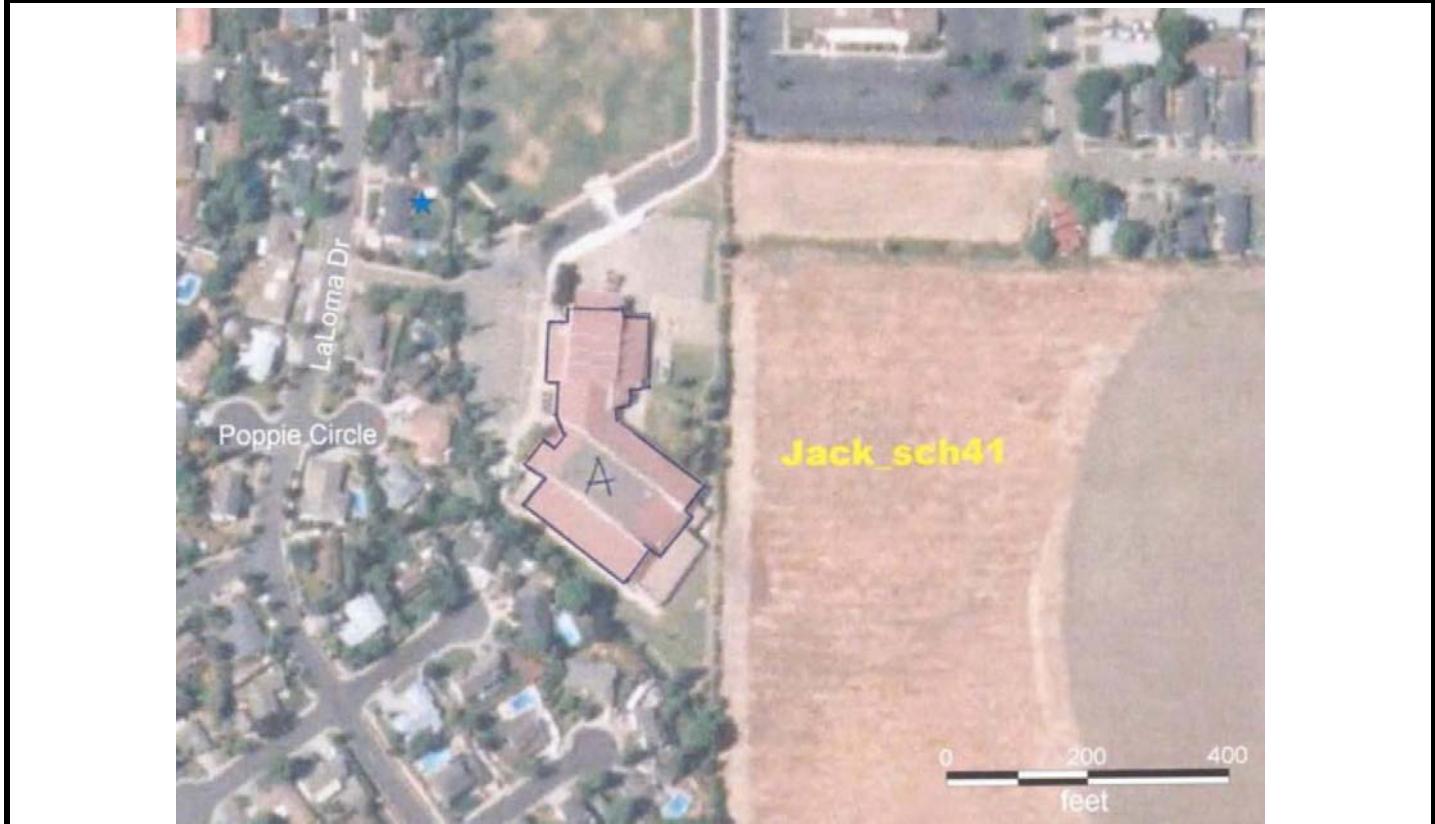
Type	Basic Score	Vert Irreg	Plan Irreg	Pre-Code	Post-Bench	Soil C	Soil D	Soil E	RVS Score
Primary	RM1	3.6	-2	-0.5	0	0	-0.8	0	0	0.3
Secondary		0	0	0	0	0	0	0	0	0
Tertiary		0	0	0	0	0	0	0	0	0

FEMA-154 Collapse Potential

High (>10%)
