Wilson Elementary School

Medford SD 549C

FEMA 154 Rapid Visual Screening Score Card

Rapid Visual Screening - Senate Bill #2 - Seismic Needs Assessment
 Oregon Department of Geology and Mineral Industries

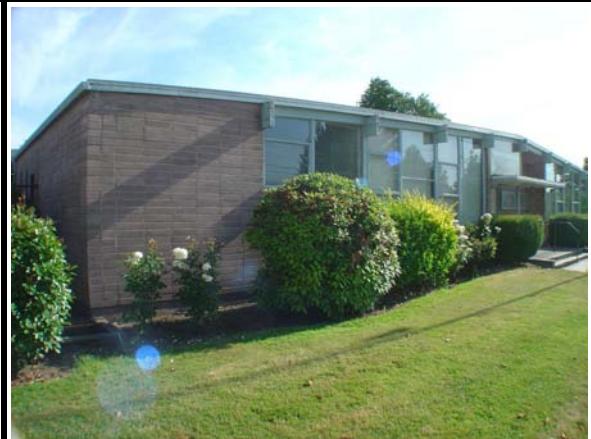
Jack_sch43A

Type	Basic Score	Vert Irreg	Plan Irreg	Pre-Code	Post-Bench	Soil C	Soil D	Soil E	RVS Score
Primary	RM1	3.6	0	0	0	0	-0.8	0	0	2.8
Secondary		0	0	0	0	0	0	0	0	0
Tertiary		0	0	0	0	0	0	0	0	0

Final Type	Final Score
RM1	2.8

Low (<1%)

Enrollment 572	Year Built (Field Verified) 1958	Year Built (Alt. Source) 1958	Est. Decade Built 1950
Total Area (square ft) 44204	Number of Stories 1	Basement	Pounding Potential No
Plan Irregularities None None None		Vertical Irregularities None None None	
Falling Hazards None None None		Poor Conditions None None None

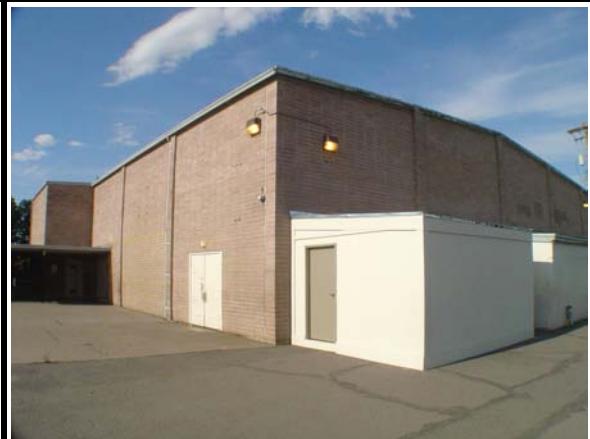
Jack_sch43B

Type	Basic Score	Vert Irreg	Plan Irreg	Pre-Code	Post-Bench	Soil C	Soil D	Soil E	RVS Score
Primary	RM2	3.4	0	-0.5	0	0	-0.6	0	0	2.3
Secondary		0	0	0	0	0	0	0	0	0
Tertiary		0	0	0	0	0	0	0	0	0

Final Type	Final Score
RM2	2.3

Low (<1%)

Enrollment 572	Year Built (Field Verified) 1958	Year Built (Alt. Source) 1958	Est. Decade Built 1950
Total Area (square ft) 44204	Number of Stories 1	Basement	Pounding Potential No
Plan Irregularities Reentrant Corners: Other None None		Vertical Irregularities Steps in Elevation View: 2 to 3 Changes (Adjacent Building/Entity) None None	
Falling Hazards None None None		Poor Conditions None None None

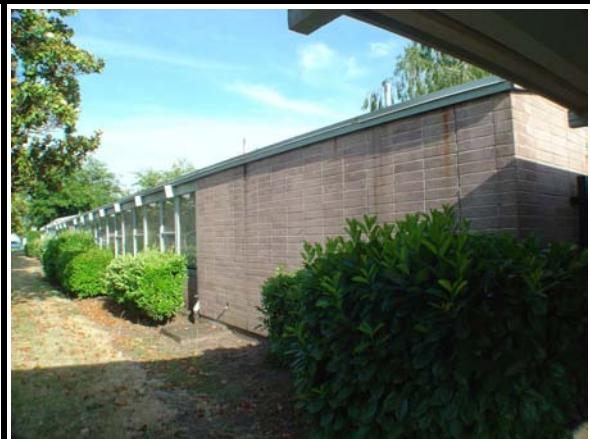
Jack_sch43C

Type	Basic Score	Vert Irreg	Plan Irreg	Pre-Code	Post-Bench	Soil C	Soil D	Soil E	RVS Score
Primary	RM1	3.6	-2	0	0	0	-0.8	0	0	0.8
Secondary		0	0	0	0	0	0	0	0	0
Tertiary		0	0	0	0	0	0	0	0	0

Final Type	Final Score
RM1	0.8

High (>10%)

Enrollment 572	Year Built (Field Verified) 1958	Year Built (Alt. Source) 1950	Est. Decade Built 1950
Total Area (square ft) 44204	Number of Stories 1	Basement	Pounding Potential No
Plan Irregularities None None None		Vertical Irregularities Steps in Elevation View: Single Change None None	
Falling Hazards None None None		Poor Conditions None None None

N Vertical Irregularity Primary

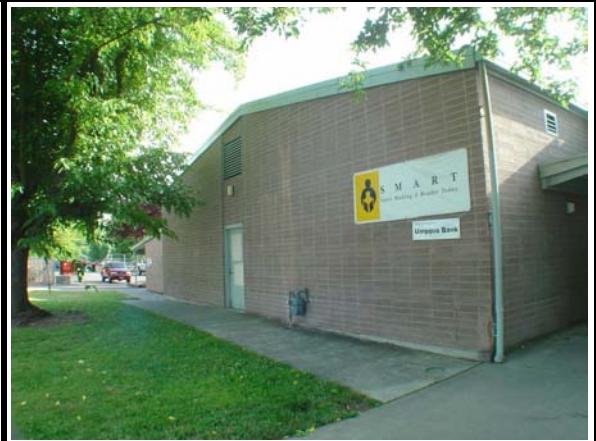
Jack_sch43D

Type	Basic Score	Vert Irreg	Plan Irreg	Pre-Code	Post-Bench	Soil C	Soil D	Soil E	RVS Score
Primary	RM1	3.6	0	0	0	0	-0.8	0	0	2.8
Secondary		0	0	0	0	0	0	0	0	0
Tertiary		0	0	0	0	0	0	0	0	0

Final Type	Final Score
RM1	2.8

Low (<1%)

Enrollment 572	Year Built (Field Verified) 1958	Year Built (Alt. Source) 1958	Est. Decade Built 1950
Total Area (square ft) 44204	Number of Stories 1	Basement	Pounding Potential Yes
Plan Irregularities None None None		Vertical Irregularities None None None	
Falling Hazards None None None		Poor Conditions None None None

E Other Joint to "E"

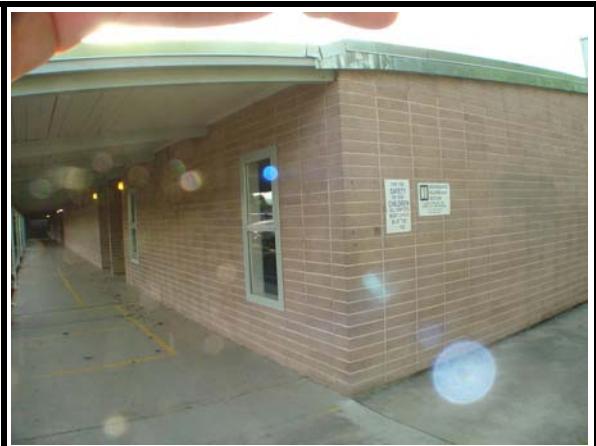
Jack_sch43E

Type	Basic Score	Vert Irreg	Plan Irreg	Pre-Code	Post-Bench	Soil C	Soil D	Soil E	RVS Score
Primary	RM1	3.6	0	0	0	0	-0.8	0	0	2.8
Secondary		0	0	0	0	0	0	0	0	0
Tertiary		0	0	0	0	0	0	0	0	0

Final Type	Final Score
RM1	2.8

Low (<1%)

Enrollment 572	Year Built (Field Verified) 1958	Year Built (Alt. Source) 1958	Est. Decade Built 1950
Total Area (square ft) 44204	Number of Stories 1	Basement No	Pounding Potential No
Plan Irregularities None None None		Vertical Irregularities None None None	
Falling Hazards None None None		Poor Conditions None None None

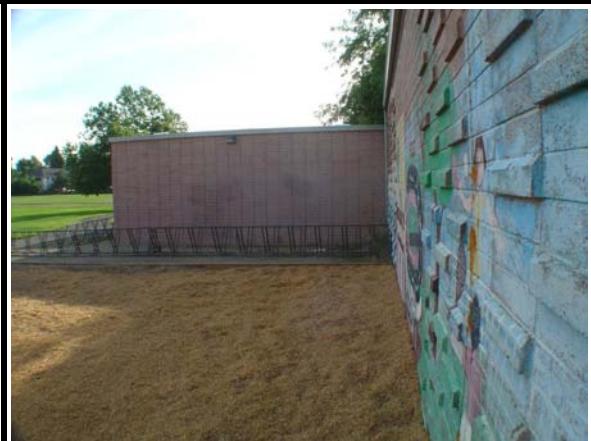
Jack_sch43F

Final Type	Final Score
RM1	2.3

Low (<1%)

Enrollment 572	Year Built (Field Verified) 1958	Year Built (Alt. Source) 1958	Est. Decade Built 1950
Total Area (square ft) 44204	Number of Stories 1	Basement No	Pounding Potential No
Plan Irregularities		Vertical Irregularities	
Reentrant Corners: Other None None		None None None	
Falling Hazards		Poor Conditions	
None None None		None None None

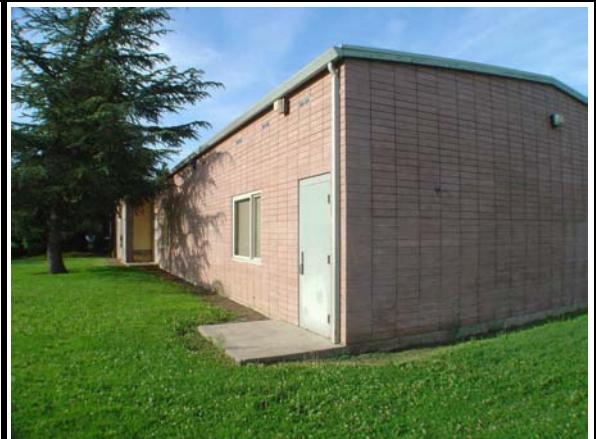
Jack_sch43G

Enrollment 572	Year Built (Field Verified) 1958	Year Built (Alt. Source) 1958	Est. Decade Built 1950
Total Area (square ft) 44204	Number of Stories 1	Basement	Pounding Potential No
Plan Irregularities Out of Plane Lateral-Force-Resistance Elements None None		Vertical Irregularities None None None	
Falling Hazards None None None		Poor Conditions None None None

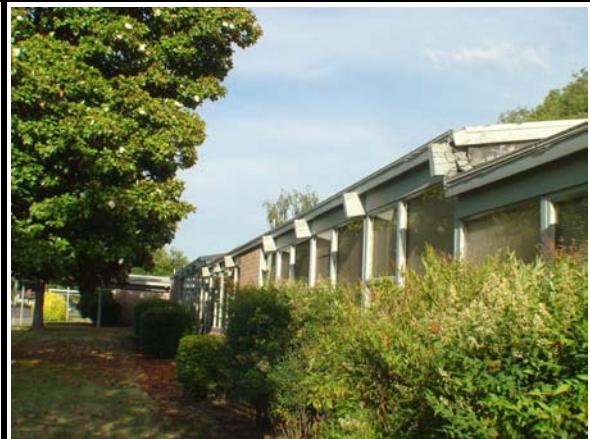
Jack_sch43H

Enrollment 572	Year Built (Field Verified) 1958	Year Built (Alt. Source) 1950	Est. Decade Built 1950
Total Area (square ft) 44204	Number of Stories 1	Basement	Pounding Potential No
Plan Irregularities None None None		Vertical Irregularities Steps in Elevation View: 2 to 3 Changes None None	
Falling Hazards None None None		Poor Conditions None None None
