Little Butte School

Jack_sch44A

FEMA 154 Rapid Visual Screening Score Card

Rapid Visual Screening - Senate Bill #2 - Seismic Needs Assessment
Oregon Department of Geology and Mineral Industries

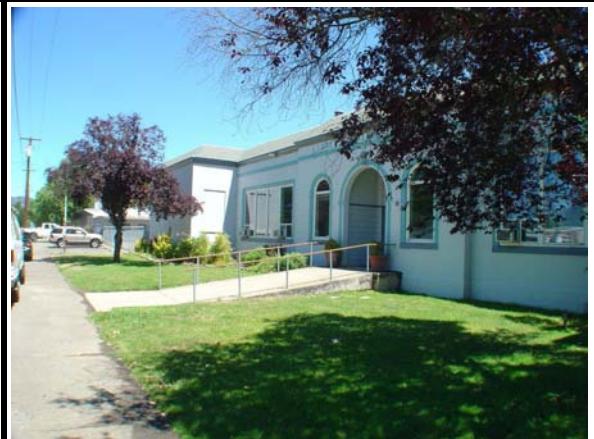
Type	Basic Score	Vert Irreg	Plan Irreg	Pre-Code	Post-Bench	Soil C	Soil D	Soil E	RVS Score
Primary	C2	3.6	0	-0.5	-0.4	0	-0.8	0	0	1.9
Secondary		0	0	0	0	0	0	0	0	0
Tertiary		0	0	0	0	0	0	0	0	0

Final Type	Final Score
C2	1.9

Moderate (>1%)

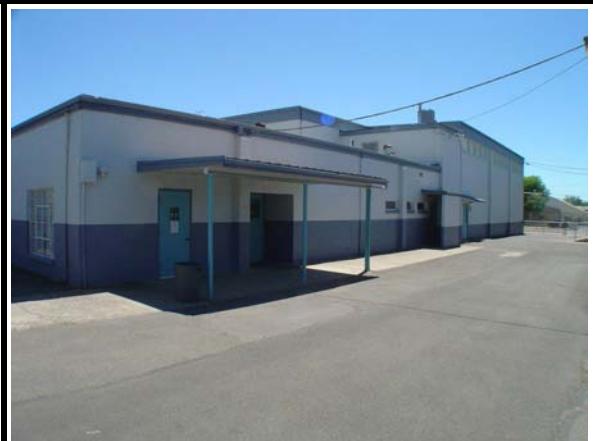
Jack_sch44B

Type	Basic Score	Vert Irreg	Plan Irreg	Pre-Code	Post-Bench	Soil C	Soil D	Soil E	RVS Score
Primary	RM1	3.6	-2	-0.5	0	0	-0.8	0	0	0.3
Secondary		0	0	0	0	0	0	0	0	0
Tertiary		0	0	0	0	0	0	0	0	0

Final Type	Final Score
RM1	0.3

High (>10%)

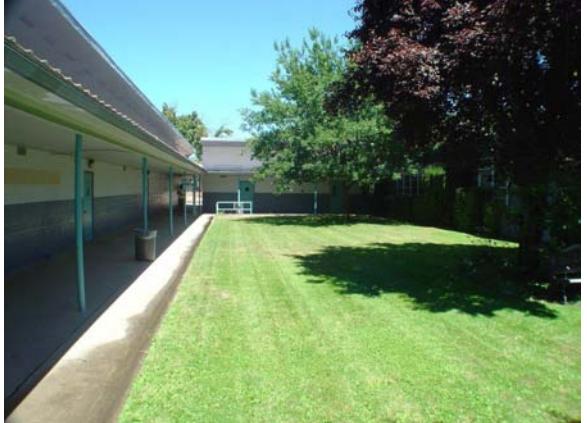
Jack_sch44C

Type	Basic Score	Vert Irreg	Plan Irreg	Pre-Code	Post-Bench	Soil C	Soil D	Soil E	RVS Score
Primary	RM1	3.6	0	-0.5	0	0	-0.8	0	0	2.3
Secondary	C2	3.6	0	-0.5	0	0	-0.8	0	0	2.3
Tertiary		0	0	0	0	0	0	0	0	0

Final Type	Final Score
RM1	2.3

Low (<1%)
