# Mountain View Hospital - Madras

Jeff\_hos01A

## FEMA 154 Rapid Visual Screening Score Card

Rapid Visual Screening - Senate Bill #2 - Seismic Needs Assessment  
Oregon Department of Geology and Mineral Industries

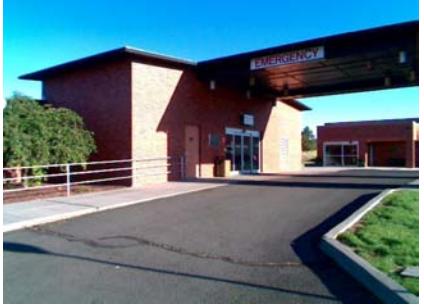
Enrollment	Year Built (Field Verified)	Year Built (Alt. Source)	Est. Decade Built
	1989	1967	1980
Total Area (square ft)	Number of Stories	Basement	Pounding Potential
	1	No	No
Plan Irregularities		Vertical Irregularities	
Reentrant Corners:Other (Adjacent Build/Entity)		Steps in Elevation View: Single Change (Adjacent Building/Entity)	
Reentrant Corners: Other		None	
None		None	
Falling Hazards		Poor Conditions	
Other: Ornamental Hazard Over Exit		None	
None		None	
None		None

SE General Site		SE Falling Hazard
