Riverside - K Building

Rogue CC

FEMA 154 Rapid Visual Screening Score Card

Rapid Visual Screening - Senate Bill #2 - Seismic Needs Assessment
Oregon Department of Geology and Mineral Industries

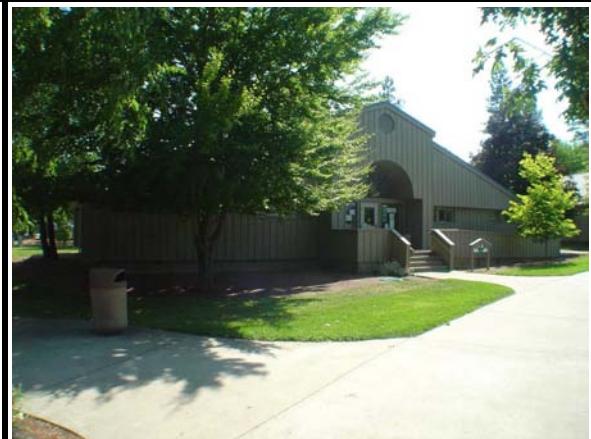
Seismicity Zone: High

| | Type | Basic Score | Vert Irreg | Plan Irreg | Pre-Code | Post-Bench | Soil C | Soil D | Soil E | RVS Score |
|---|---|---|---|---|---|---|---|---|---|---|
| Primary | W1 | 4.4 | -2.5 | -0.5 | -1 | 0 | 0 | 0 | 0 | 0.4 |

| Final Type | Final Score |
|---|---|
| W1 | 0.4 |

High (>10%)
