Madrona Elementary School

Three Rivers/Josephine County SD

FEMA 154 Rapid Visual Screening Score Card

Rapid Visual Screening - Senate Bill #2 - Seismic Needs Assessment
Oregon Department of Geology and Mineral Industries

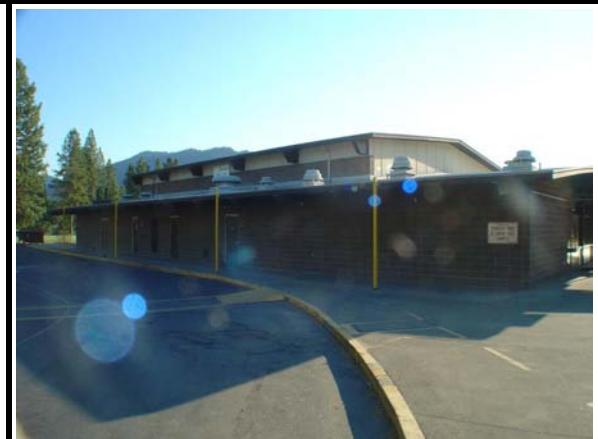
Jose_sch19A

Type	Basic Score	Vert Irreg	Plan Irreg	Pre-Code	Post-Bench	Soil C	Soil D	Soil E	RVS Score
Primary	RM1	2.8	-1	0	0	0	0	0	0	1.8
Secondary		0	0	0	0	0	0	0	0	0
Tertiary		0	0	0	0	0	0	0	0	0

Final Type	Final Score
RM1	1.8

Moderate (>1%)

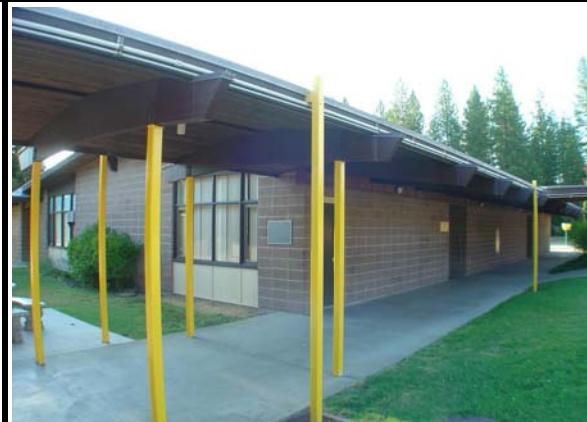
Jose_sch19B

Type	Basic Score	Vert Irreg	Plan Irreg	Pre-Code	Post-Bench	Soil C	Soil D	Soil E	RVS Score
Primary	RM1	2.8	0	0	0	0	0	0	0	2.8
Secondary		0	0	0	0	0	0	0	0	0
Tertiary		0	0	0	0	0	0	0	0	0

Final Type	Final Score
RM1	2.8

Low (<1%)

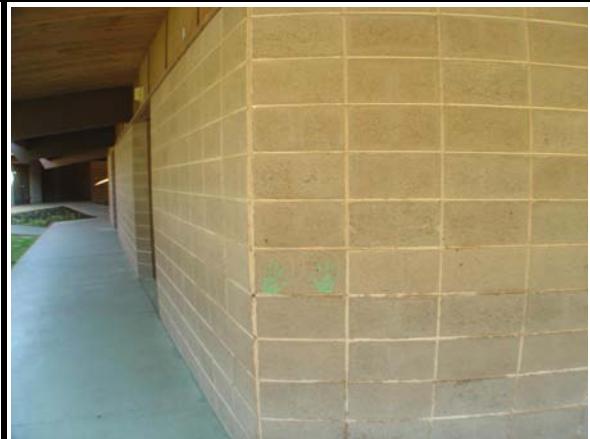
Jose_sch19C

Type	Basic Score	Vert Irreg	Plan Irreg	Pre-Code	Post-Bench	Soil C	Soil D	Soil E	RVS Score
Primary	RM1	2.8	0	-0.5	0	0	0	0	0	2.3
Secondary		0	0	0	0	0	0	0	0	0
Tertiary		0	0	0	0	0	0	0	0	0

Final Type	Final Score
RM1	2.3

Low (<1%)

Enrollment 299	Year Built (Field Verified) 1967	Year Built (Alt. Source) 1967	Est. Decade Built 1960
Total Area (square ft) 37816	Number of Stories 1	Basement	Pounding Potential No
Plan Irregularities Non-Parallel System None None		Vertical Irregularities None None None	
Falling Hazards None None None		Poor Conditions None None None

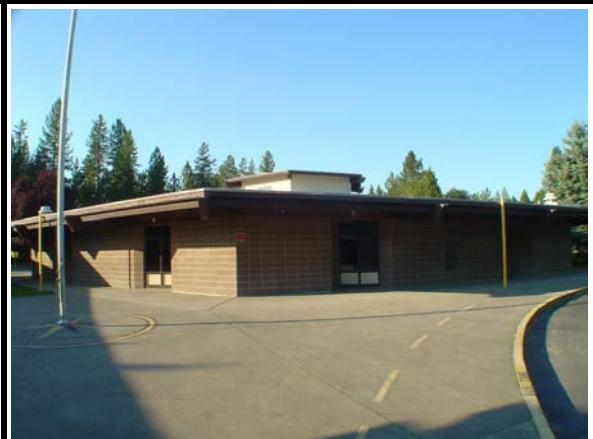
Jose_sch19D

Type	Basic Score	Vert Irreg	Plan Irreg	Pre-Code	Post-Bench	Soil C	Soil D	Soil E	RVS Score
Primary	RM1	2.8	0	-0.5	0	0	0	0	0	2.3
Secondary		0	0	0	0	0	0	0	0	0
Tertiary		0	0	0	0	0	0	0	0	0

Final Type	Final Score
RM1	2.3

Low (<1%)

Enrollment 299	Year Built (Field Verified) 1967	Year Built (Alt. Source) 1967	Est. Decade Built 1960
Total Area (square ft) 37816	Number of Stories 1	Basement	Pounding Potential No
Plan Irregularities Non-Parallel System Reentrant Corners: Other (Adjacent Build/Entity) None		Vertical Irregularities None None None	
Falling Hazards None None None		Poor Conditions None None None

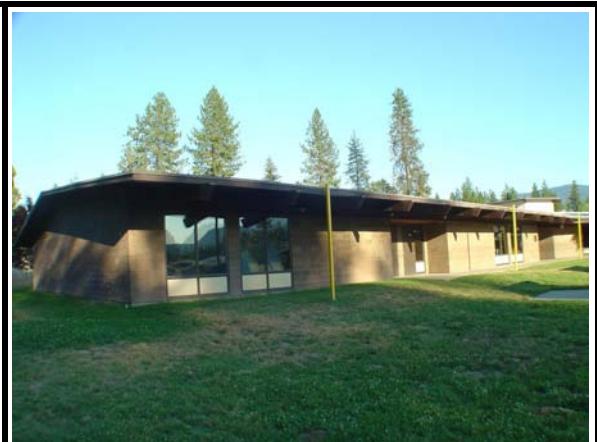
Jose_sch19E

Enrollment 299	Year Built (Field Verified) 1986	Year Built (Alt. Source) 1967	Est. Decade Built 1980
Total Area (square ft) 37816	Number of Stories 1	Basement	Pounding Potential No
Plan Irregularities Reentrant Corners:Other (Adjacent Build/Entity) None None		Vertical Irregularities None None None	
Falling Hazards None None None		Poor Conditions None None None
