# Merrill RFPD

Klam\_fir16A

| RVS in 2006 | | 7/21/2006 | |

Rapid Visual Screening - Senate Bill #2 - Seismic Needs Assessment  
Oregon Department of Geology and Mineral Industries

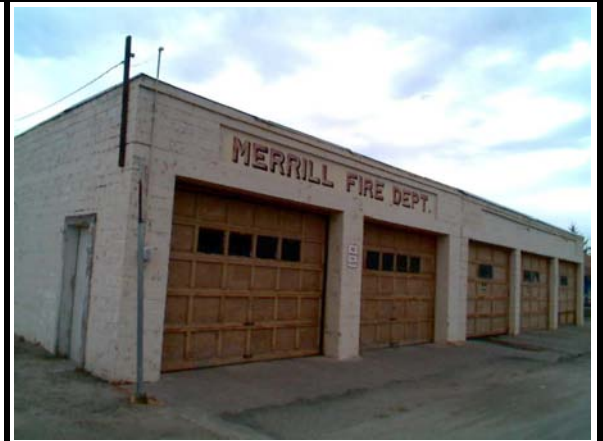
Seismicity Zone: High

| | Type | Basic Score | Vert Irreg | Plan Irreg | Pre-Code | Post-Bench | Soil C | Soil D | Soil E | RVS Score |
|---|---|---|---|---|---|---|---|---|---|---|
| Primary | RM1 | 2.8 | 0 | -0.5 | 0 | 0 | 0 | -0.6 | 0 | 1.7 |

1.7

Moderate (>1%)

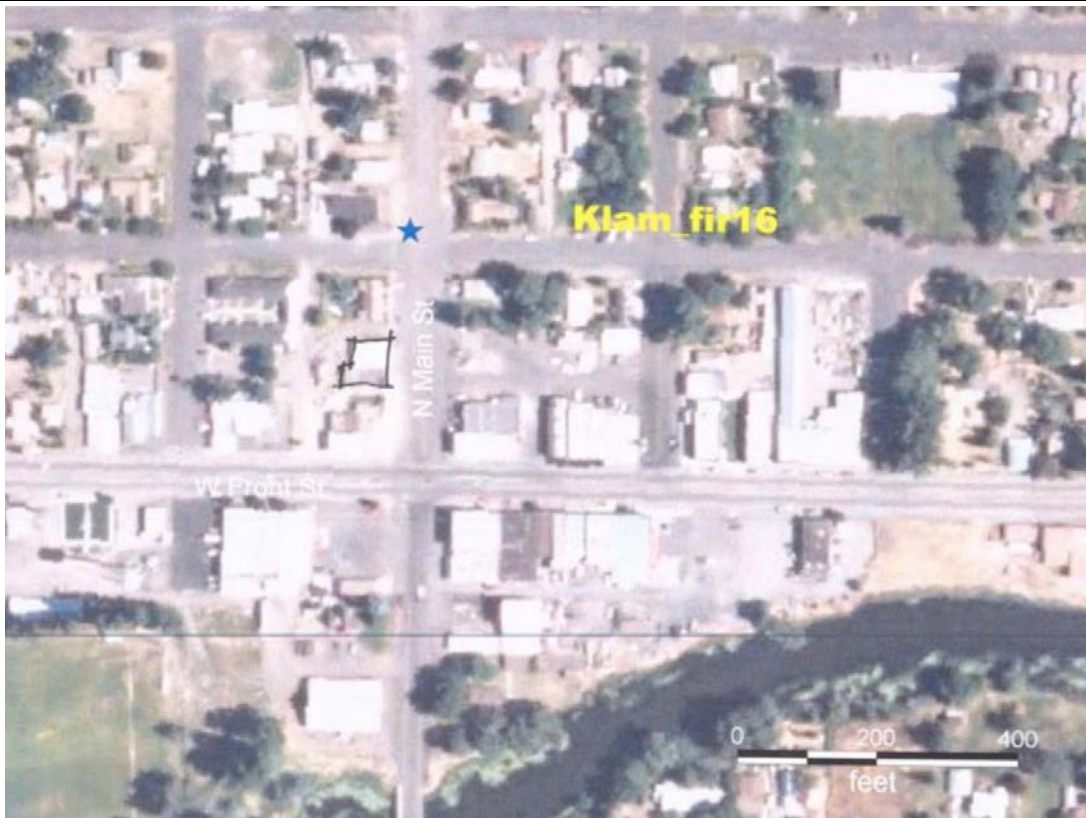
| Torsion: Eccentric Stiffness | None |
| Reentrant Corners: L Shaped | None |

| Unreinforced Chimneys | None |

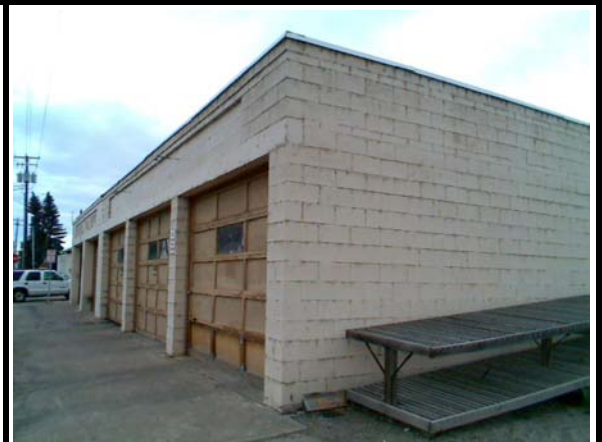
Seismicity Zone: High

| | Type | Basic Score | Vert Irreg | Plan Irreg | Pre-Code | Post-Bench | Soil C | Soil D | Soil E | RVS Score |
|---|---|---|---|---|---|---|---|---|---|---|
| Primary | RM1 | 2.8 | 0 | -0.5 | 0 | 0 | 0 | -0.6 | 0 | 1.7 |

1.7

Moderate (>1%)
