Merle West Medical Center - Klamath Falls

Klam_hos01A

Building Type	County	
Hospital	Klamath	
Street		
2865 Daggett Ave		
City	State	Zip
Klamath Falls	OR	97601
Latitude	Longitude	
42.25316	121.78483	
Tracking Code	Inspection Date	
New Building	7/20/2006

Rapid Visual Screening - Senate Bill #2 - Seismic Needs Assessment
Oregon Department of Geology and Mineral Industries

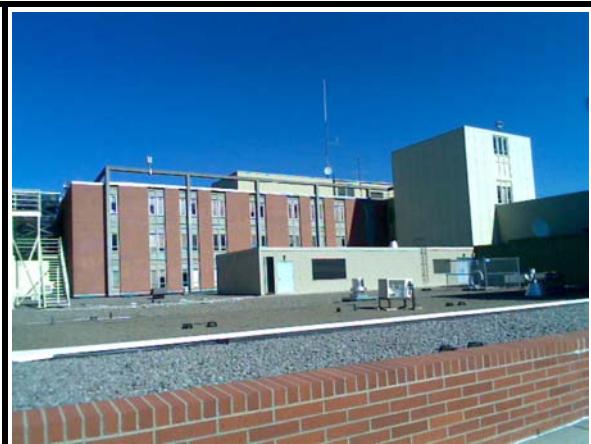
Type	Basic Score	Vert Irreg	Plan Irreg	Pre-Code	Post-Bench	Soil C	Soil D	Soil E	RVS Score
Primary	C1	2.9	-1.5	-0.5	0	0	0	0	0	0.9
Secondary	C1	2.9	-1.5	-0.5	0	0	0	0	0	0.9
Tertiary	RM1	3.2	-1	-0.5	0	0	0	0	0	1.7

Final Type	Final Score
C1	0.9

Low (<1%)

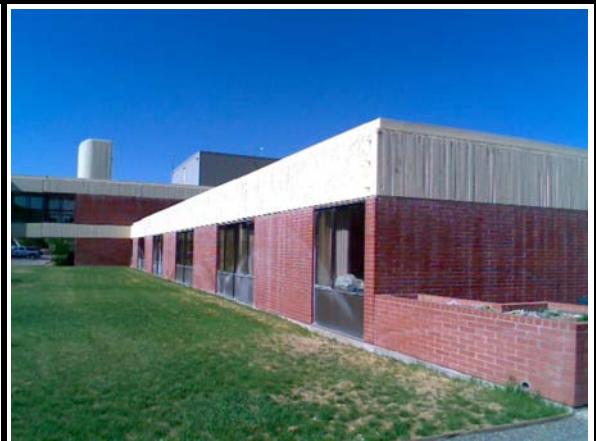
Klam_hos01B

C2 1.3

Low (<1%)

FEMA 154 Rapid Visual Screening Score Card										
	Type	Basic Score	Vert Irreg	Plan Irreg	Pre-Code	Post-Bench	Soil C	Soil D	Soil E	RVS Score
Primary	C2	2.8	-1	-0.5	0	0	0	0	0	1.3
Secondary	RM1	2.8	-1	-0.5	0	0	0	0	0	1.3
Tertiary		0	0	0	0	0	0	0	0	0

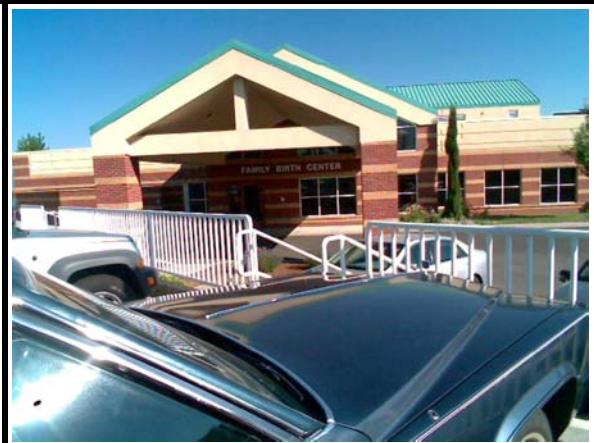
Klam_hos01C

Type	Basic Score	Vert Irreg	Plan Irreg	Pre-Code	Post-Bench	Soil C	Soil D	Soil E	RVS Score
Primary	RM1	2.8	-1	-0.5	0	0	0	0	0	1.3
Secondary	S2	3	-1.5	-0.5	0	0	0	0	0	1
Tertiary	C2	2.8	-1	-0.5	0	0	0	0	0	1.3

Final Type	Final Score
S2	1

Low (<1%)

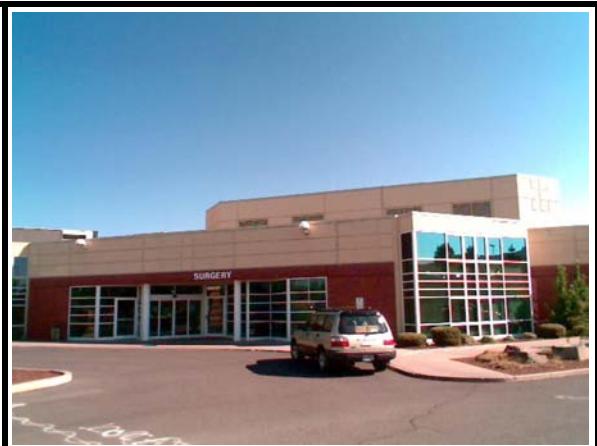
Klam_hos01D

Type	Basic Score	Vert Irreg	Plan Irreg	Pre-Code	Post-Bench	Soil C	Soil D	Soil E	RVS Score
Primary	S2	3	-1.5	-0.5	0	0	0	0	0	1
Secondary	RM1	2.8	-1	-0.5	0	0	0	0	0	1.3
Tertiary	C2	2.8	-1	-0.5	0	0	0	0	0	1.3

Final Type	Final Score
S2	1

Low (<1%)
