Mazama High School

Klamath Falls City Schools

Klam_sch18A

Rapid Visual Screening - Senate Bill #2 - Seismic Needs Assessment
Oregon Department of Geology and Mineral Industries

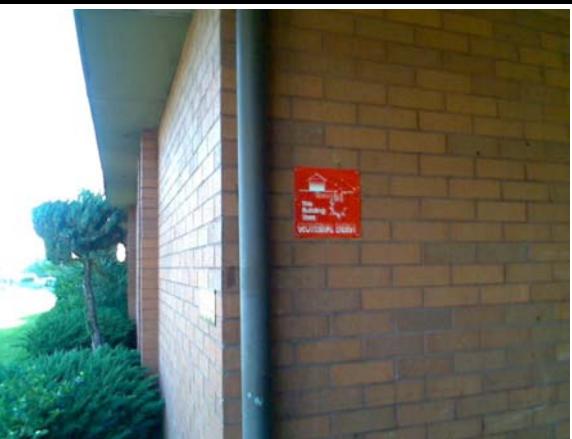
Building Type	County	
School	Klamath	
Street		
3009 Summers Ln		
City	State	Zip
Klamath Falls	OR	97603
Latitude	Longitude	
42.19859	121.73356	
Tracking Code	Inspection Date	
RVS in 2006	7/20/2006

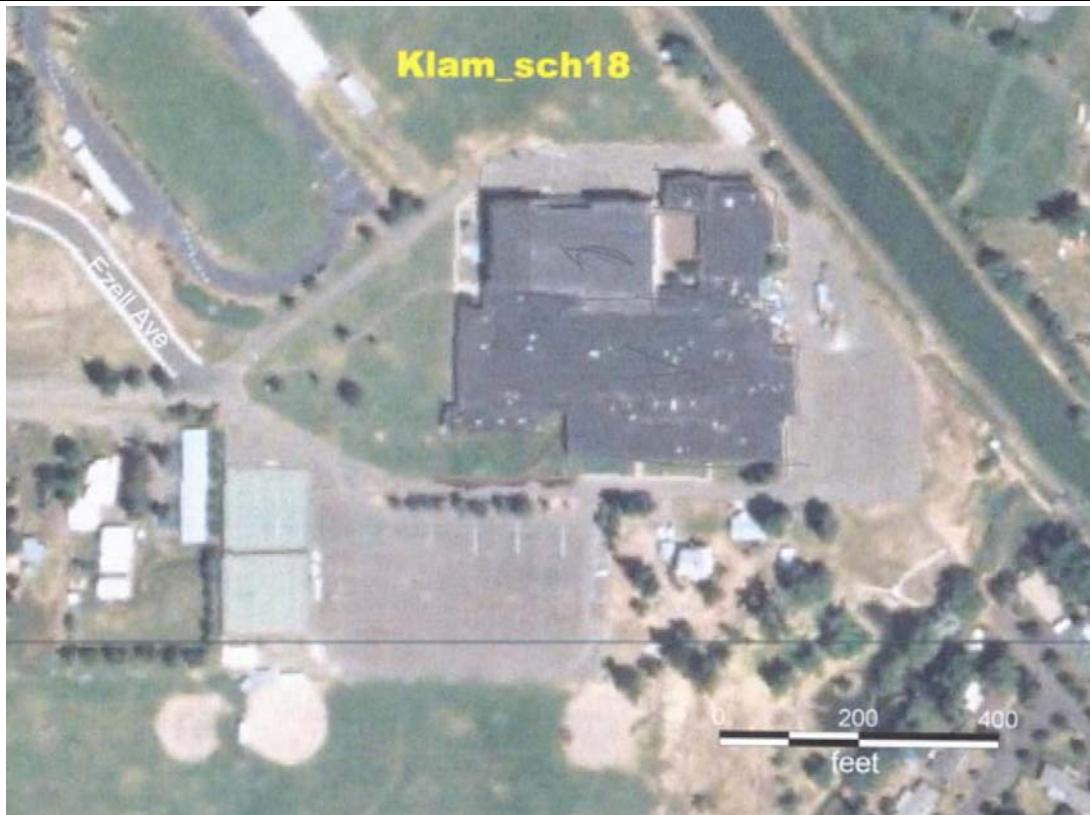
Type	Basic Score	Vert Irreg	Plan Irreg	Pre-Code	Post-Bench	Soil C	Soil D	Soil E	RVS Score
Primary	RM1	2.8	-1	-0.5	0	0	0	-0.6	0	0.7
Secondary		0	0	0	0	0	0	0	0	0
Tertiary		0	0	0	0	0	0	0	0	0

Final Type	Final Score
RM1	0.7

High (>10%)

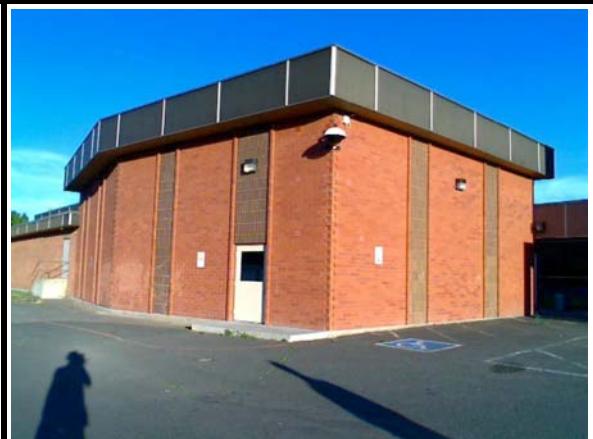
Klam_sch18B

Building Type	County
School	Klamath
Street	
3009 Summers Ln	
City	State Zip
Klamath Falls	OR 97603
Latitude	Longitude
42.19931	121.73328
Tracking Code	Inspection Date
RVS in 2006	7/20/2006

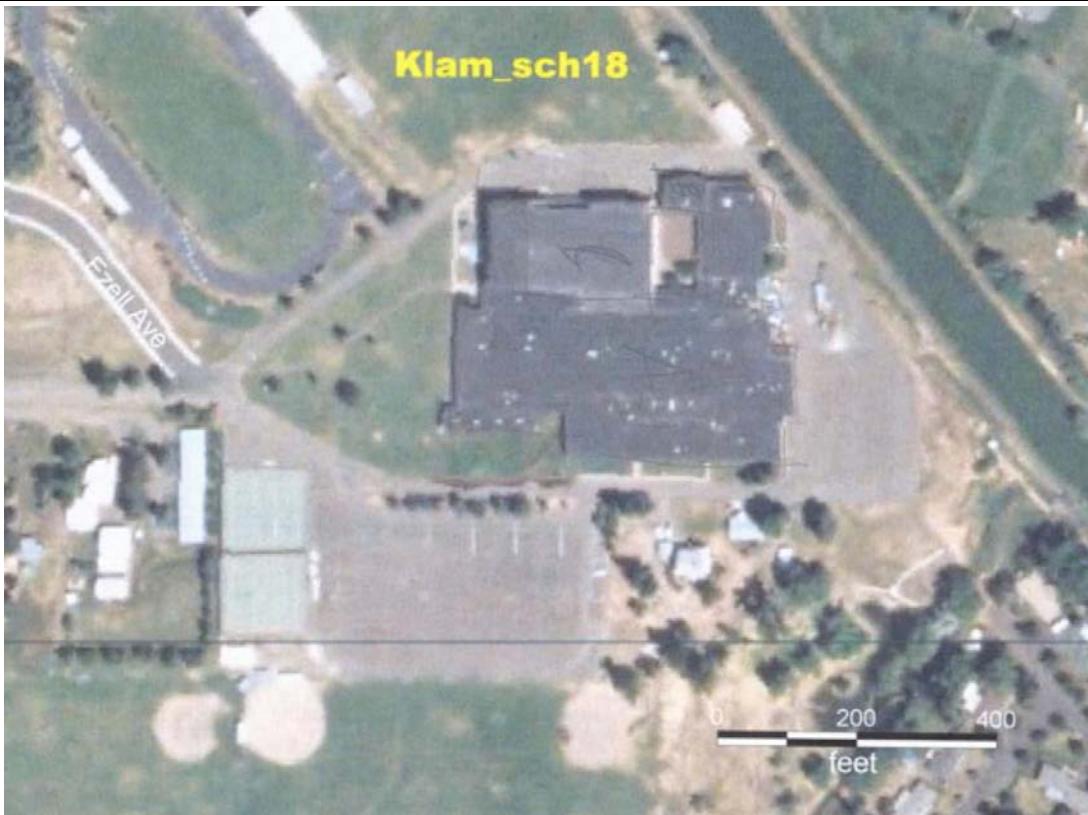
Type	Basic Score	Vert Irreg	Plan Irreg	Pre-Code	Post-Bench	Soil C	Soil D	Soil E	RVS Score
Primary	RM1	2.8	-1	-0.5	0	0	0	-0.6	0	0.7
Secondary		0	0	0	0	0	0	0	0	0
Tertiary		0	0	0	0	0	0	0	0	0

Final Type	Final Score
RM1	0.7

High (>10%)

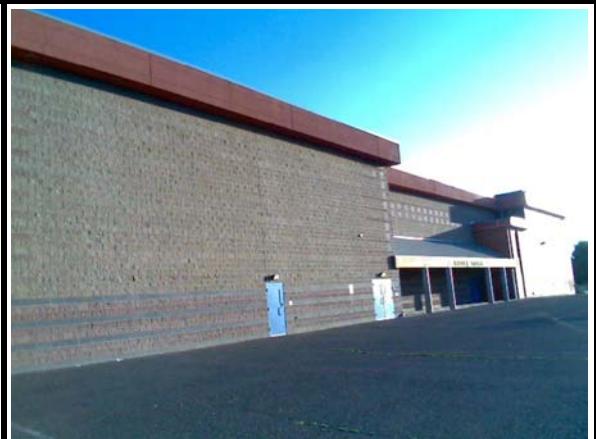
Klam_sch18C

Building Type	County
School	Klamath
Street	
3009 Summers Ln	
City	State Zip
Klamath Falls	OR 97603
Latitude	Longitude
42.19908	121.7339
Tracking Code	Inspection Date
RVS in 2006	7/20/2006
