Ponderosa Junior High School

Klamath Falls City Schools

FEMA 154 Rapid Visual Screening Score Card

Rapid Visual Screening - Senate Bill #2 - Seismic Needs Assessment
Oregon Department of Geology and Mineral Industries

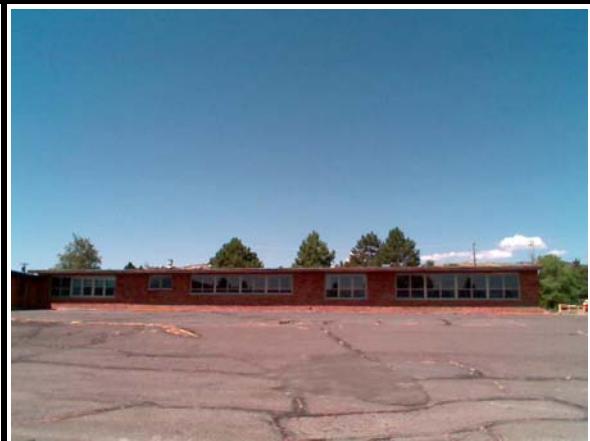
Klam_sch19A

Type	Basic Score	Vert Irreg	Plan Irreg	Pre-Code	Post-Bench	Soil C	Soil D	Soil E	RVS Score
Primary	C2	2.8	-1	-0.5	0	0	-0.4	0	0	0.9
Secondary	RM1	2.8	-1	-0.5	0	0	-0.4	0	0	0.9
Tertiary		0	0	0	0	0	0	0	0	0

Final Type	Final Score
C2	0.9

High (>10%)

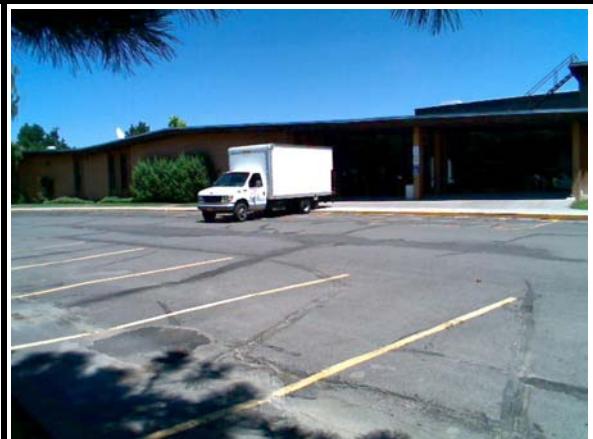
Klam_sch19B

Type	Basic Score	Vert Irreg	Plan Irreg	Pre-Code	Post-Bench	Soil C	Soil D	Soil E	RVS Score
Primary	RM1	2.8	-1	-0.5	0	0	-0.4	0	0	0.9
Secondary	C2	2.8	-1	-0.5	0	0	-0.4	0	0	0.9
Tertiary	W1	4.4	-2.5	-0.5	0	0	0	0	0	1.4

Final Type	Final Score
RM1	0.9

High (>10%)

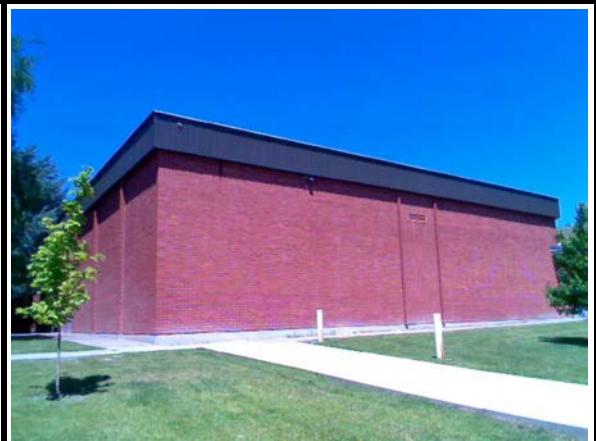
Klam_sch19C

Type	Basic Score	Vert Irreg	Plan Irreg	Pre-Code	Post-Bench	Soil C	Soil D	Soil E	RVS Score
Primary	RM1	2.8	-1	-0.5	0	0	-0.4	0	0	0.9
Secondary	C2	2.8	-1	-0.5	0	0	-0.4	0	0	0.9
Tertiary		0	0	0	0	0	0	0	0	0

Final Type	Final Score
RM1	0.9

High (>10%)
