Joseph Conger Elementary School

Klamath Falls City Schools

FEMA 154 Rapid Visual Screening Score Card

Rapid Visual Screening - Senate Bill #2 - Seismic Needs Assessment
Oregon Department of Geology and Mineral Industries

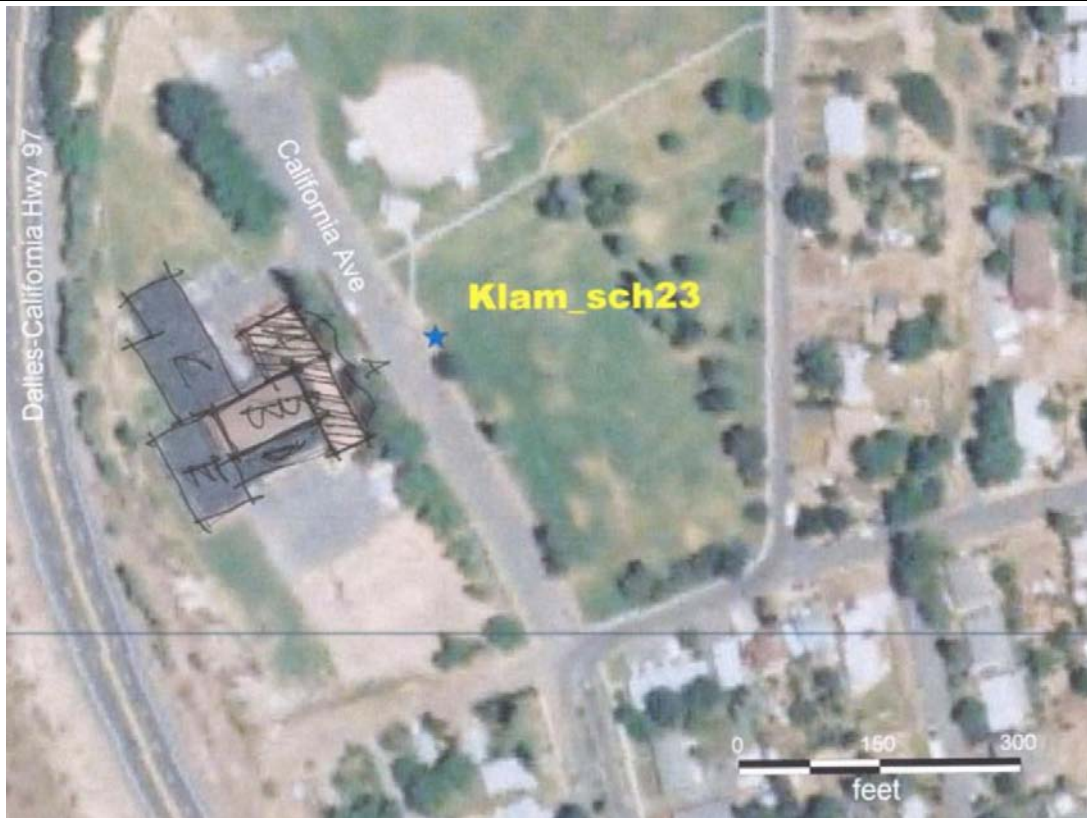
Klam_sch23A

URM

-0.5

Very High (100%)

Plan Irregularities	Vertical Irregularities
Reentrant Corners: L Shaped	Steps in Elevation View: Single Change
Reentrant Corners: Other	Steps in Elevation View: 2 to 3 Changes (Adjacent Building/Entity)
None	None

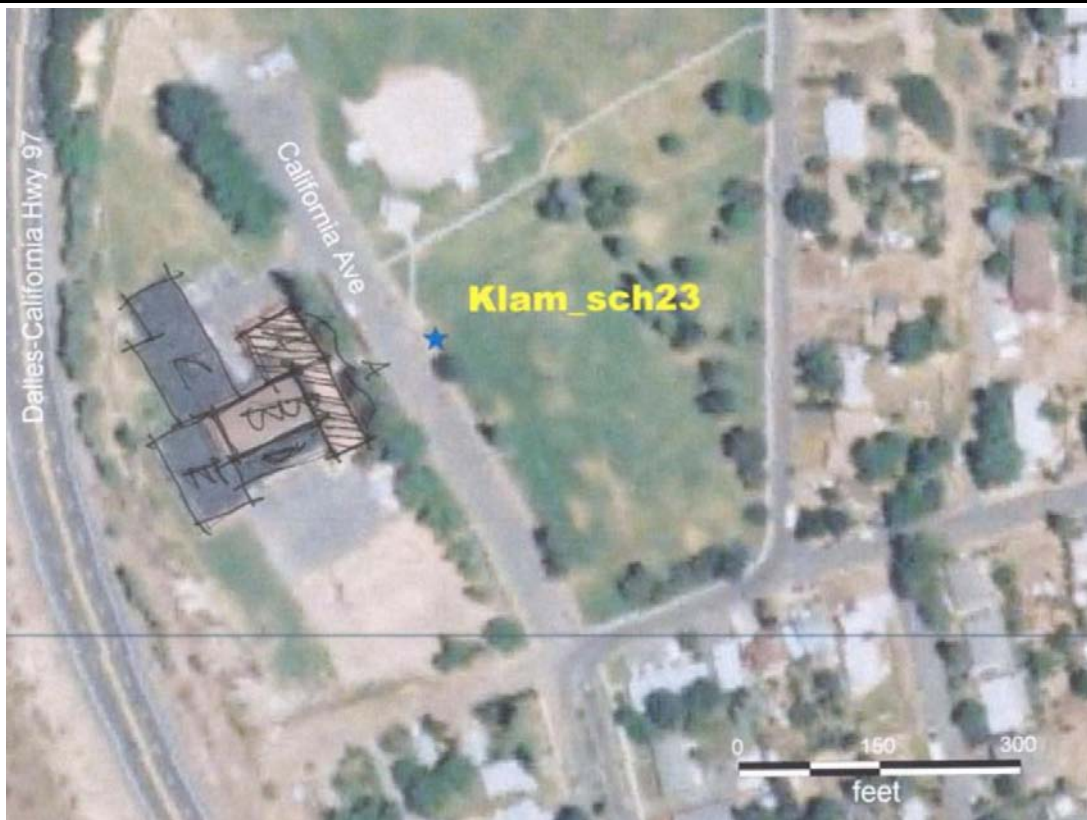
Klam_sch23B

C2

-0.3

Very High (100%)

Plan Irregularities	Vertical Irregularities
Reentrant Corners: Other (Adjacent Build/Entity)	Steps in Elevation View: 2 to 3 Changes (Adjacent Building/Entity)
None	None
None	None

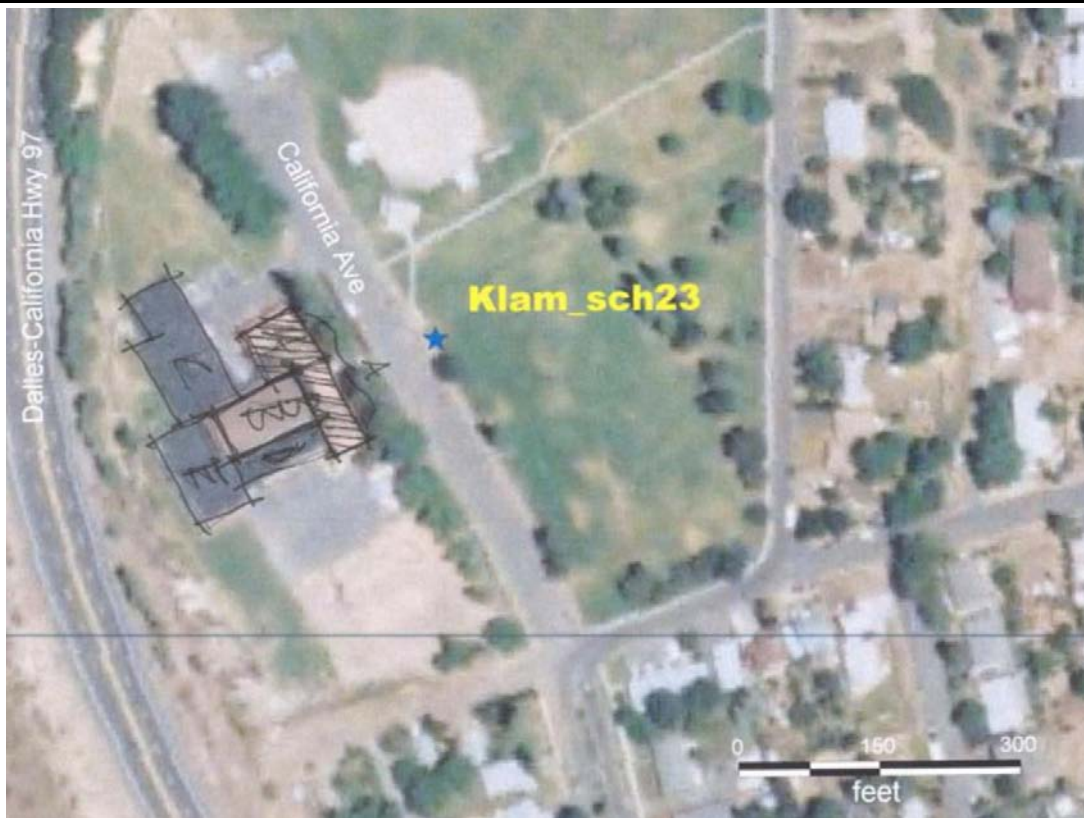
Klam_sch23C

RM1

0.7

High (>10%)

Plan Irregularities	Vertical Irregularities
Reentrant Corners:L shaped (Adjacent Build/Entity)	Steps in Elevation View: Single Change (Adjacent Building/Entity)
None	None
None	None

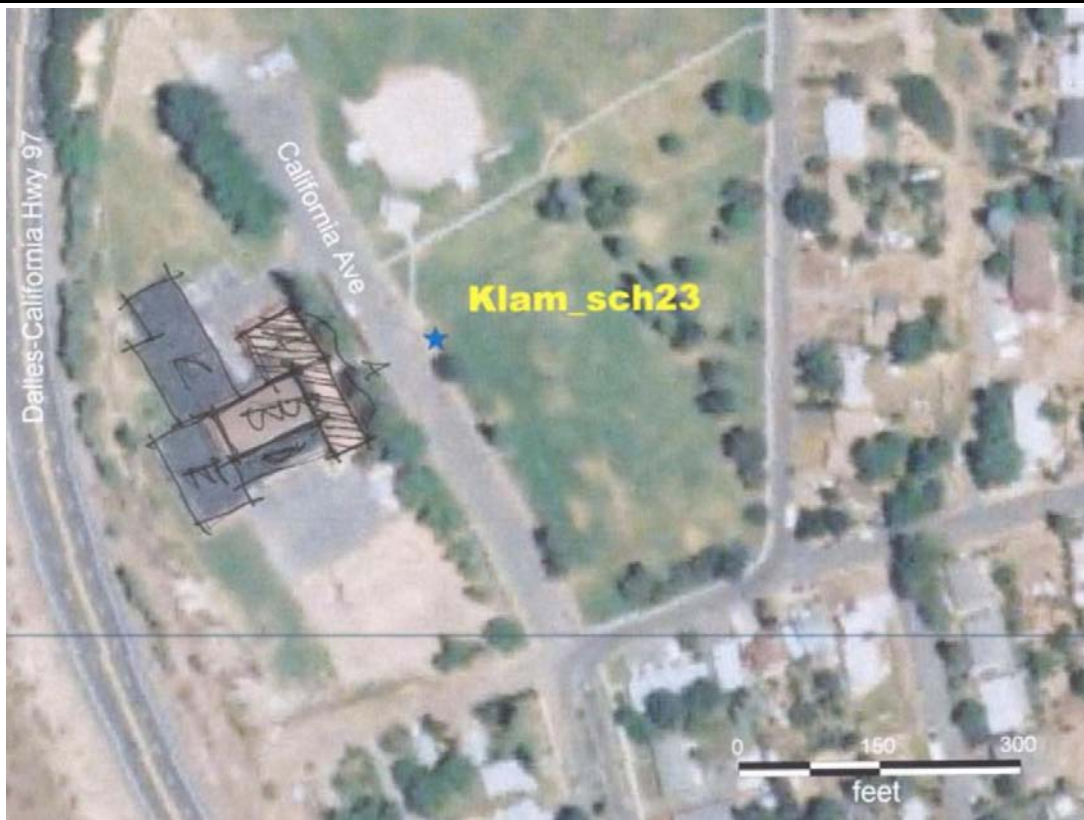
Klam_sch23D

RM1

0.7

High (>10%)

Plan Irregularities	Vertical Irregularities
Reentrant Corners:Other (Adjacent Build/Entity)	Steps in Elevation View: 2 to 3 Changes (Adjacent Building/Entity)
None	None
None	None
