Lake District Hospital - Lakeview

Lake_hos01A

FEMA 154 Rapid Visual Screening Score Card

Rapid Visual Screening - Senate Bill #2 - Seismic Needs Assessment
Oregon Department of Geology and Mineral Industries

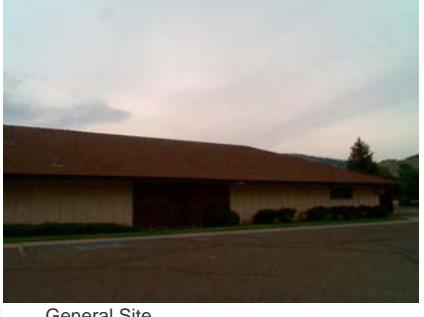
S Primary Structural Type looks like wood beams inside	S Primary Structural Type wood beams coming from inside going outside.	E Primary Structural Type wood beams

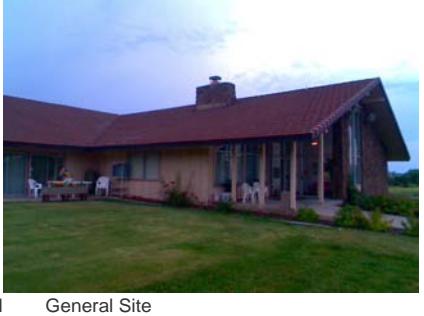
W General Site	N Primary Structural Type wood post and beams	N General Site
