Fremont/Hay Elementary School

Lake County SD 7

FEMA 154 Rapid Visual Screening Score Card

Rapid Visual Screening - Senate Bill #2 - Seismic Needs Assessment
Oregon Department of Geology and Mineral Industries

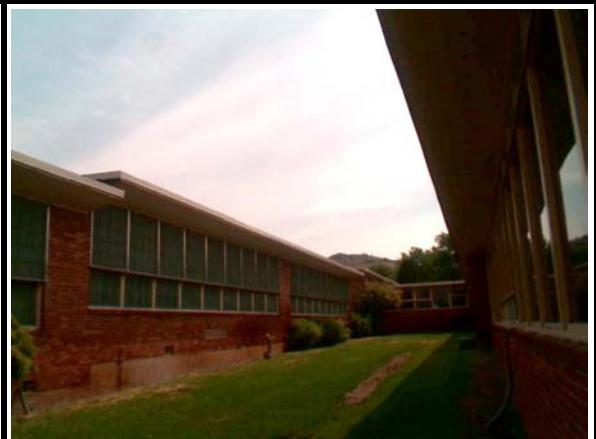
Lake_sch02A

Seismicity Zone: Moderate

Type	Basic Score	Vert Irreg	Plan Irreg	Pre-Code	Post-Bench	Soil C	Soil D	Soil E	RVS Score
Primary	W2	4.8	-3	-0.5	0	0	0	-1.2	0	0.1
Secondary		0	0	0	0	0	0	0	0	0
Tertiary		0	0	0	0	0	0	0	0	0

Final Type	Final Score
W2	0.1

High (>10%)

Enrollment 324	Year Built (Field Verified) 1920	Year Built (Alt. Source) 1920	Est. Decade Built 1950
Total Area (square ft) 17500	Number of Stories 1	Basement	Pounding Potential No
Plan Irregularities Reentrant Corners: H Shaped None None		Vertical Irregularities Steps in Elevation View: Single Change None None	
Falling Hazards Other: Brick Veneer None None		Poor Conditions None None None

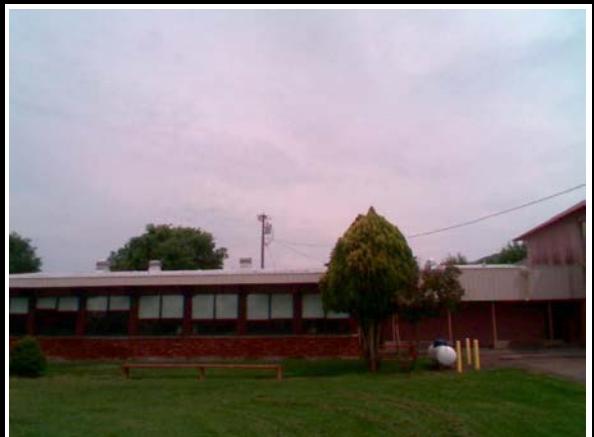
Lake_sch02B

Seismicity Zone: Moderate

Type	Basic Score	Vert Irreg	Plan Irreg	Pre-Code	Post-Bench	Soil C	Soil D	Soil E	RVS Score
Primary	W2	4.8	-3	-0.5	-0.2	0	0	-1.2	0	-0.1
Secondary		0	0	0	0	0	0	0	0	0
Tertiary		0	0	0	0	0	0	0	0	0

Final Type	Final Score
W2	-0.1

Very High (100%)

Enrollment 324	Year Built (Field Verified) 1920	Year Built (Alt. Source) 1940	Est. Decade Built 1940
Total Area (square ft) 17500	Number of Stories 1	Basement No	Pounding Potential Yes
Plan Irregularities Reentrant Corners:L shaped (Adjacent Build/Entity) None None		Vertical Irregularities Steps in Elevation View: Single Change (Adjacent Building/Entity) None None	
Falling Hazards None None None		Poor Conditions None None None

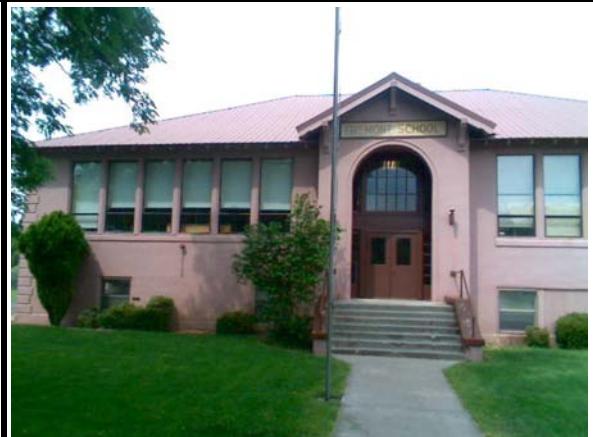
Lake_sch02C

Seismicity Zone: Moderate

Enrollment 324	Year Built (Field Verified) 1920	Year Built (Alt. Source) 1920	Est. Decade Built 1920
Total Area (square ft) 17500	Number of Stories 1	Basement	Pounding Potential Yes
Plan Irregularities Reentrant Corners:L shaped (Adjacent Build/Entity) None None		Vertical Irregularities Steps in Elevation View: Single Change (Adjacent Building/Entity) None None	
Falling Hazards None None None		Poor Conditions None None None
