# Creswell Station

Building Type Fire - RFPD	County Lane	
Street 55 1st St		
City Creswell	State OR	Zip 97426
Latitude 43.91742	Longitude 123.02024	
Tracking Code RVS in 2006	Inspection Date 7/21/2006

Rapid Visual Screening - Senate Bill #2 - Seismic Needs Assessment  
Oregon Department of Geology and Mineral Industries

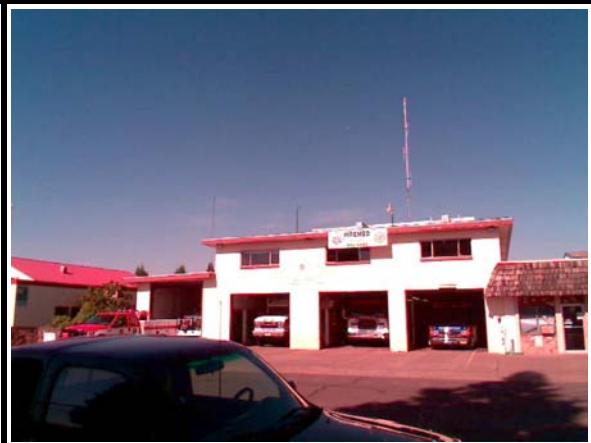
Seismicity Zone: High

Type	Basic Score	Vert Irreg	Plan Irreg	Pre-Code	Post-Bench	Soil C	Soil D	Soil E	RVS Score
Primary	RM1	2.8	-1	-0.5	0	0	0	-0.6	0	0.7
Secondary		0	0	0	0	0	0	0	0	0
Tertiary		0	0	0	0	0	0	0	0	0

Final Type	Final Score
RM1	0.7

High (>10%)
