Siuslaw Valley F & R

Lane_fir14A

FEMA 154 Rapid Visual Screening Score Card

Rapid Visual Screening - Senate Bill #2 - Seismic Needs Assessment
Oregon Department of Geology and Mineral Industries

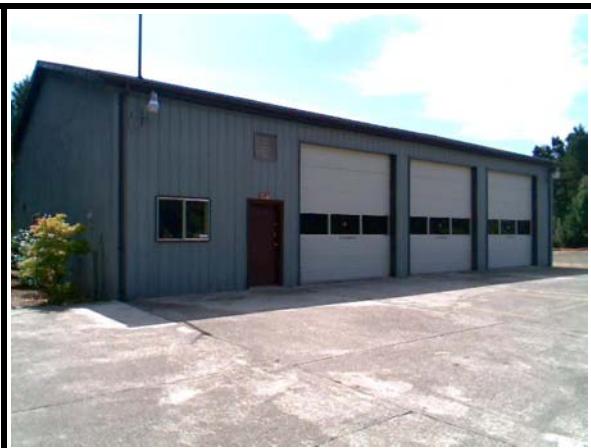
Seismicity Zone: Very High

Type	Basic Score	Vert Irreg	Plan Irreg	Pre-Code	Post-Bench	Soil C	Soil D	Soil E	RVS Score
Primary	S3	3.2	0	-0.5	0	0	0	-0.6	0	2.1
Secondary		0	0	0	0	0	0	0	0	0
Tertiary		0	0	0	0	0	0	0	0	0

Final Type	Final Score
S3	2.1

Low (<1%)
