Mckenzie Fire & Rescue

Lane_fir24A

Building Type Fire - RFPD	County Lane	
Street 49243 Mckenzie Highway		
City Vida	State OR	Zip 97488
Latitude 44.1115	Longitude 122.43265	
Tracking Code RVS in 2006	Inspection Date 7/20/2006

Rapid Visual Screening - Senate Bill #2 - Seismic Needs Assessment
Oregon Department of Geology and Mineral Industries

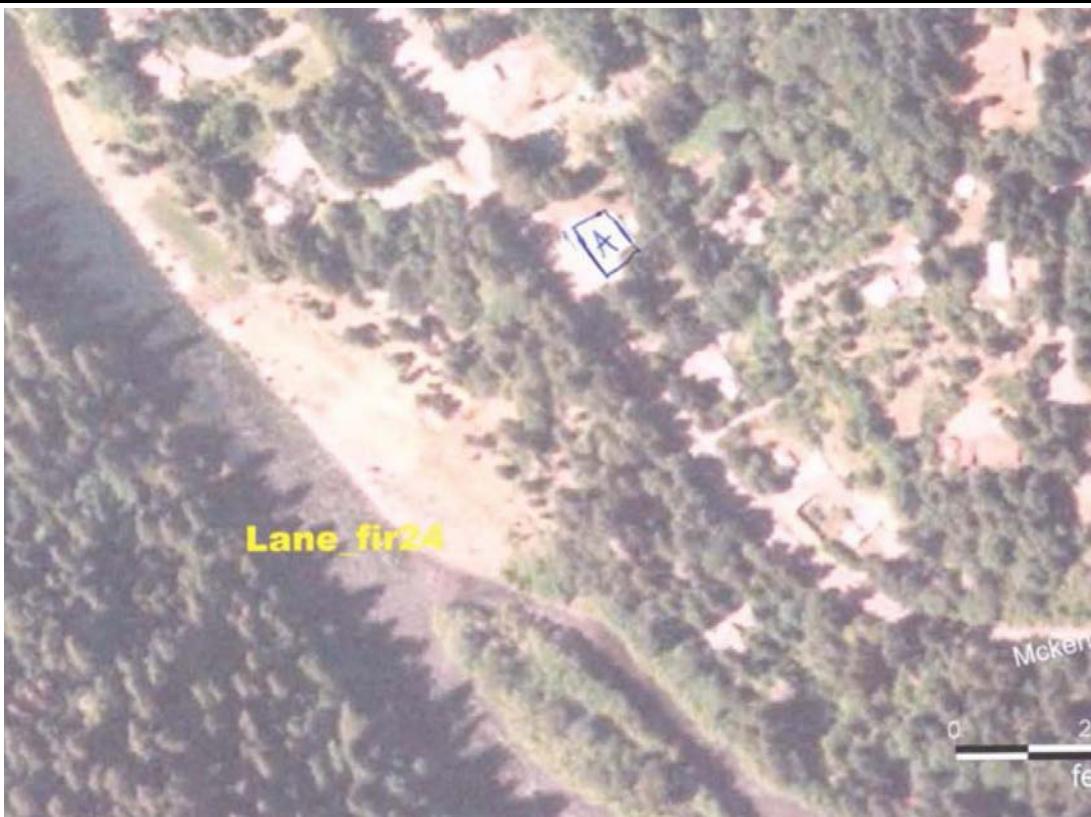
Seismicity Zone: Moderate										
FEMA 154 Rapid Visual Screening Score Card										
	Type	Basic Score	Vert Irreg	Plan Irreg	Pre-Code	Post-Bench	Soil C	Soil D	Soil E	RVS Score
Primary	W2	4.8	0	-0.5	0	1.6	-0.8	0	0	5.1
Secondary		0	0	0	0	0	0	0	0	0
Tertiary		0	0	0	0	0	0	0	0	0

Final Type	Final Score
W2	5.1

Low (<1%)
