# Swisshome-Deadwood RFPD

Lane\_fir41A

## FEMA 154 Rapid Visual Screening Score Card

Rapid Visual Screening - Senate Bill #2 - Seismic Needs Assessment  
Oregon Department of Geology and Mineral Industries

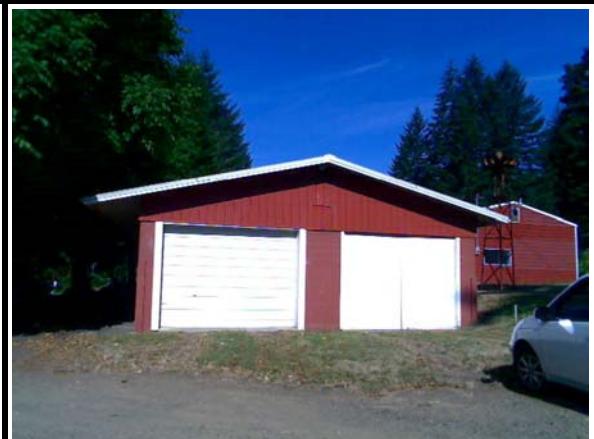
Type	Basic Score	Vert Irreg	Plan Irreg	Pre-Code	Post-Bench	Soil C	Soil D	Soil E	RVS Score
Primary	RM1	2.8	-1	-0.5	0	0	-0.4	0	0	0.9
Secondary	S3	3.2	0	-0.5	0	0	-0.4	0	0	2.3
Tertiary		0	0	0	0	0	0	0	0	0

Final Type	Final Score
RM1	0.9

High (>10%)

Enrollment	Year Built (Field Verified)	Year Built (Alt. Source)	Est. Decade Built
			1970
Total Area (square ft)	Number of Stories	Basement	Pounding Potential
	1	No	No
Plan Irregularities		Vertical Irregularities	
Torsion: Eccentric Stiffness		Vertical Change in Structural Type (Soft over Stiff)	
None		None	
None		None	
Falling Hazards		Poor Conditions	
None		None	
None		None	
None		None

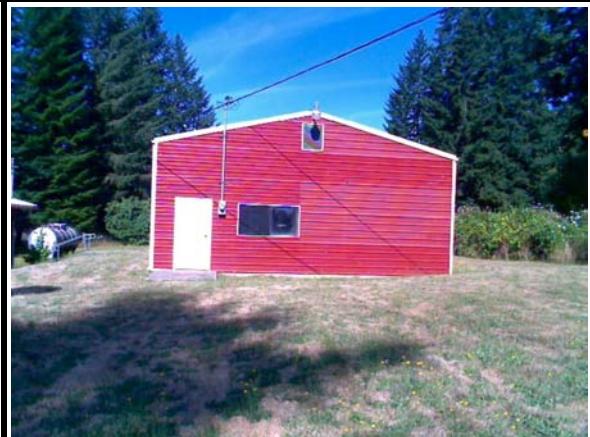
Lane\_fir41B

Type	Basic Score	Vert Irreg	Plan Irreg	Pre-Code	Post-Bench	Soil C	Soil D	Soil E	RVS Score
Primary	S3	3.2	0	-0.5	0	0	-0.4	0	0	2.3
Secondary		0	0	0	0	0	0	0	0	0
Tertiary		0	0	0	0	0	0	0	0	0

Final Type	Final Score
S3	2.3

Low (<1%)

Enrollment	Year Built (Field Verified)	Year Built (Alt. Source)	Est. Decade Built
			1980
Total Area (square ft)	Number of Stories	Basement	Pounding Potential
	1	No	No
Plan Irregularities		Vertical Irregularities	
Torsion: Eccentric Stiffness		None	
None		None	
None		None	
Falling Hazards		Poor Conditions	
None		None	
None		None	
None		None
