Sacred Heart Medical Center - Eugene

Lane_hos03A

Street 1255 Hilyard St		
City Eugene	State OR	Zip 97401
Latitude 44.04699	Longitude 123.08114	
Tracking Code New Building	Inspection Date 7/20/2006

Rapid Visual Screening - Senate Bill #2 - Seismic Needs Assessment
Oregon Department of Geology and Mineral Industries

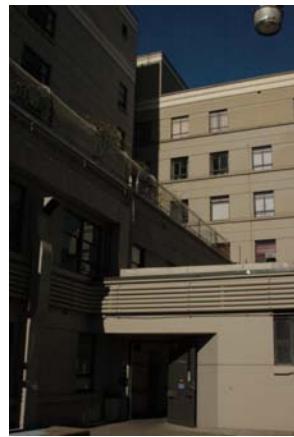
FEMA 154 Rapid Visual Screening Score Card										
	Type	Basic Score	Vert Irreg	Plan Irreg	Pre-Code	Post-Bench	Soil C	Soil D	Soil E	RVS Score
Primary	C2	3.2	-1	-0.5	-1	0	0	0	0	0.7
Secondary		0	0	0	0	0	0	0	0	0
Tertiary		0	0	0	0	0	0	0	0	0

Final Type C2	Final Score 0.7
------------------	--------------------

Low (<1%)

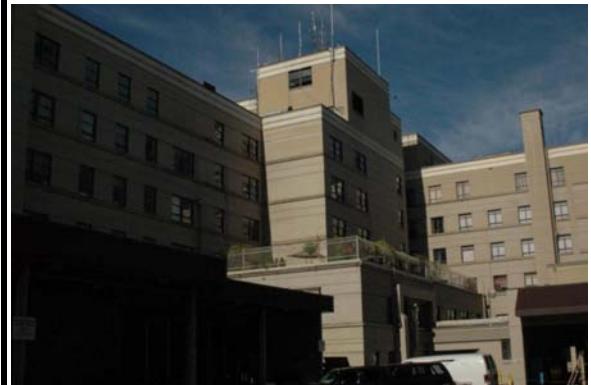
Lane_hos03B

Type	Basic Score	Vert Irreg	Plan Irreg	Pre-Code	Post-Bench	Soil C	Soil D	Soil E	RVS Score
Primary	C2	3.2	0	-0.5	0	0	0	0	0	2.7
Secondary		0	0	0	0	0	0	0	0	0
Tertiary		0	0	0	0	0	0	0	0	0

Final Type	Final Score
C2	2.7

Low (<1%)

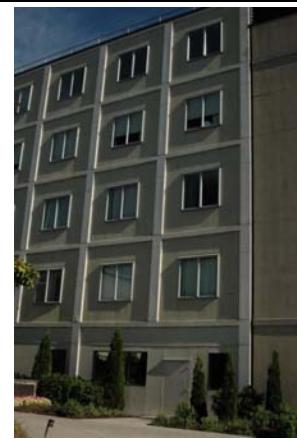
Lane_hos03C

C1 0.9

Low (<1%)

FEMA 154 Rapid Visual Screening Score Card										
	Type	Basic Score	Vert Irreg	Plan Irreg	Pre-Code	Post-Bench	Soil C	Soil D	Soil E	RVS Score
Primary	C1	2.9	-1.5	-0.5	0	0	0	0	0	0.9
Secondary	C2	3.2	-1	-0.5	0	0	0	0	0	1.7
Tertiary		0	0	0	0	0	0	0	0	0

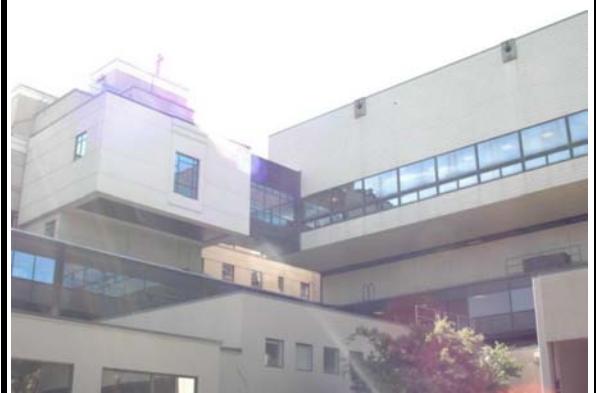
Lane_hos03D

FEMA 154 Rapid Visual Screening Score Card										
	Type	Basic Score	Vert Irreg	Plan Irreg	Pre-Code	Post-Bench	Soil C	Soil D	Soil E	RVS Score
Primary	S4	3.2	-1	-0.5	0	0	0	0	0	1.7
Secondary	C1	2.9	-1.5	-0.5	0	0	0	0	0	0.9
Tertiary		0	0	0	0	0	0	0	0	0

Final Type	Final Score
C1	0.9

Low (<1%)

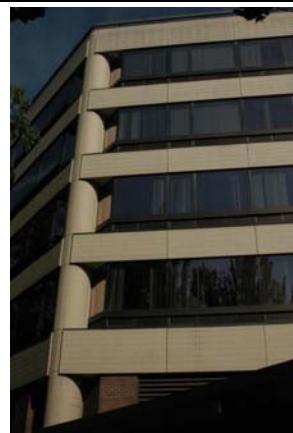
Lane_hos03E

Final Type C1	Final Score 0.9
------------------	--------------------

Low (<1%)
